INSPECTION OF: Site Scaffoldings

SITE: Aberavon House, Port Talbot, SA13 1 PB

UNIQUE IDENTIFICATION NUMBER: AS 260 North Elevation

Date of Scaffold Inspection: Tuesday 27th March 2018

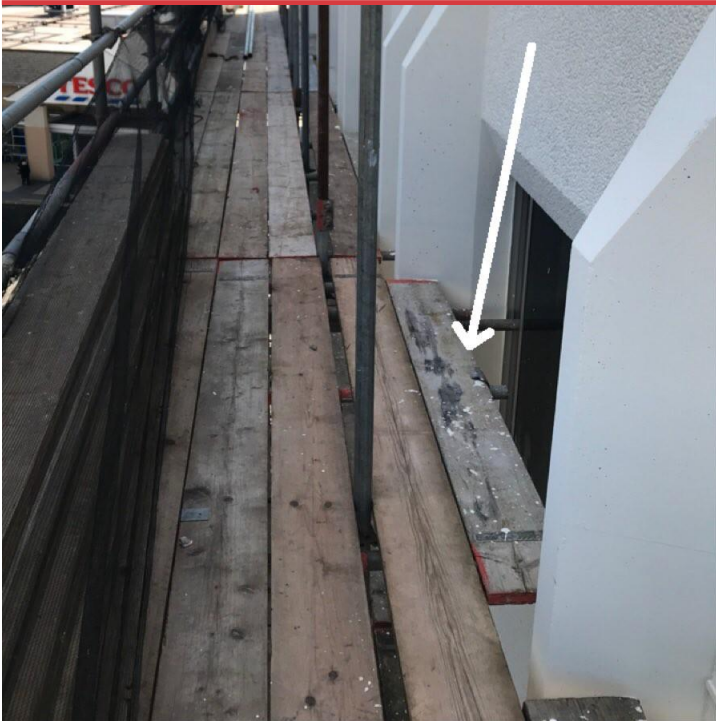
NORTH ELEVATION TOP WORKING LIFT

The Working Lifts are clear of waste materials and debris but there are gaps between the Working Lift and the Internal Area, this gap needs to be eliminated in order to prevent objects falling into the Internal area.

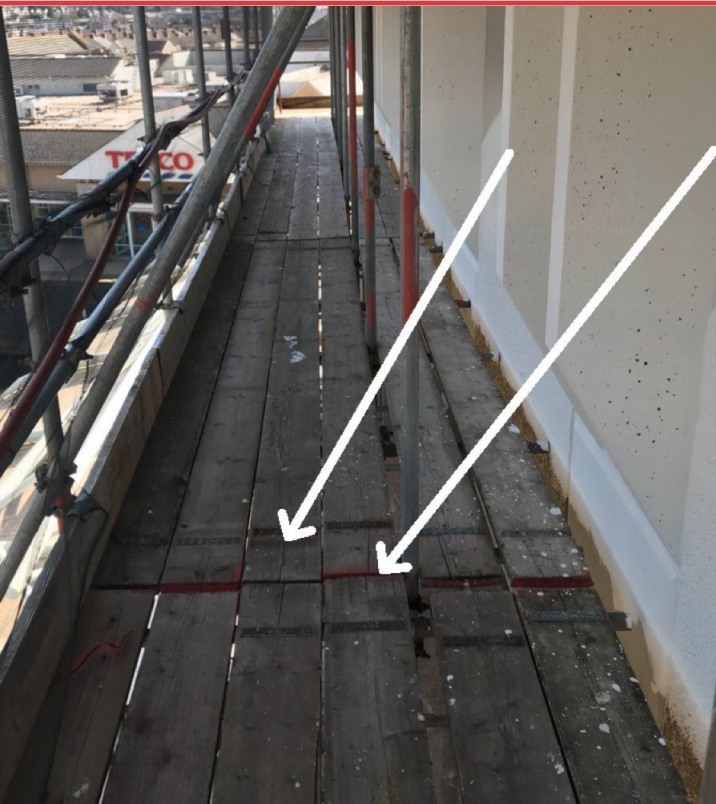
NORTH ELEVATION

The Working Lifts were clear of waste materials and debris at the time of the scaffold inspection, but there was evidence of warped boards which are a potential tripping hazard

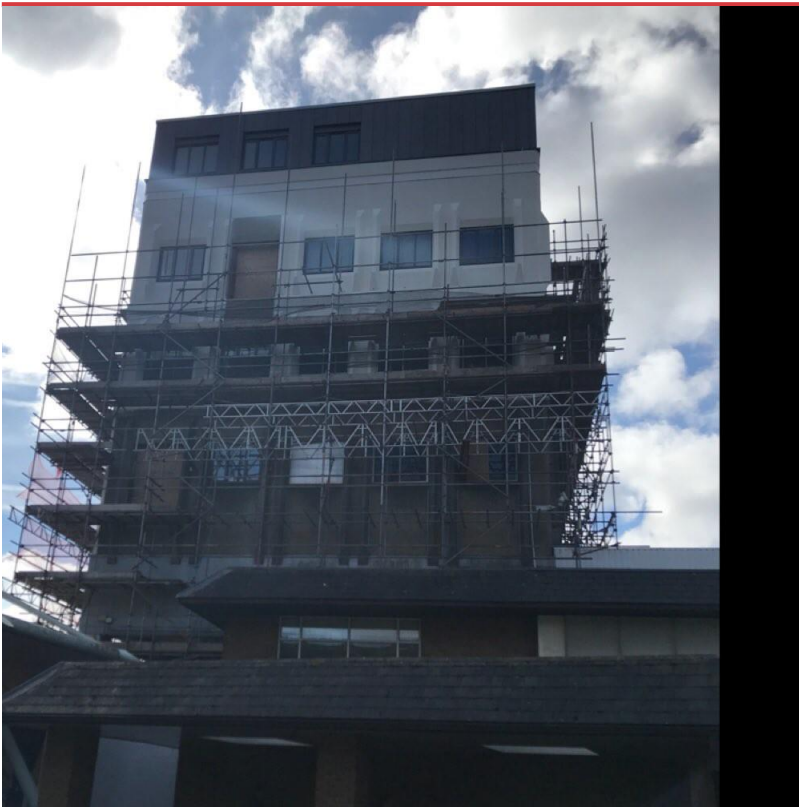
NORTH ELEVATION

There are sufficient Handrails on the Working Lifts since the modifications-and alterations in order to prevent falls from height and objects falling from height.

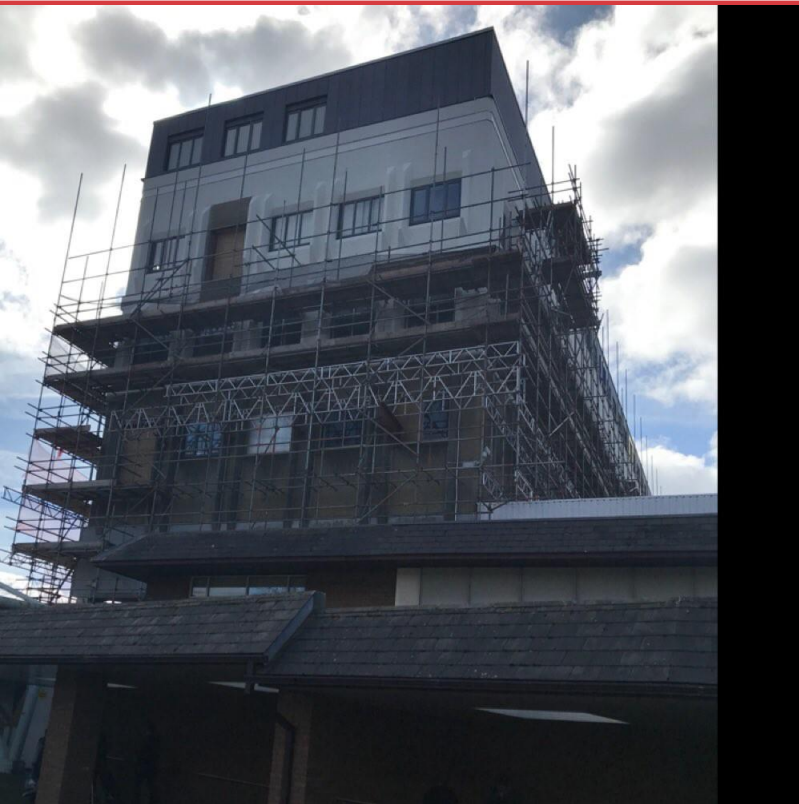
NORTH ELEVATION

The highest Working Lift has been shortened due to the requirements of the Contractors for the Pod

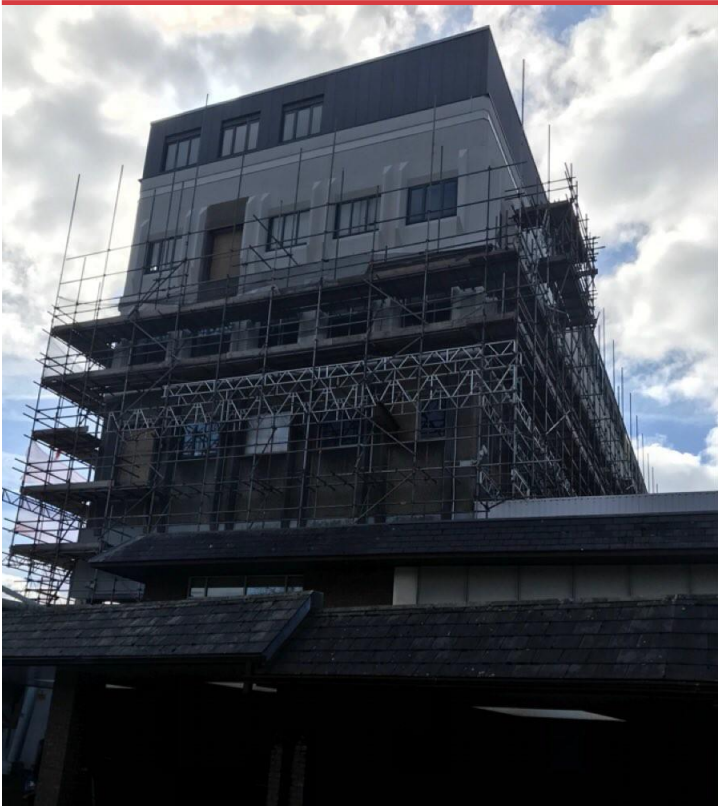
NORTH ELEVATION

The highest Working Lift has been shortened due to the requirements of the Contractors for the Pod

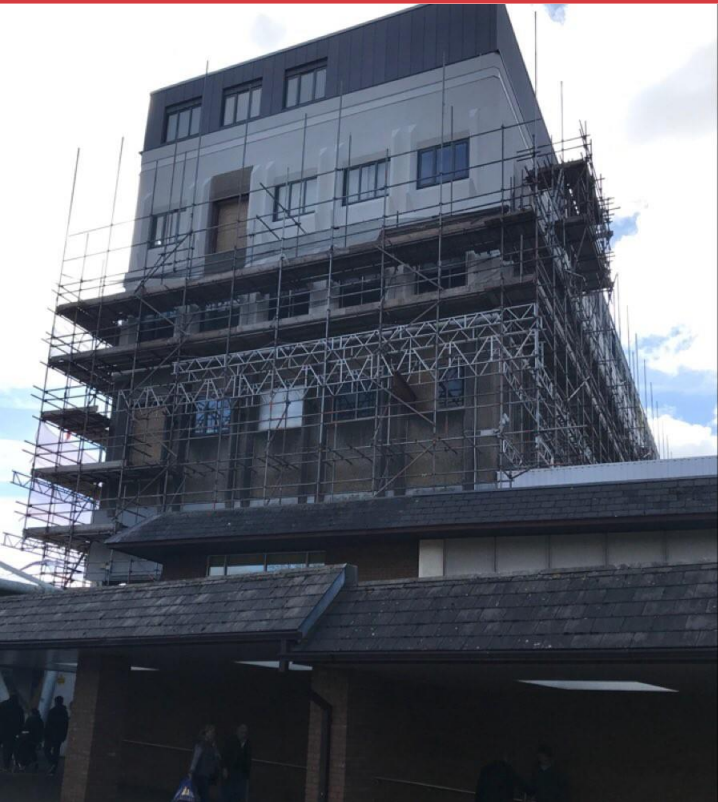
NORTH ELEVATION

Modifications to the scaffold on the North Elevation had taken place since the previous scaffold inspection

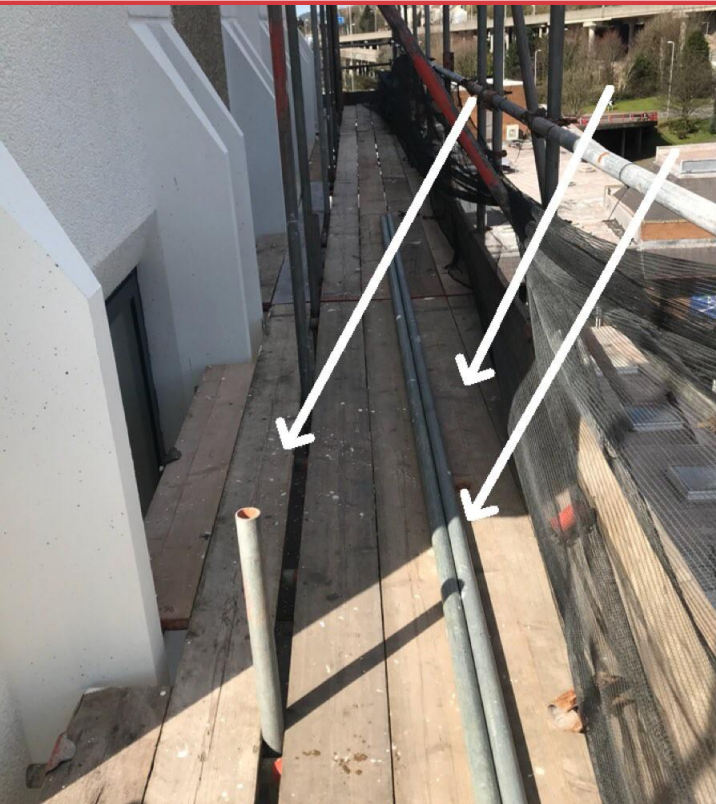
NORTH ELEVATION

There are scaffold materials that need to be removed prior to next use.

The protruding tube is due to Contractors requirement to fit materials externally to the building, the tubes should either be cut flush to the same level as the Working Lift or raised 1m above the Working Lift

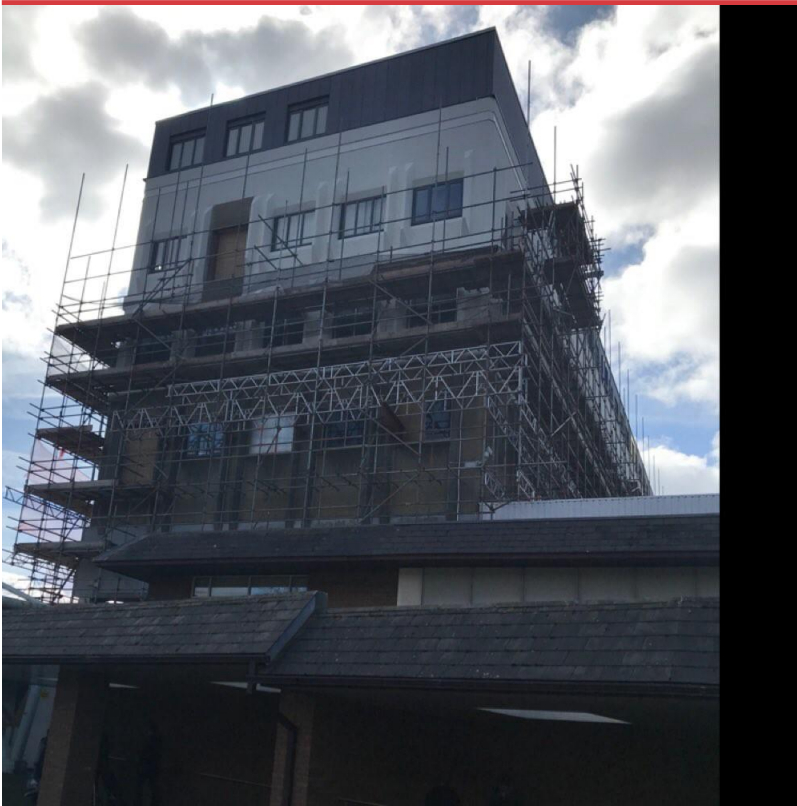
NORTH ELEVATION

There are ongoing modifications and alterations on the scaffold on the North Elevation, this scaffold needs to be clear of scaffold materials placed on the Working Lift and all modifications completed by the Scaffold Contractor prior t next use
