INSPECTION OF: Site Scaffoldings

SITE: Aberavon House, Port Talbot, SA13 1 PB

UNIQUE IDENTIFICATION NUMBER: AS 260 Front Elevation

Date of Scaffold Inspection: Tuesday 27th March 2018

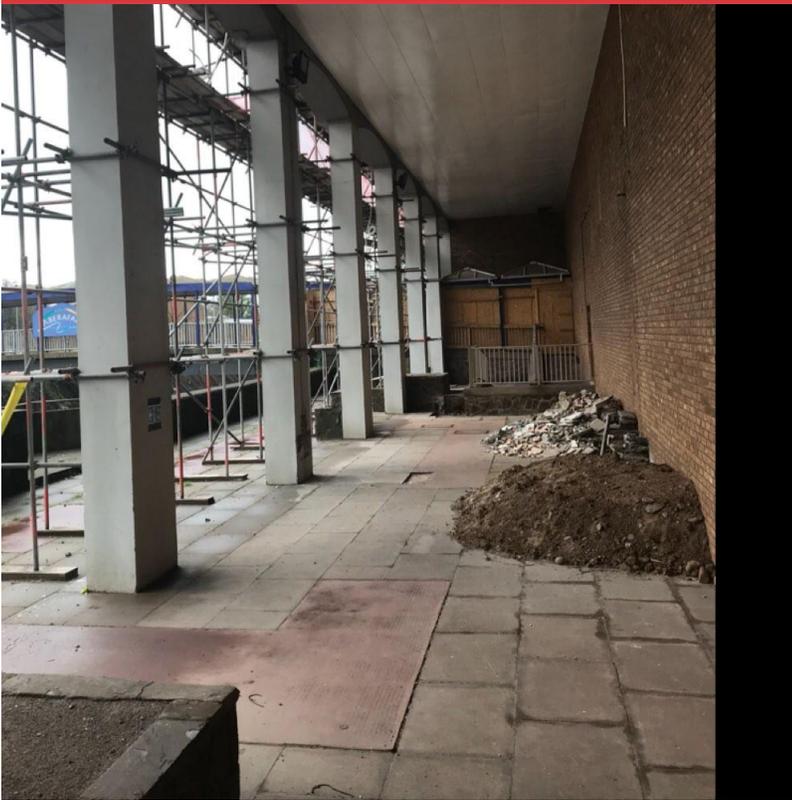
FRONT ELEVATION

There are sufficient ties around the Pillars of the scaffold on the Front Elevation in order to meet the requirements of the Design and TG20:13

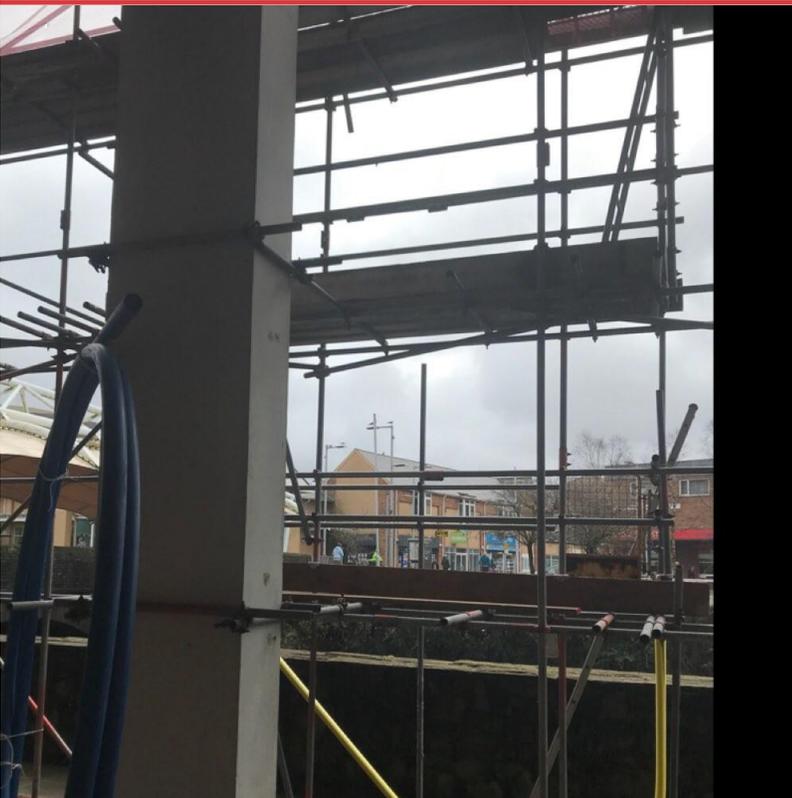
FRONT ELEVATION

There are sufficient ties around the Pillars of the scaffold on the Front Elevation in order to meet the requirements of the Design and TG20:13

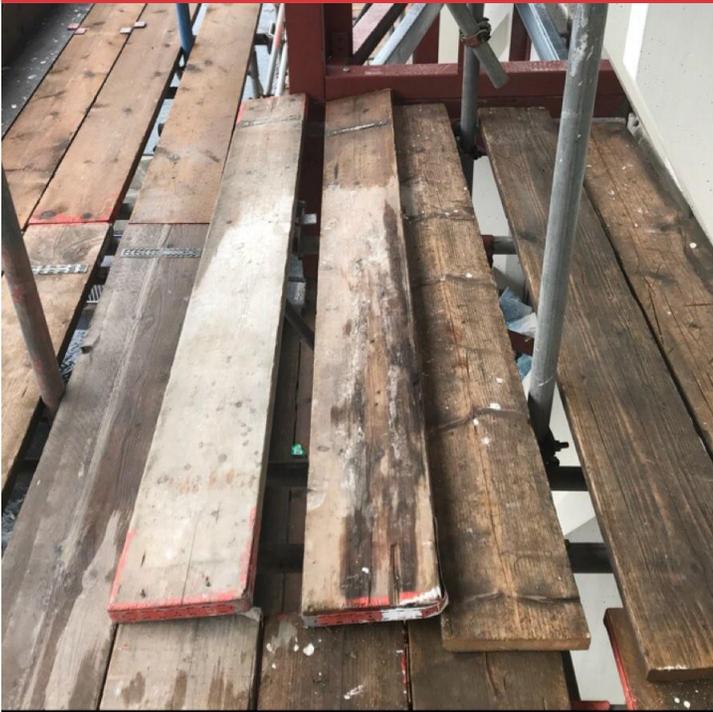
FRONT ELEVATION

Scaffold materials need to be removed from the Top Working Lift prior to the next use, modifications were taking place at the time of the scaffold inspection and these need to be completed prior to next use

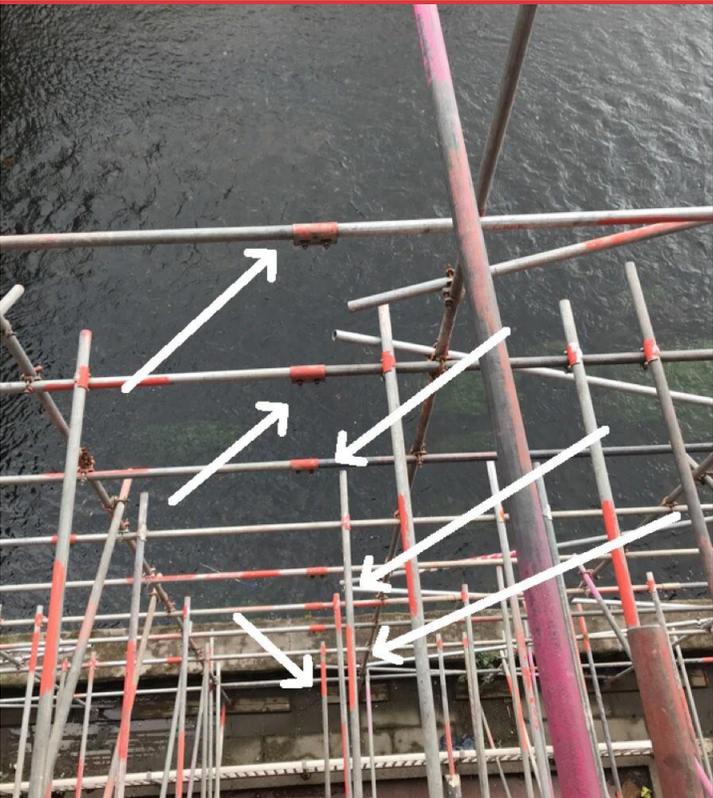
FRONT ELEVATION OUTER SCAFFOLD

The scaffold on the outside of the Front Elevation has not had the Ledger Sleeves staggered or spliced correctly (in/out, in/out) in order to meet compliance.

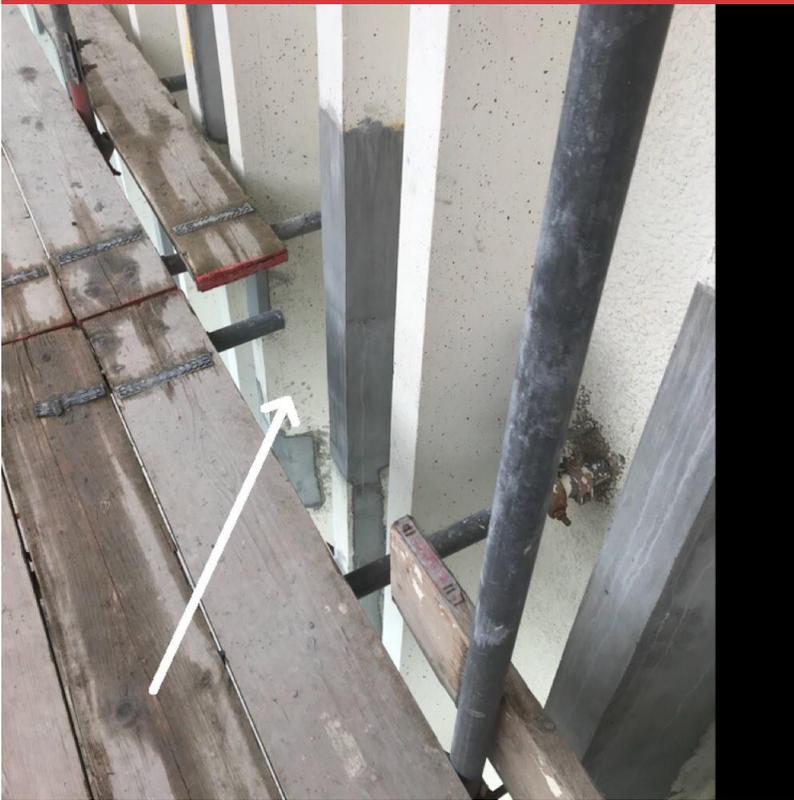
**FRONT ELEVATION 3RD
WORKING LIFT**

Boards have been moved by contractors in order to put render on the external walls

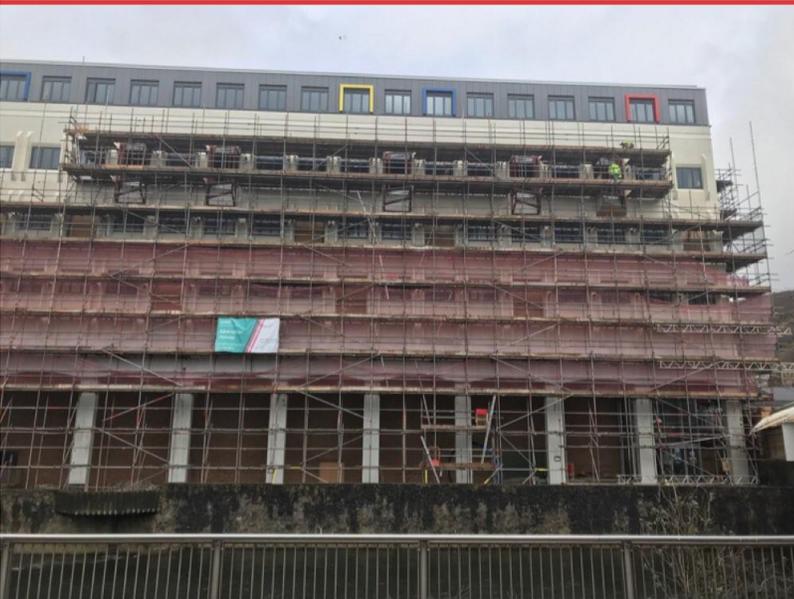
FRONT ELEVATION

The Top Working Lifts have been dismantled, all of the Trap Doors were in the closed position at the time of the inspection

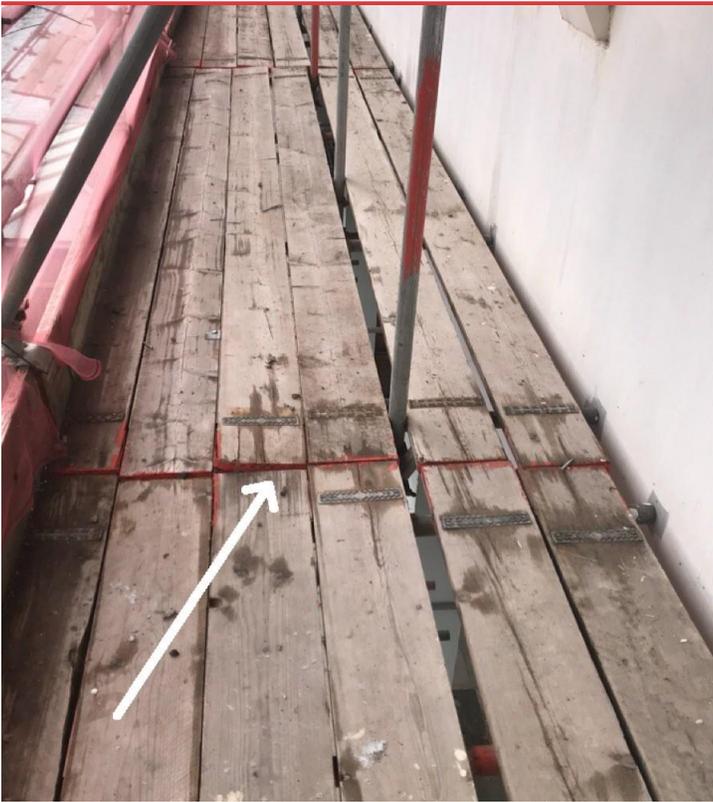
FRONT ELEVATION

Warped boards are evident again since the previous scaffold inspection.

The scaffold on the Front Elevation has been cleared of scaffold materials since the dismantle of the Top Working Lifts but there is evidence of warped boards that are a potential tripping hazard

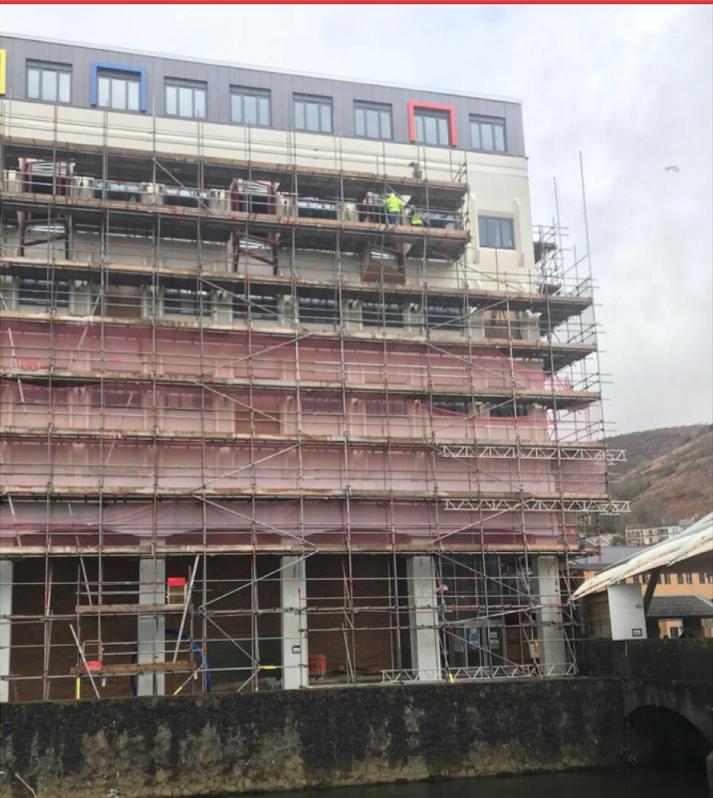
FRONT ELEVATION

The scaffold on the Front Elevation has sufficient ties in order to meet the requirements of the Design and TG20:13

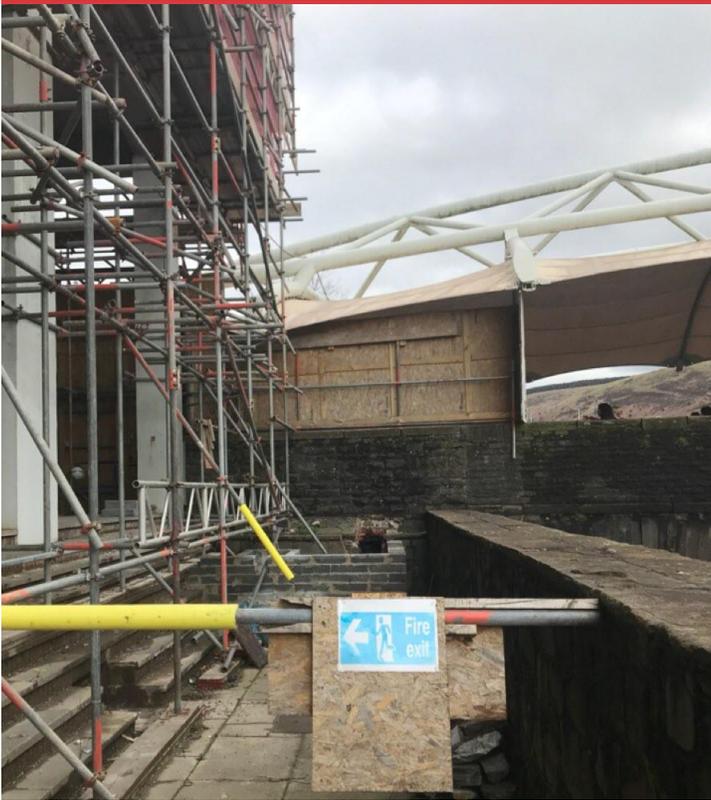
FRONT ELEVATION

There are 2 x Man Hole Covers that need to be clear of scaffolding in order to be available for emergency use, the Beam has been fitted and a Standard removed from the Front Elevation near to the North Elevation, the Design shows the Beam in a more elevated position

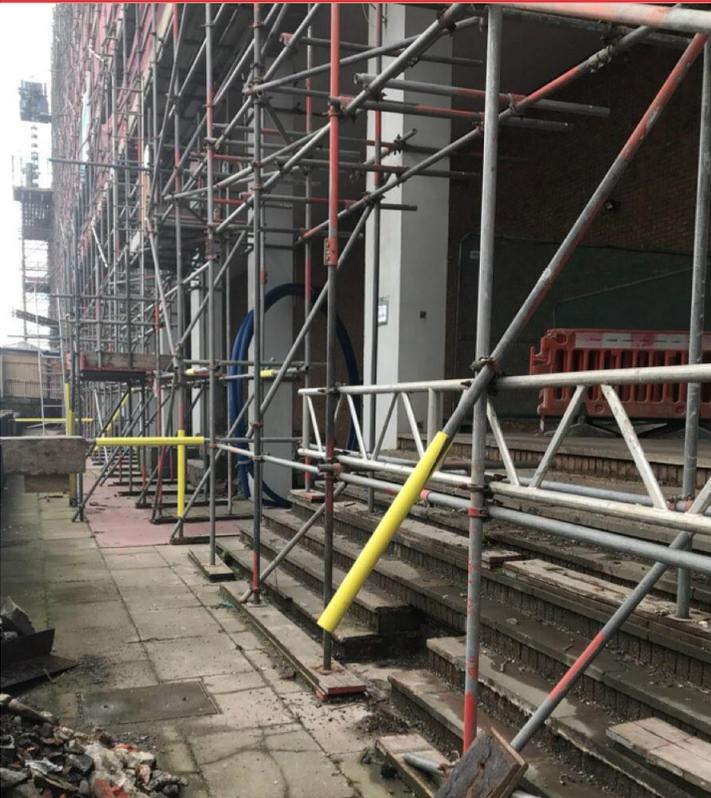
FRONT ELEVATION

There are 2 x Man Hole Covers that need to be clear of scaffolding in order to be available for emergency use, the Beam has been fitted and a Standard removed from the Front Elevation near to the North Elevation, the Design shows the Beam in a more elevated position

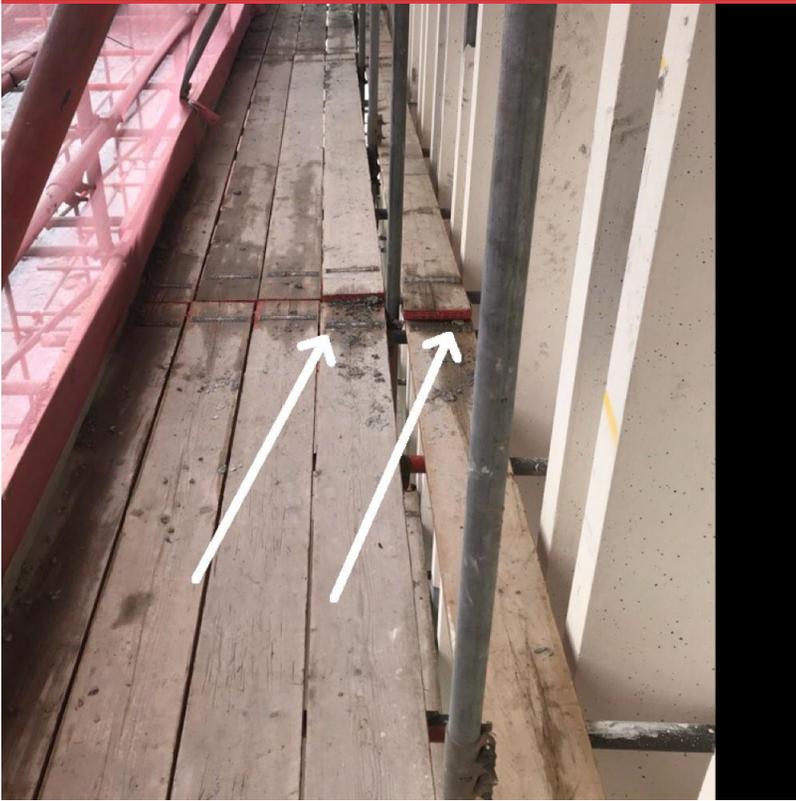
FRONT ELEVATION

The Working Lifts were free from debris and waste materials but there are warped boards that are a potential tripping hazard

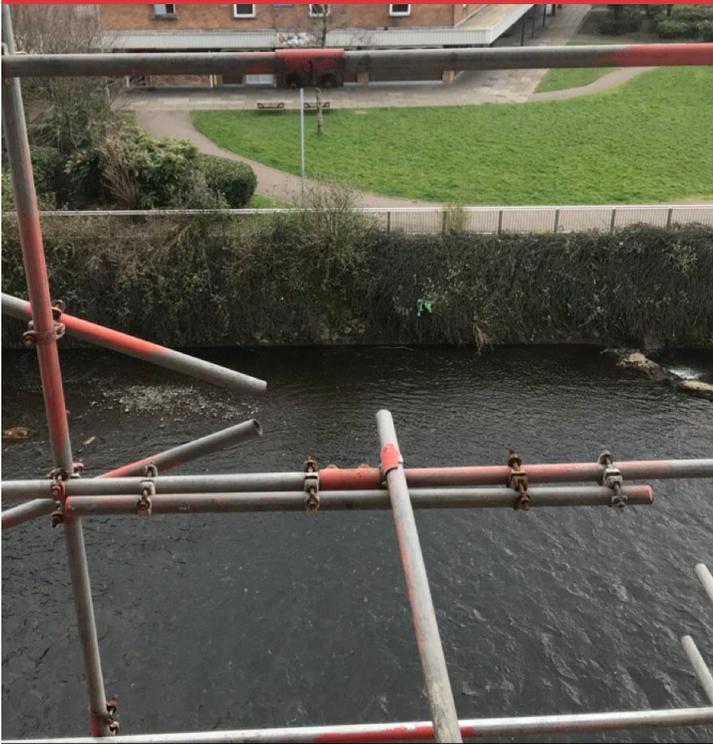
FRONT ELEVATION

The Ledger Sleeves have been spliced in order to meet the compliance of TG20:13 and the Design.

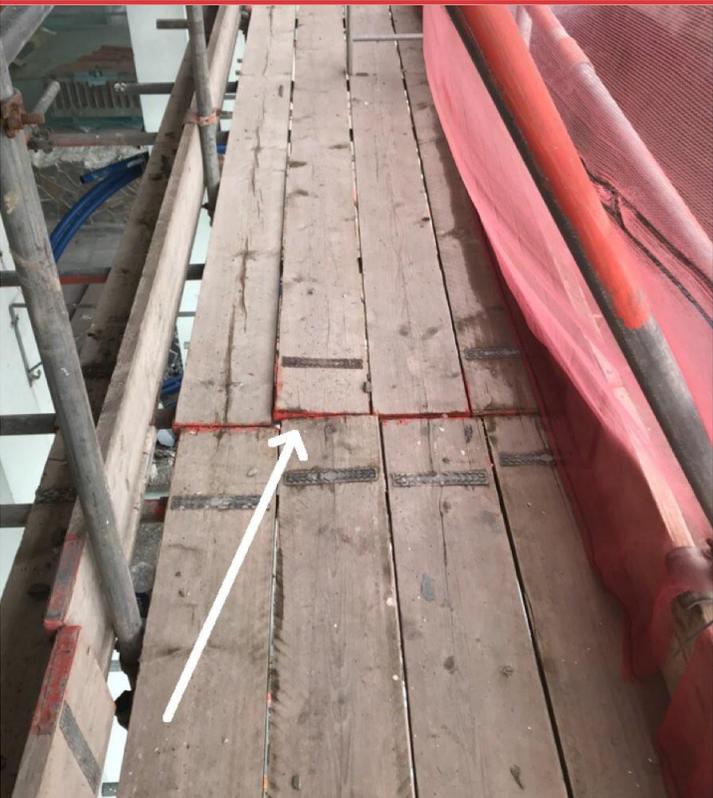
FRONT ELEVATION

Warped boards have started to become evident in most Working Lifts on the scaffold on the Front Elevation

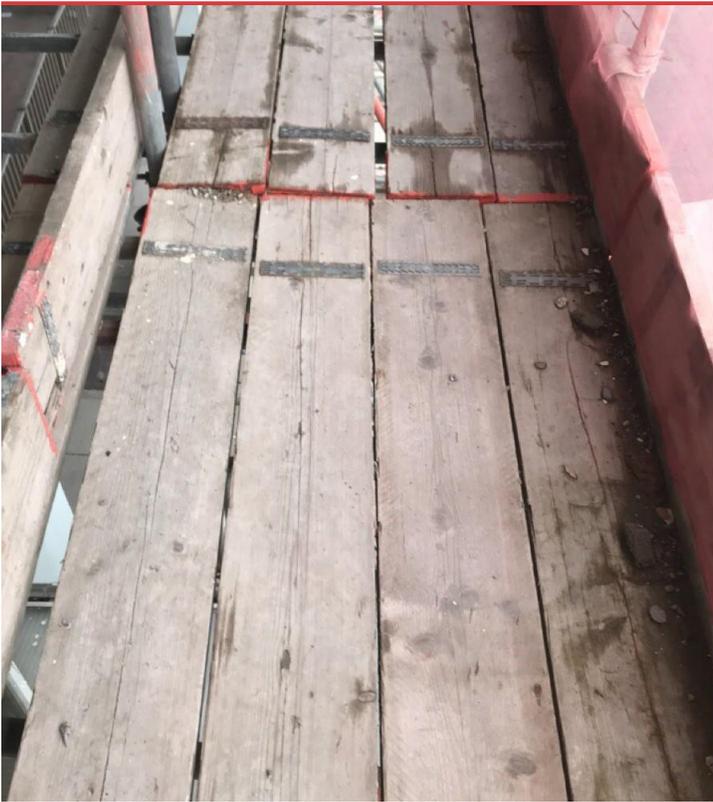
FRONT ELEVATION

Warped boards have become evident on the Working Lifts on the Front Elevation since the last scaffold inspection

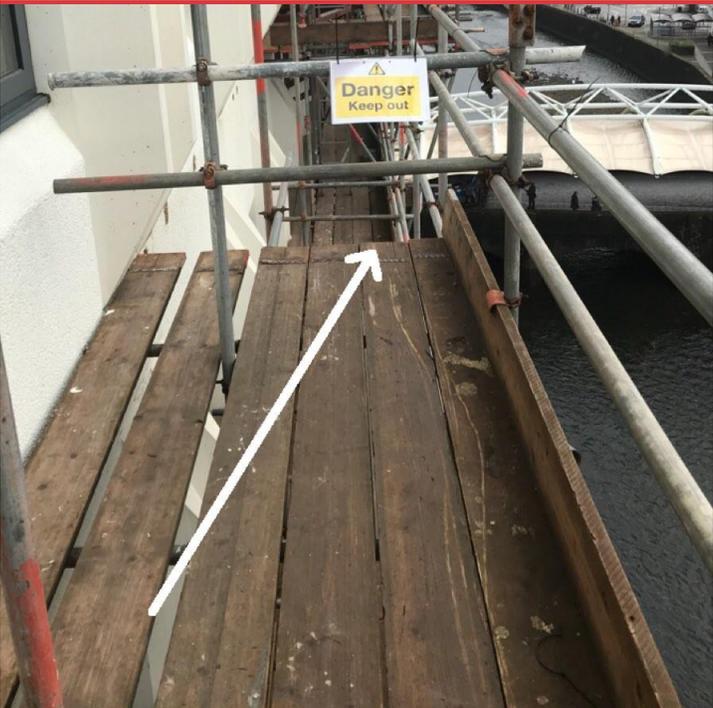
FRONT ELEVATION TOP WORKING LIFT

The Top Working Lift has been shortened and Handrailled off whilst modifications and alterations are taking place, a Toeboard needs to be put in place in order to prevent objects falling from height

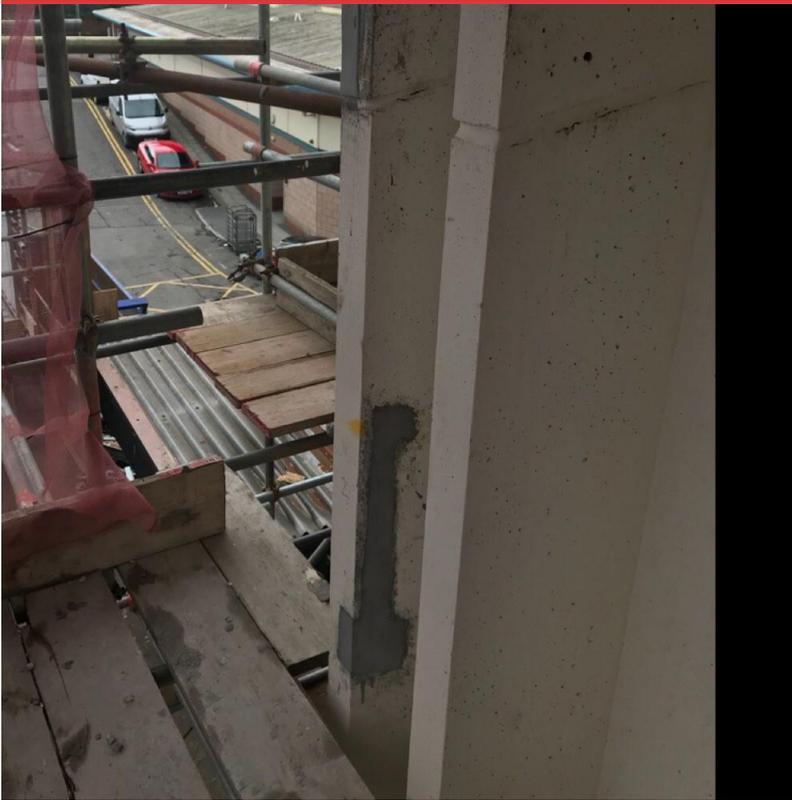
FRONT ELEVATION

A handrail needs to be put in place in order to minimise the potential of a fall from height

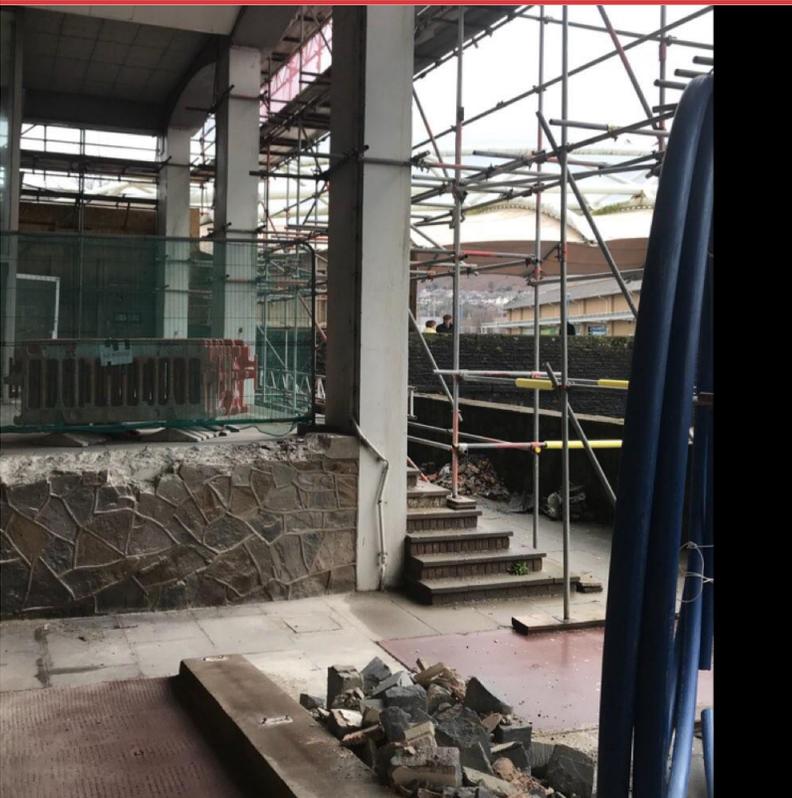
FRONT ELEVATION

There are sufficient ties used on the Pillars in order to meet the compliance of TG20:13 and the Design.

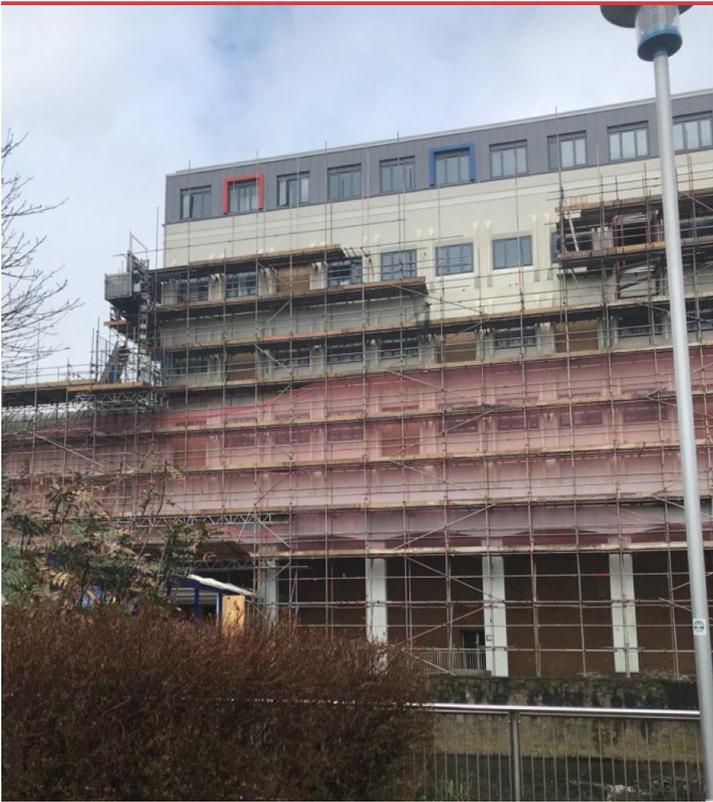
FRONT ELEVATION

The scaffold on the Front Elevation has sufficient ties in order to meet the requirements of the Design and TG20:13

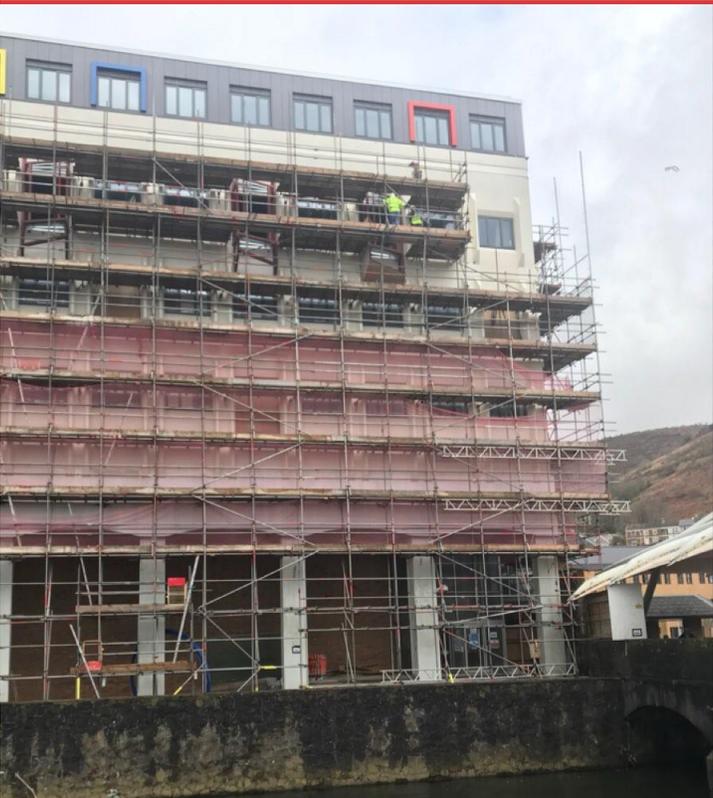
FRONT ELEVATION

There have been modifications to the scaffold on the Front Elevation since the previous inspection

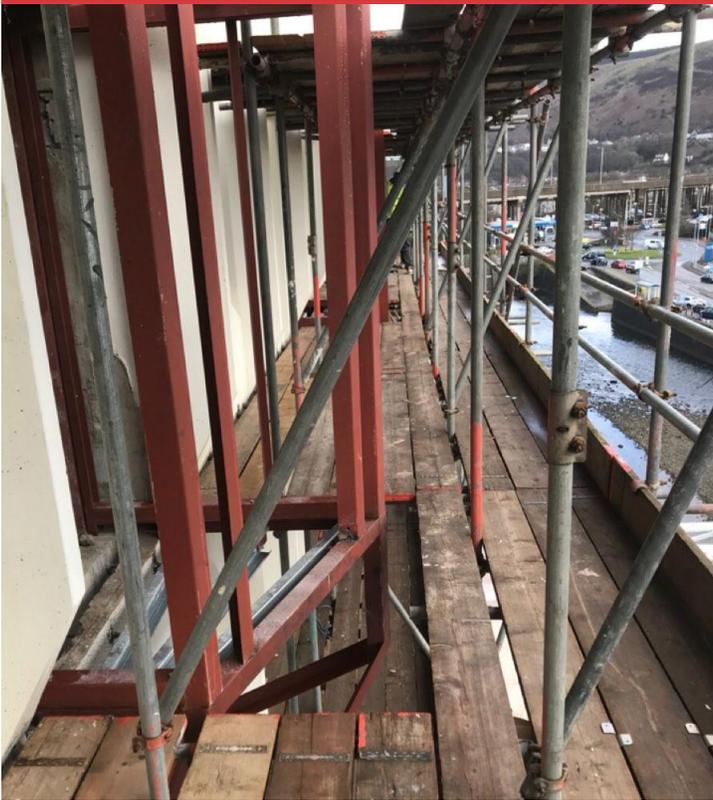
FRONT ELEVATION

Modifications and alterations have taken place since the last scaffold inspection, the most notable being the accommodating of the Steel Work that was being erected, there are excessive gaps between the Steelwork and the Working Lifts that need to be monitored, Fall Arrest PPE may need to be worn when working near these excessive gaps.

There have been modifications to the scaffold on the Front Elevation since the previous inspection, Steel Work has been erected on the Front of the Front Elevation in order to build Pods, there are excessive gaps between the Steelwork and the Working Lift that need to be monitored, Fall Arrest PPE may need to be used when working near the excessive gaps between Steelwork and Working Lifts.

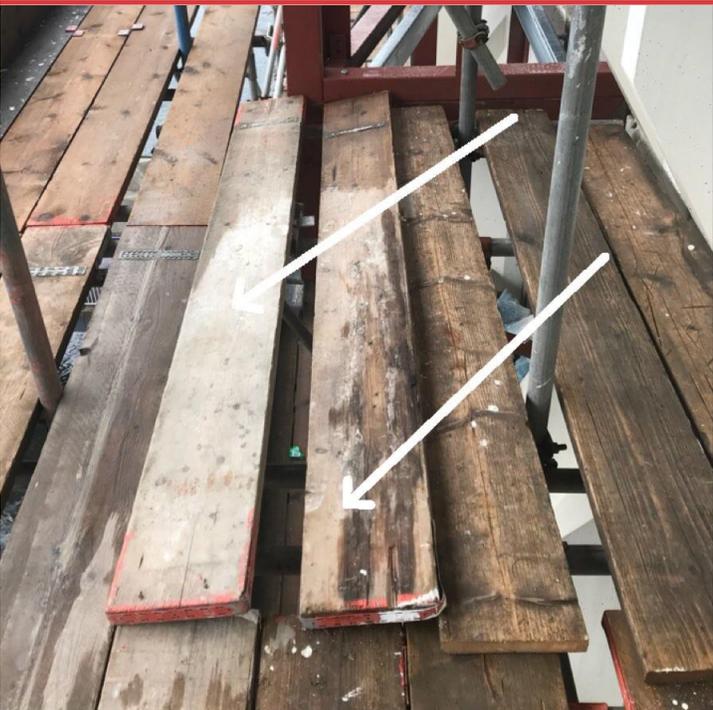
FRONT ELEVATION

The boards in the photo need to be either nailed down or removed in order for them to not become a tripping hazard

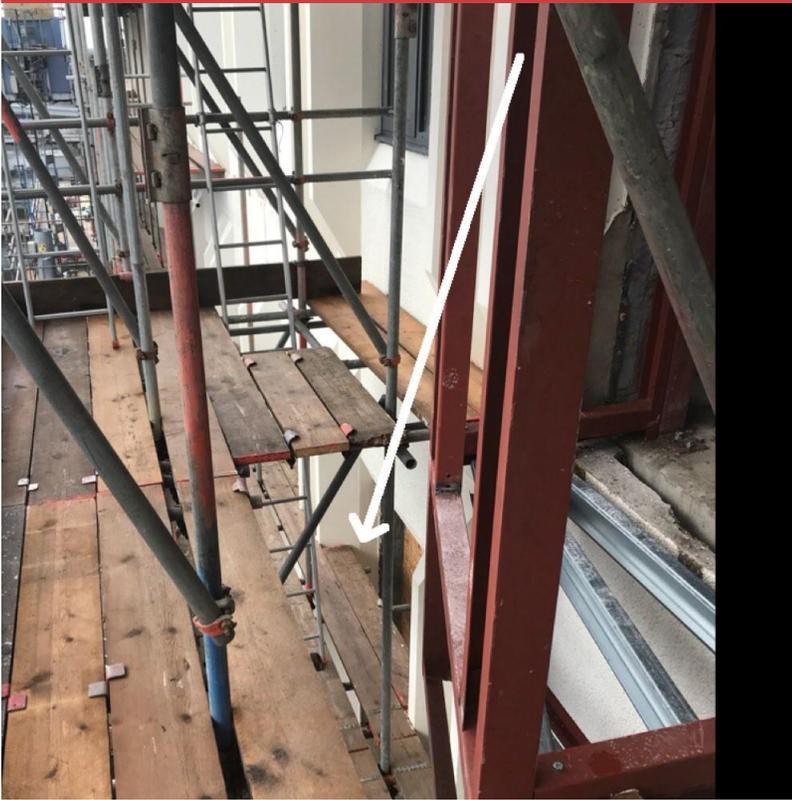
FRONT ELEVATION

Trap Doors need to be added to the recently modified scaffold that was added to the Front Elevation in order to accommodate the erecting of Pods, the Trap Doors need to be added in order to prevent falls from height and objects falling from height.

The Steelwork that has been constructed on the scaffold on the Front Elevation has been done so in order to build external Pods, there is a Trap Door missing on this scaffold but also there is an excessive gap between the Steelwork and Working Lift that needs to be monitored and possibly Contractors wearing Fall Arrest PPE when Working in this area.

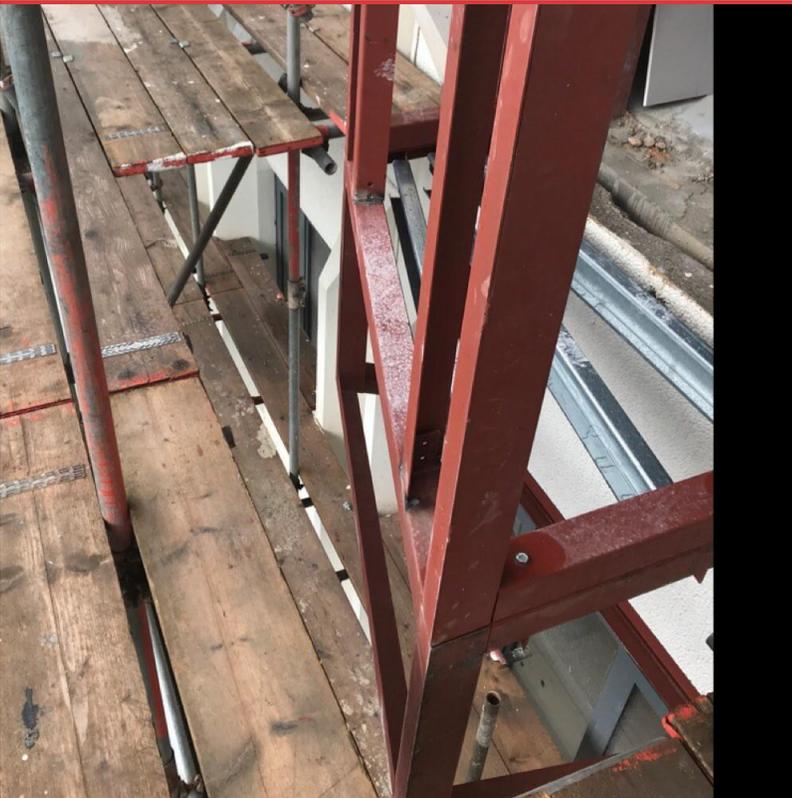
FRONT ELEVATION

The Steelwork that has been constructed on the scaffold on the Front Elevation has been done so in order to build external Pods, there is a Trap Door missing on this scaffold but also there is an excessive gap between the Steelwork and Working Lift that needs to be monitored and possibly Contractors wearing Fall Arrest PPE when Working in this area.

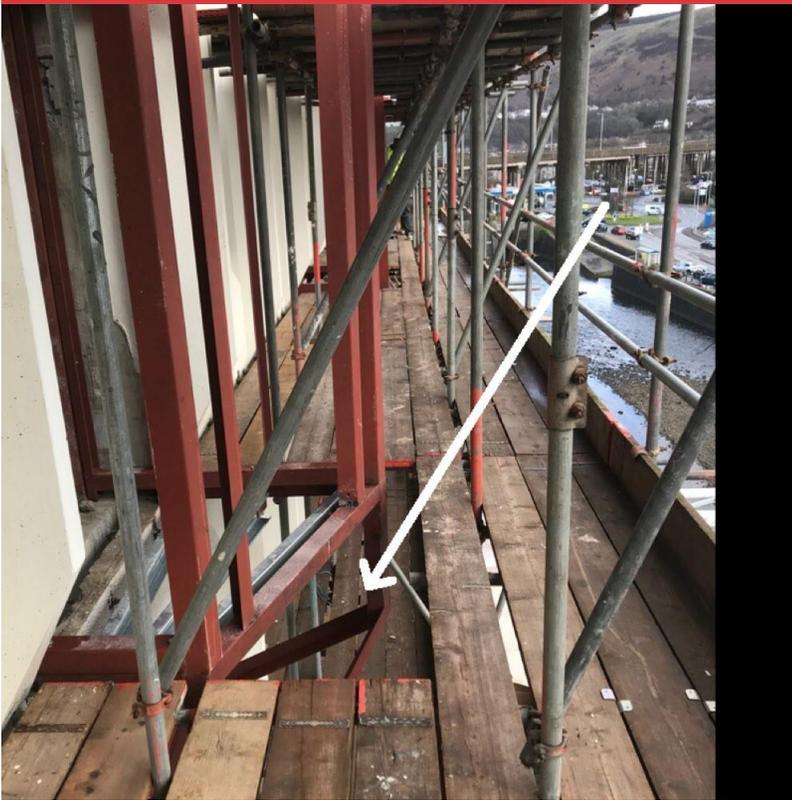
FRONT ELEVATION

The Steelwork that has been constructed on the scaffold on the Front Elevation has been done so in order to build external Pods, there is an excessive gap between the Steelwork and Working Lift that needs to be monitored and possibly Contractors wearing Fall Arrest PPE when Working in this area.

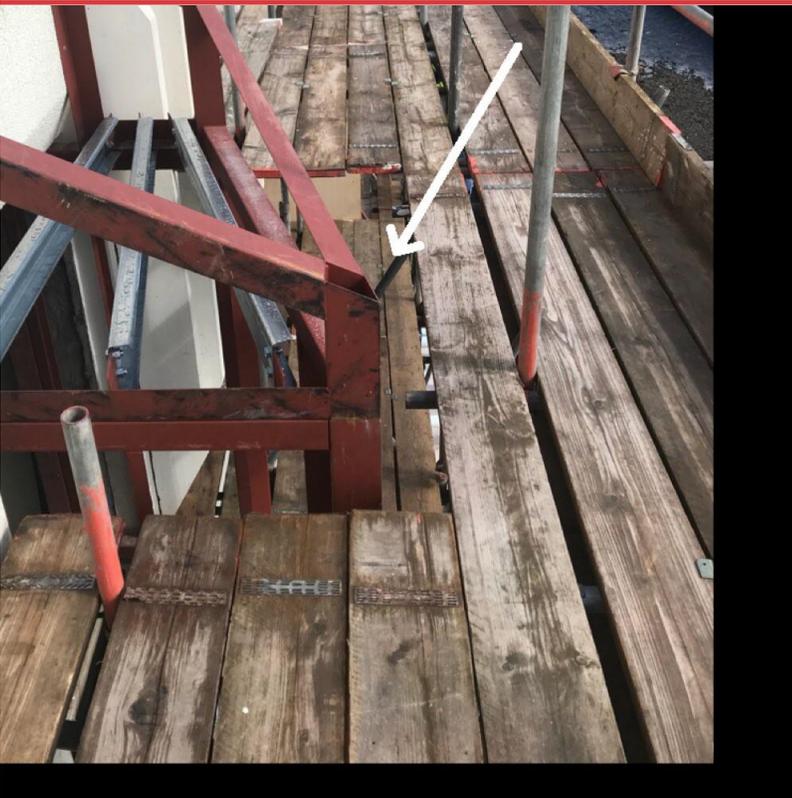
FRONT ELEVATION

The Steelwork that has been constructed on the scaffold on the Front Elevation has been done so in order to build external Pods, there is an excessive gap between the Steelwork and Working Lift that needs to be monitored and possibly Contractors wearing Fall Arrest PPE when Working in this area.

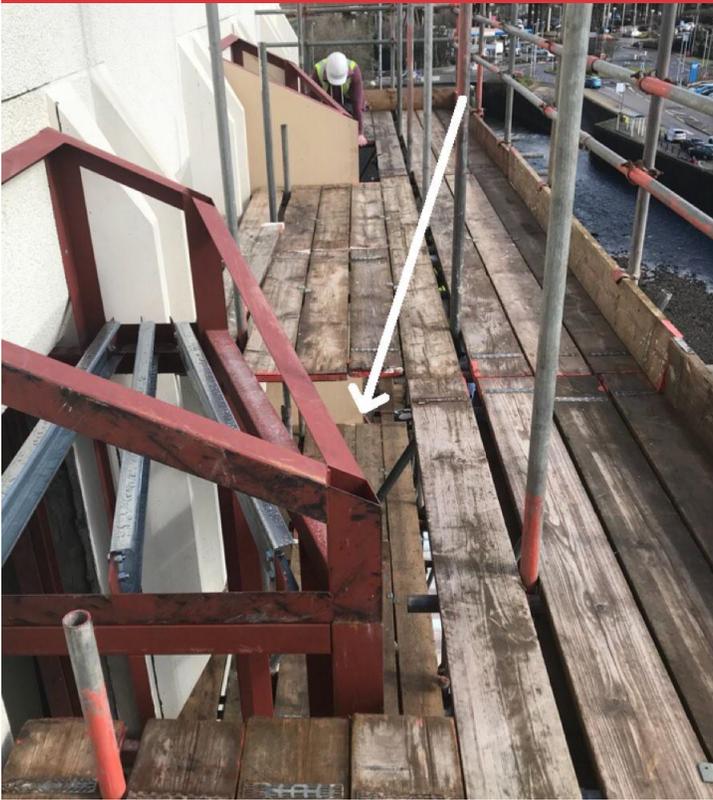
FRONT ELEVATION

The Steelwork that has been constructed on the scaffold on the Front Elevation has been done so in order to build external Pods, there is an excessive gap between the Steelwork and Working Lift that needs to be monitored and possibly Contractors wearing Fall Arrest PPE when Working in this area.

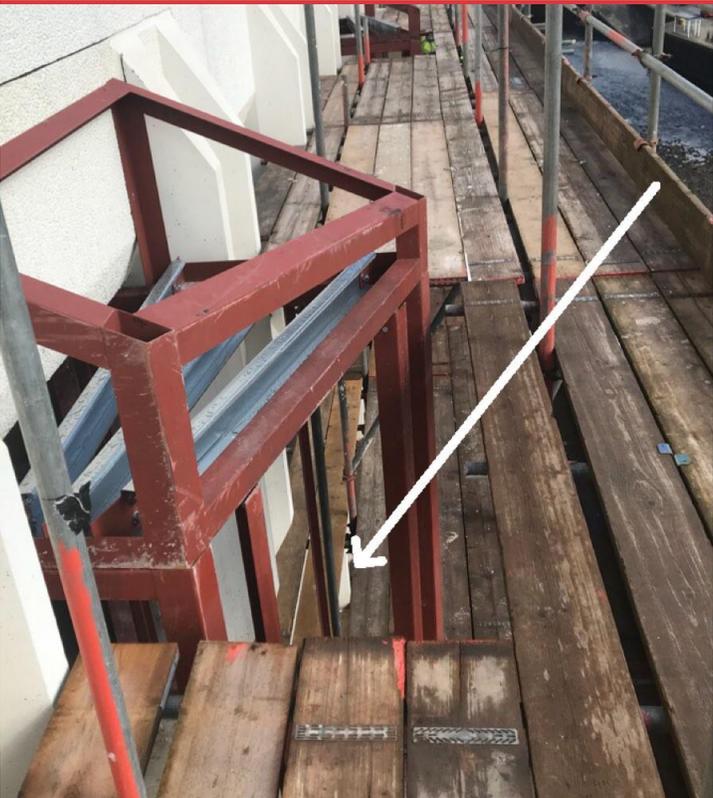
FRONT ELEVATION

The Steelwork that has been constructed on the scaffold on the Front Elevation has been done so in order to build external Pods, there is an excessive gap between the Steelwork and Working Lift that needs to be monitored and possibly Contractors wearing Fall Arrest PPE when Working in this area.

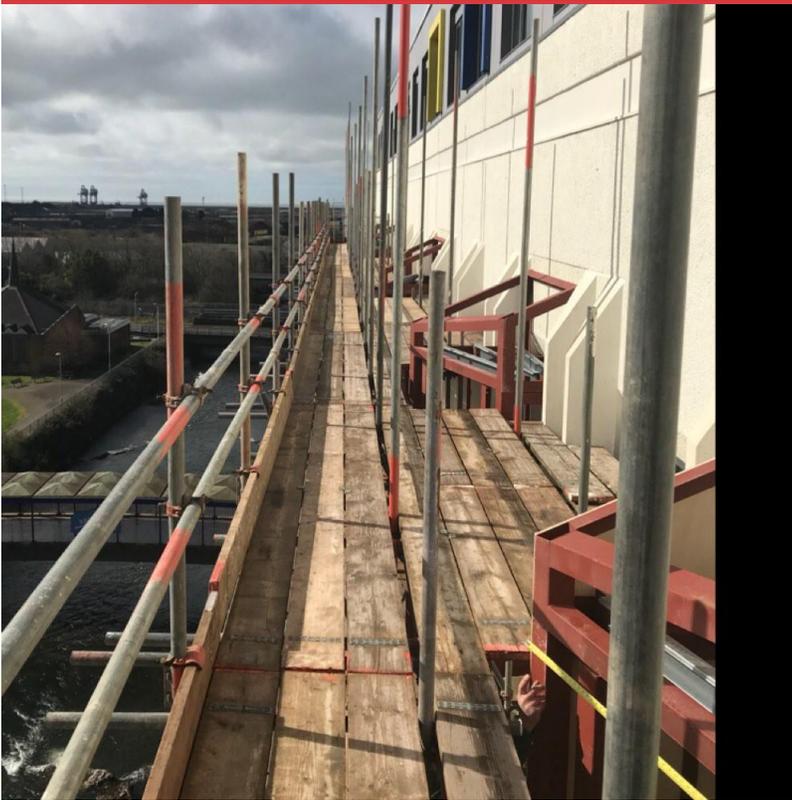
FRONT ELEVATION

The Working Lifts were free of debris and waste materials and the Housekeeping was of optimum condition

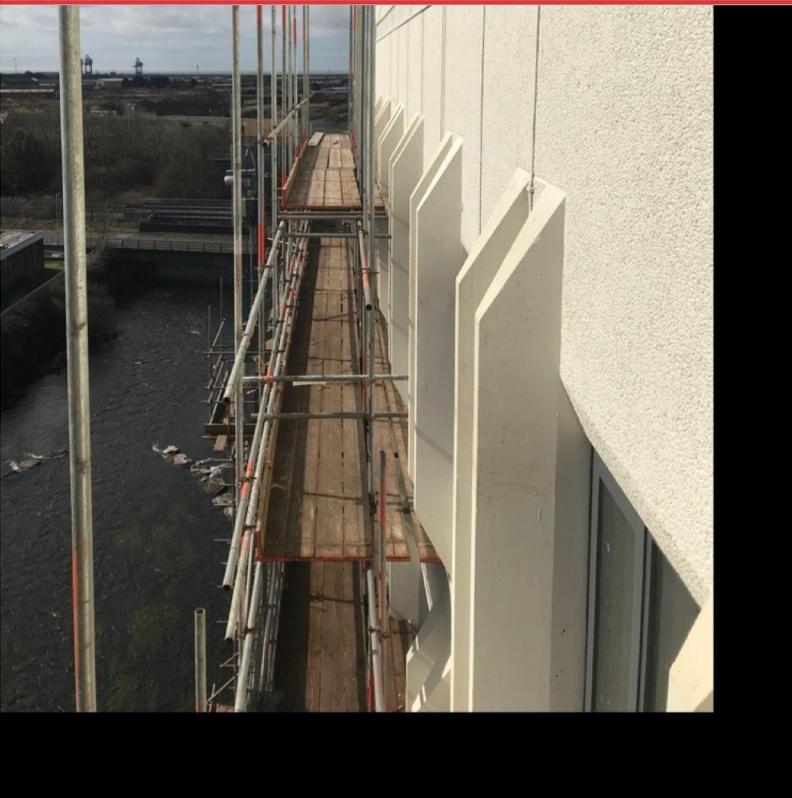
FRONT ELEVATION

The scaffold has had numerous alterations due to the stage that the project has reached, hence the removal of 4 ties on what was the 9th Working Lift but is now the highest Working Lift.

Modifications and alterations had taken place on the scaffold since the last scaffold inspection, ties have been removed as part of the dismantle process

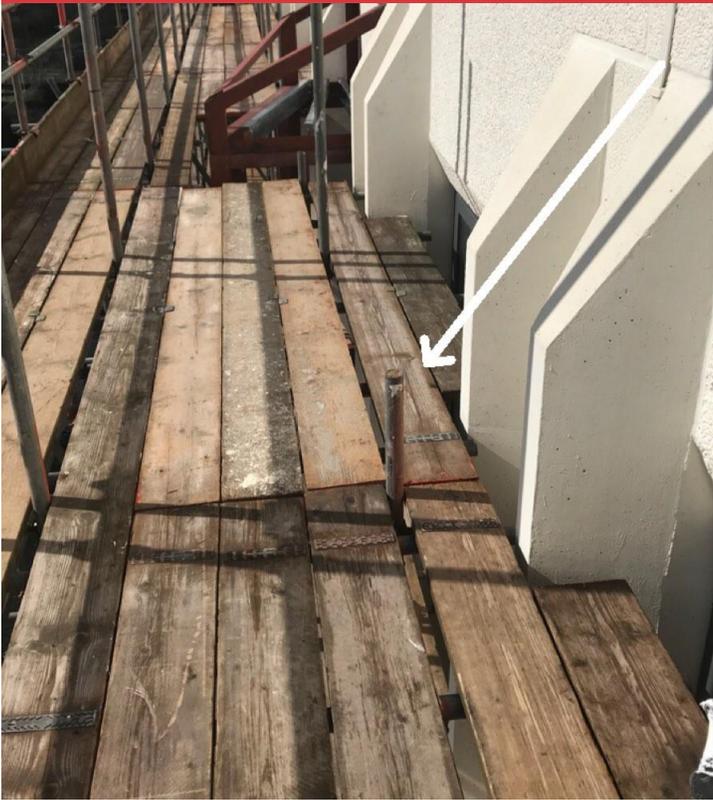
FRONT ELEVATION

The protruding tube has not been cut flush to the same level as the Working Lift or raised 1m above the Working Lift due to the requirement of the Contractors

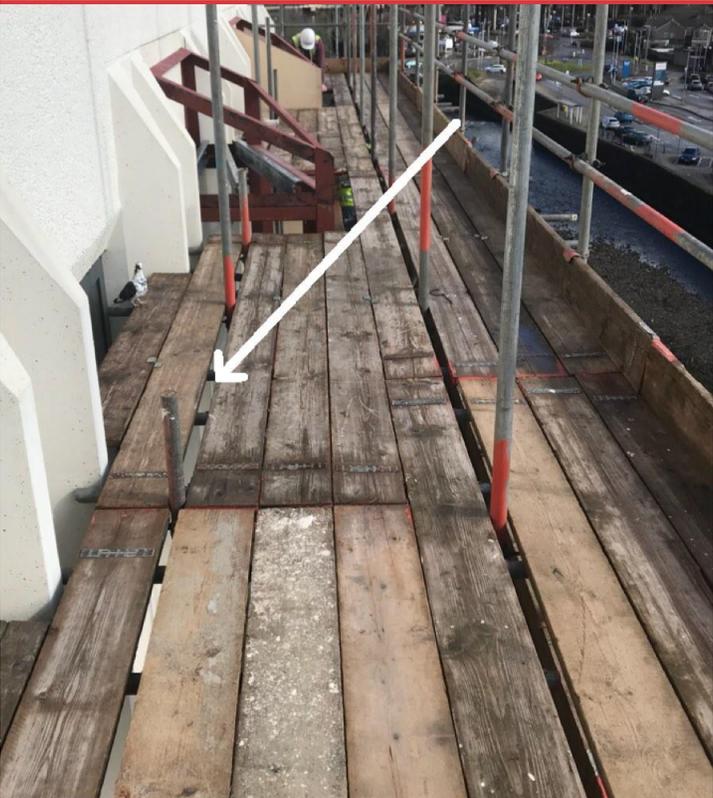
FRONT ELEVATION

The protruding tube has not been cut flush to the same level as the Working Lift or raised 1m above the Working Lift due to the requirement of the Contractors
