Cymru Scaffold Inspections

Tesco, Eastgate Rd, Eastville, Bristol BS5 6XU

Wednesday 13th March 2024

INSPECTION OF: Site Scaffolds & Scaffold Management on Site

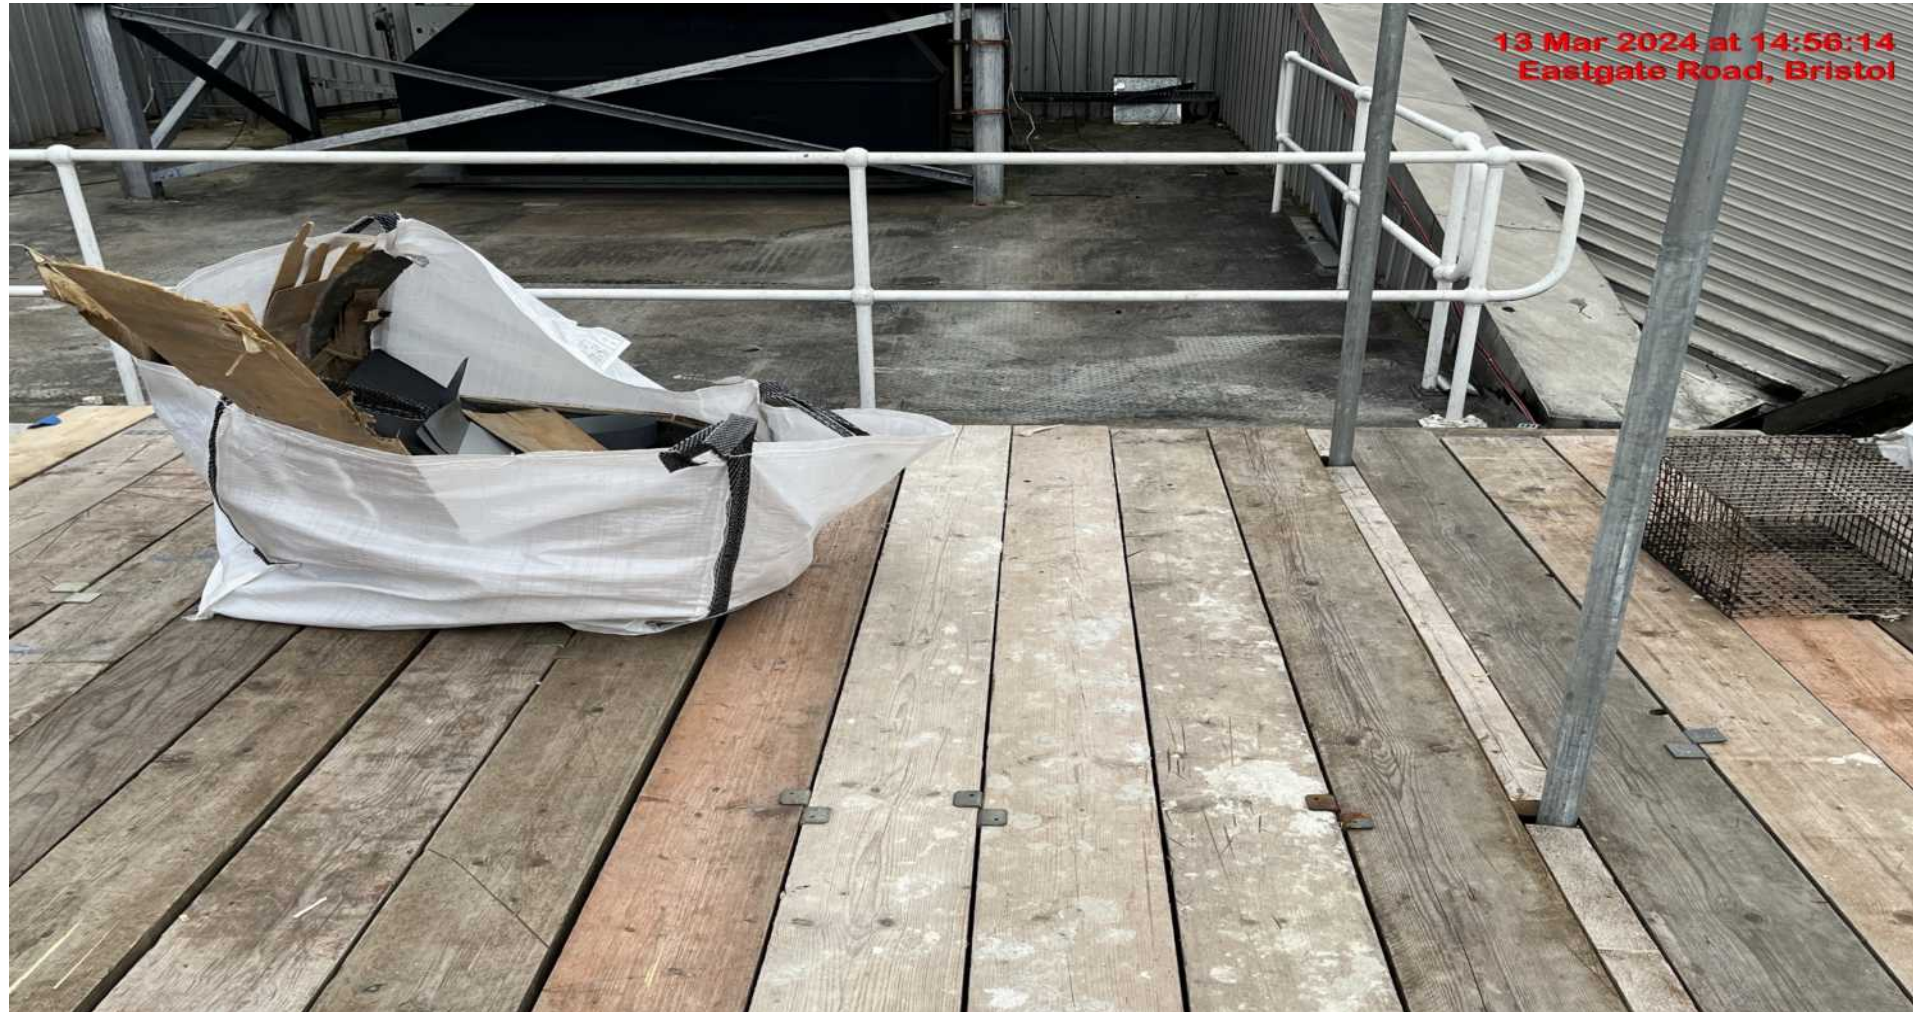
EAS 001

Scaffold has been Tied into the Building in order to prevent movement..

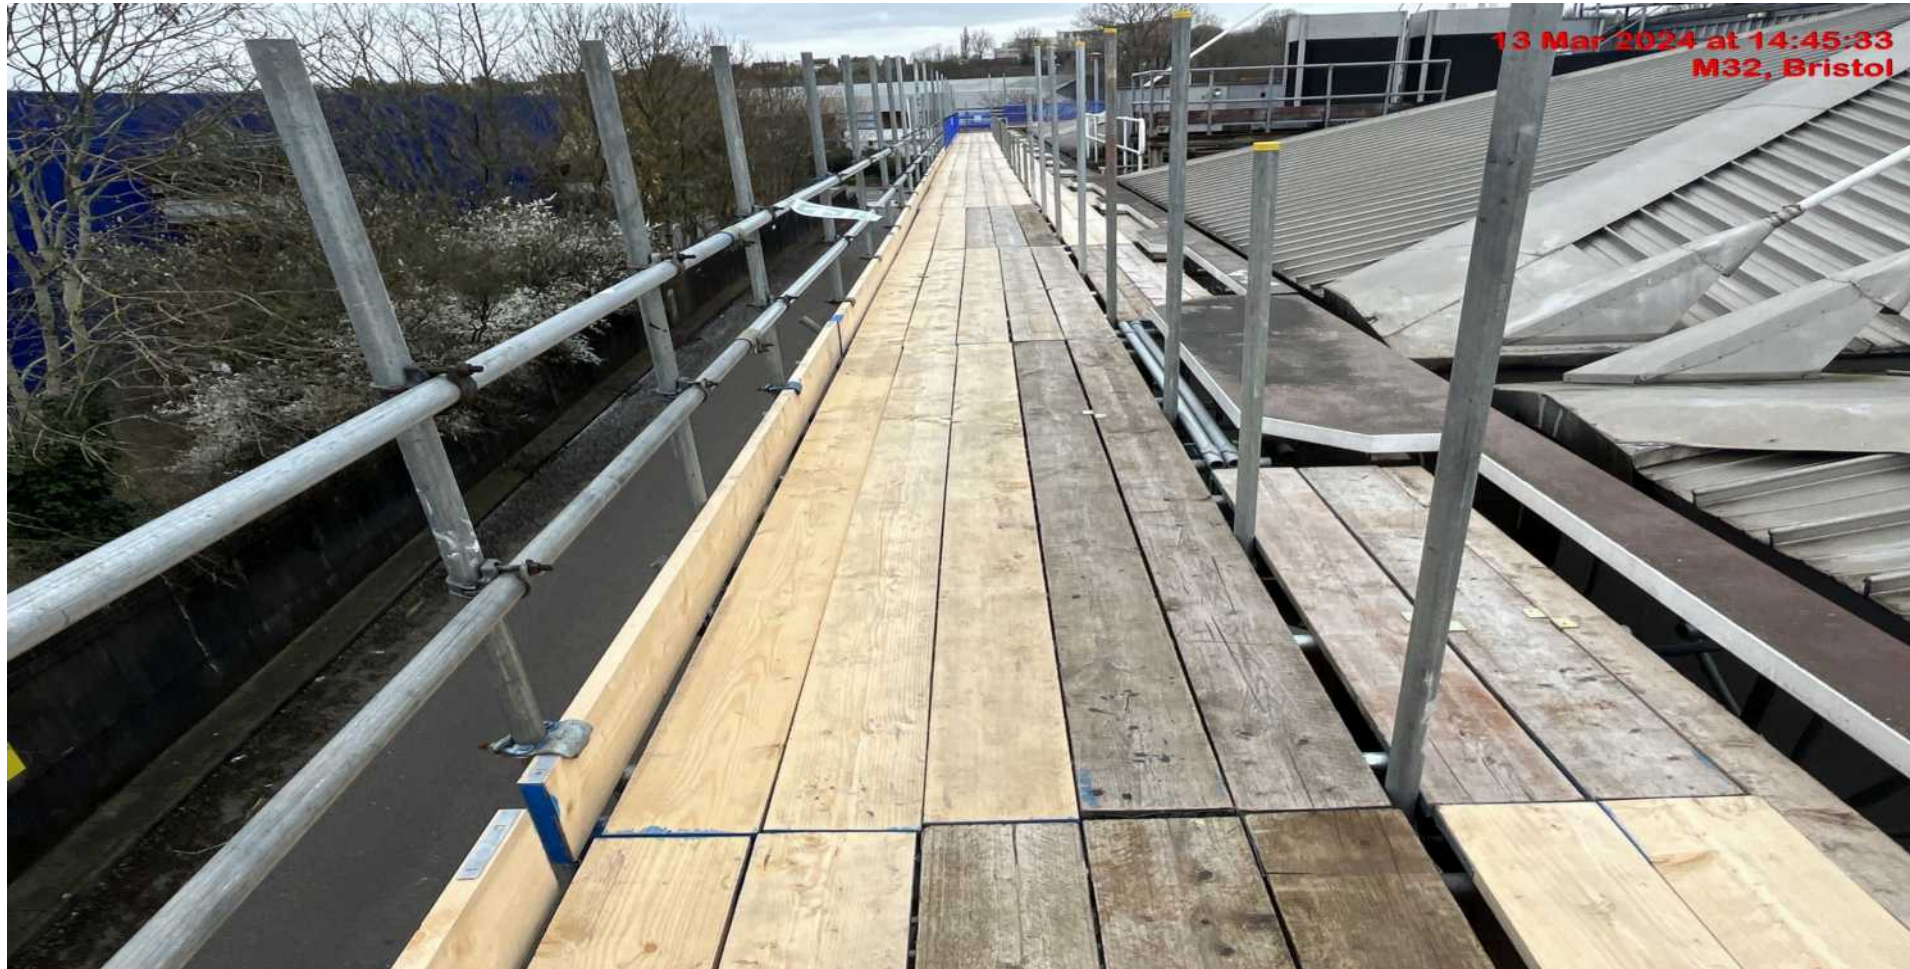
EAS 003

Some of the Scaffold Boards near to the Glass Windows of the Building and/or needed to be secured in more than 1 position.

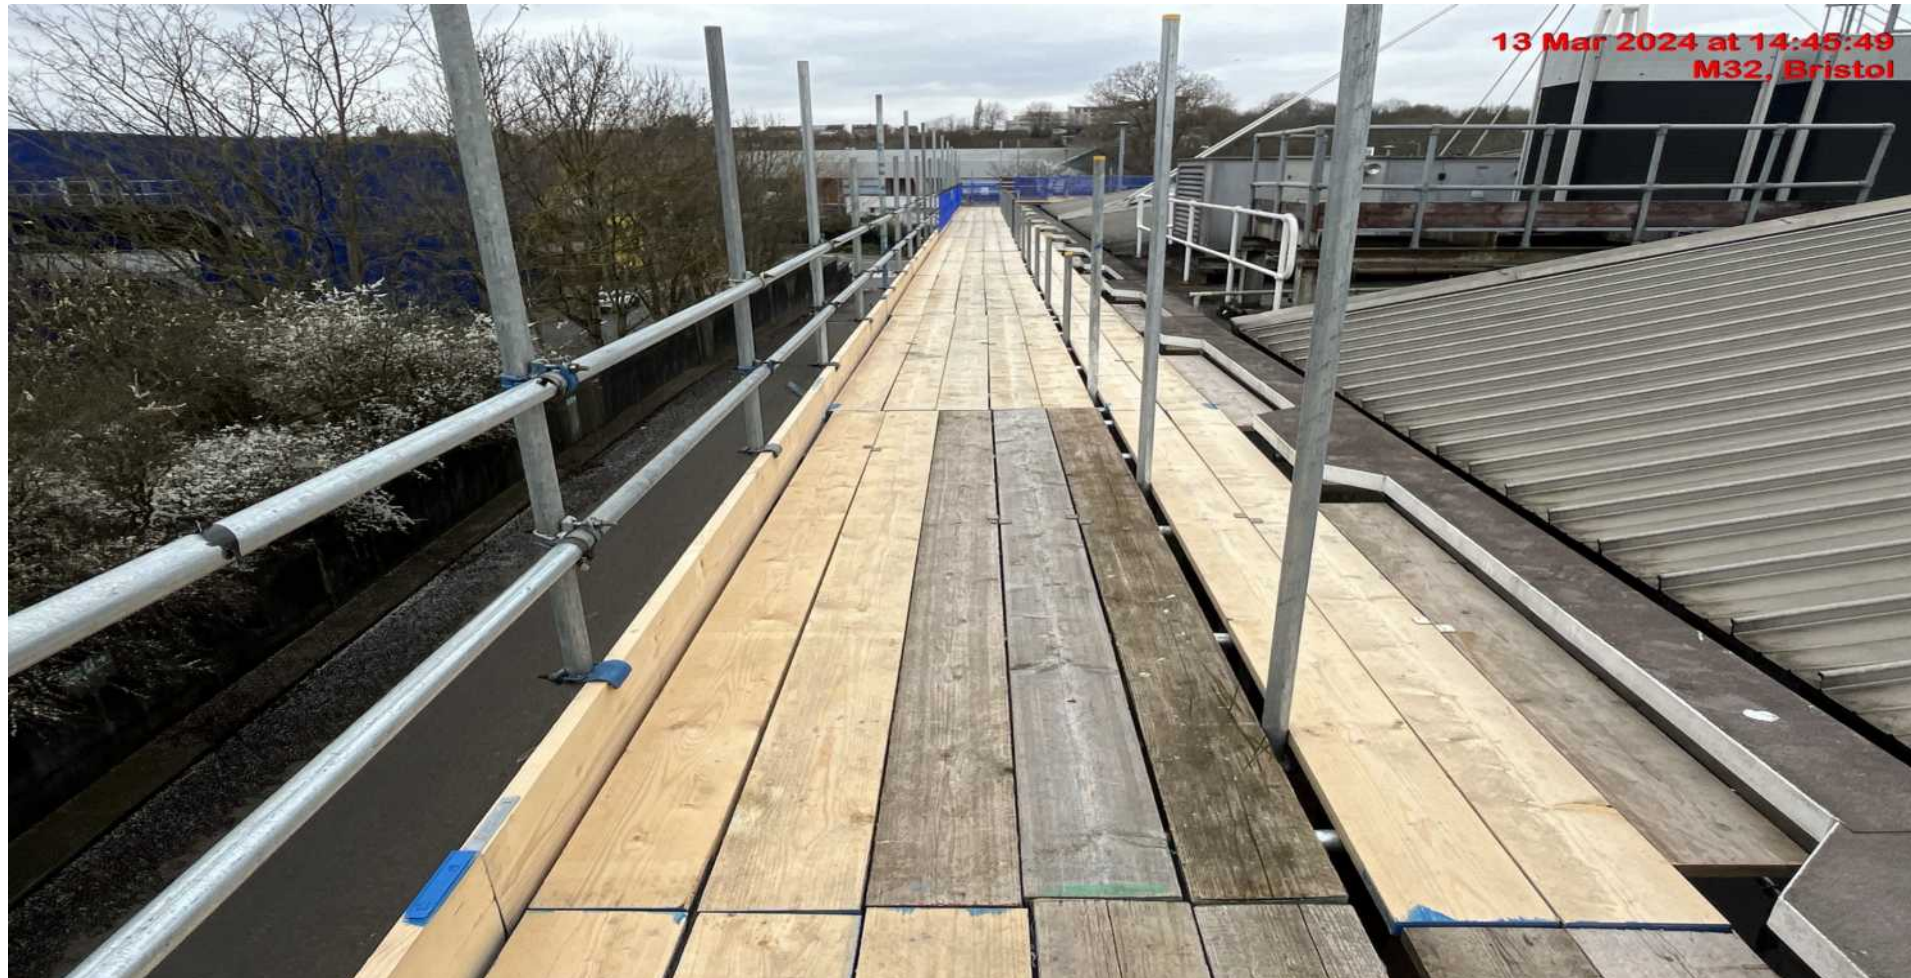
EAS 003

Some of the Scaffold Boards near to the Glass Windows of the Building and/or needed to be secured in more than 1 position.

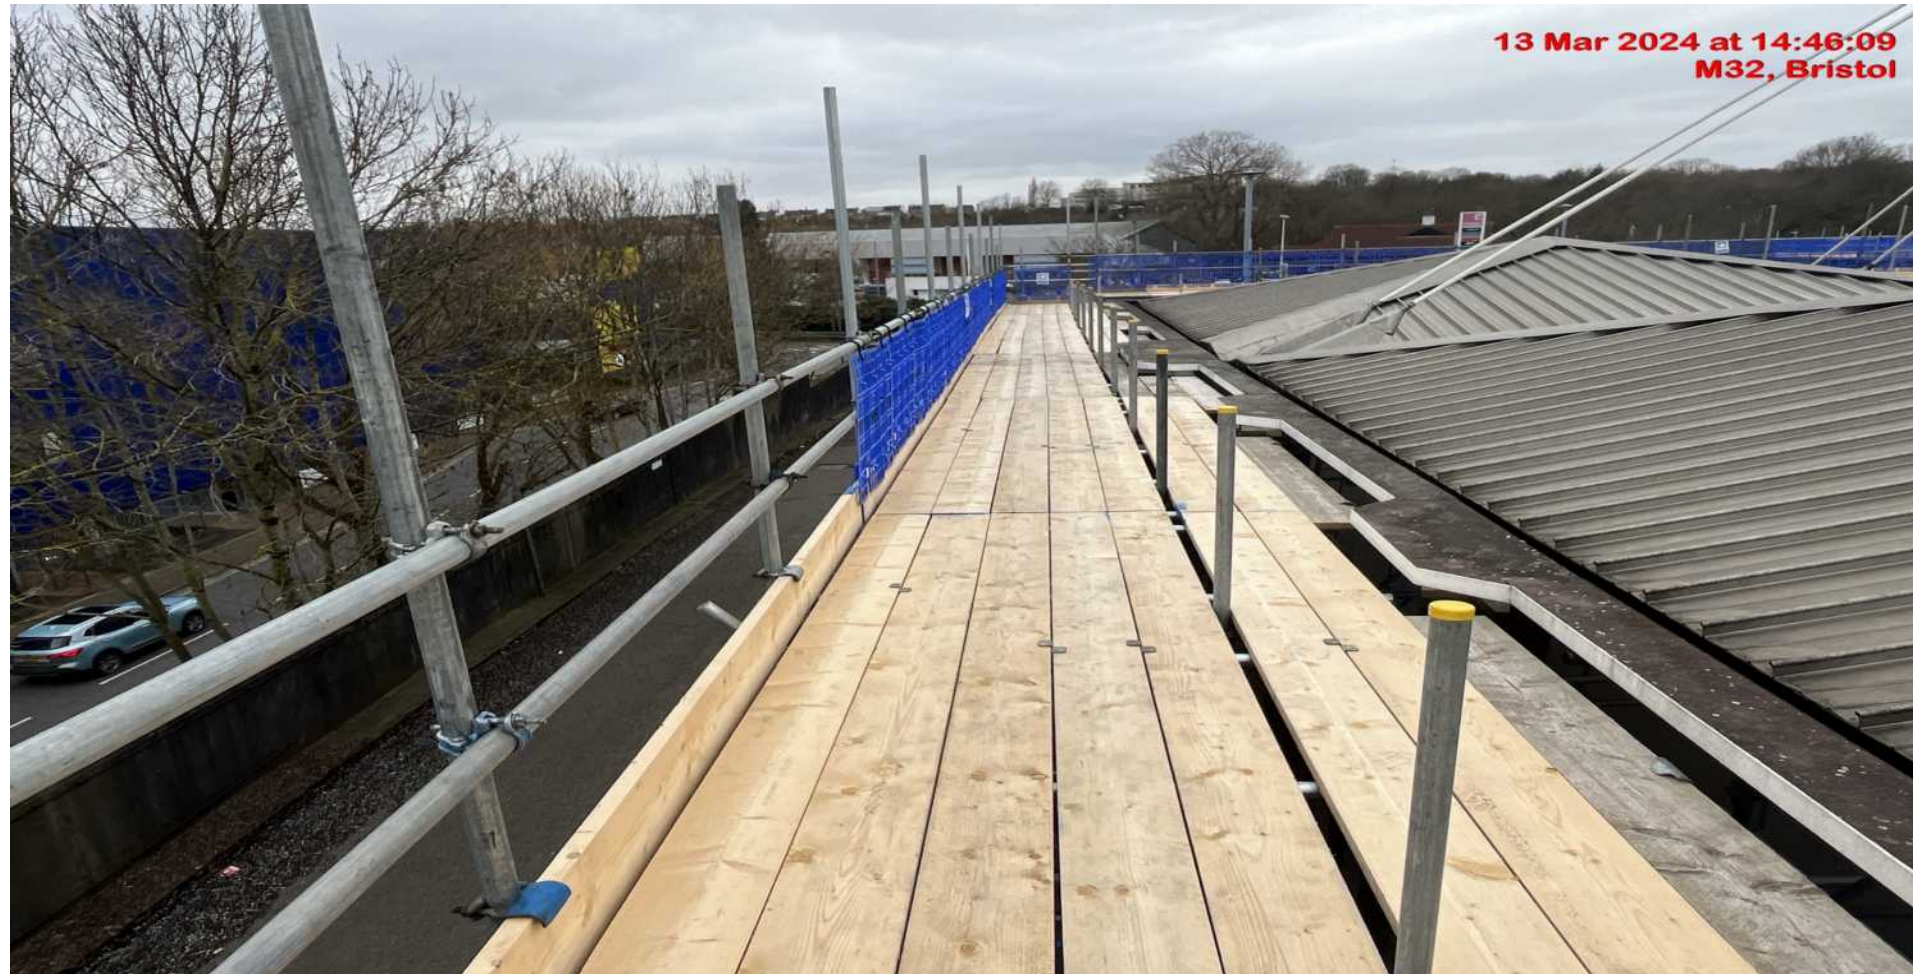
EAS 003

Some of the Scaffold Boards near to the Glass Windows of the Building and/or needed to be secured in more than 1 position.

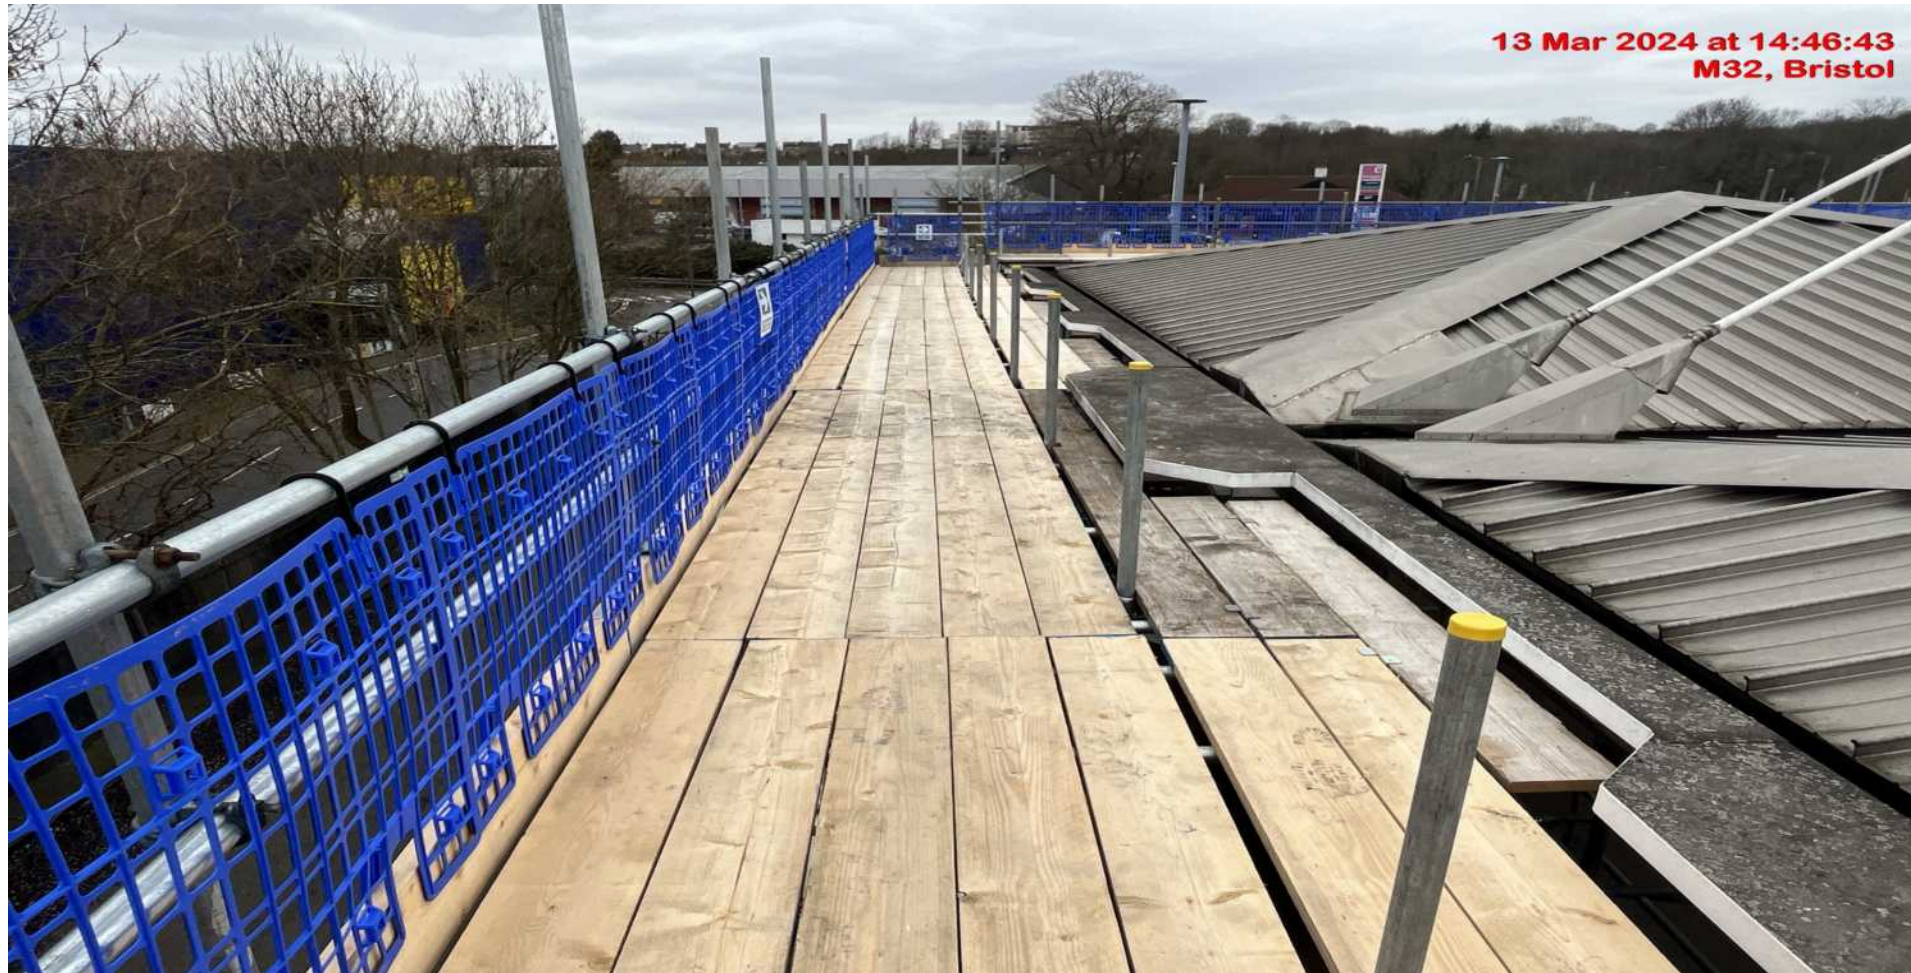
EAS 003

Some of the Scaffold Boards near to the Glass Windows of the Building and/or needed to be secured in more than 1 position.

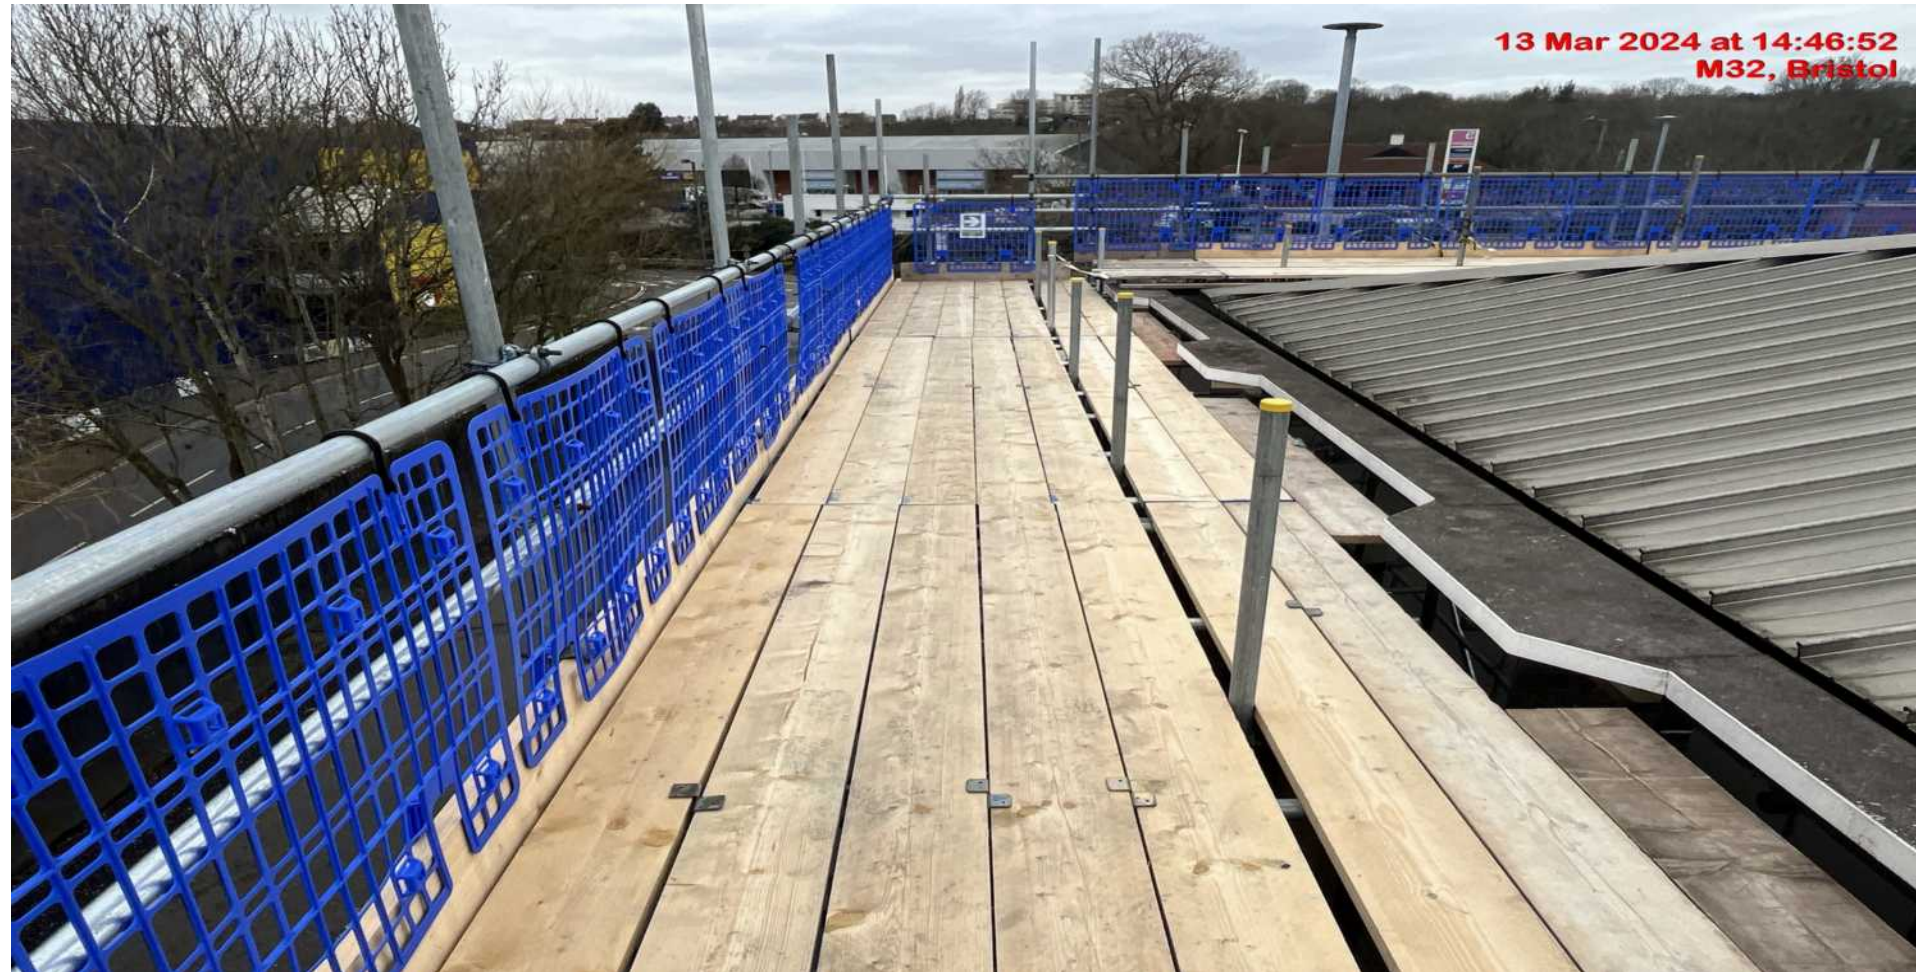
EAS 003

Some of the Scaffold Boards near to the Glass Windows of the Building and/or needed to be secured in more than 1 position.

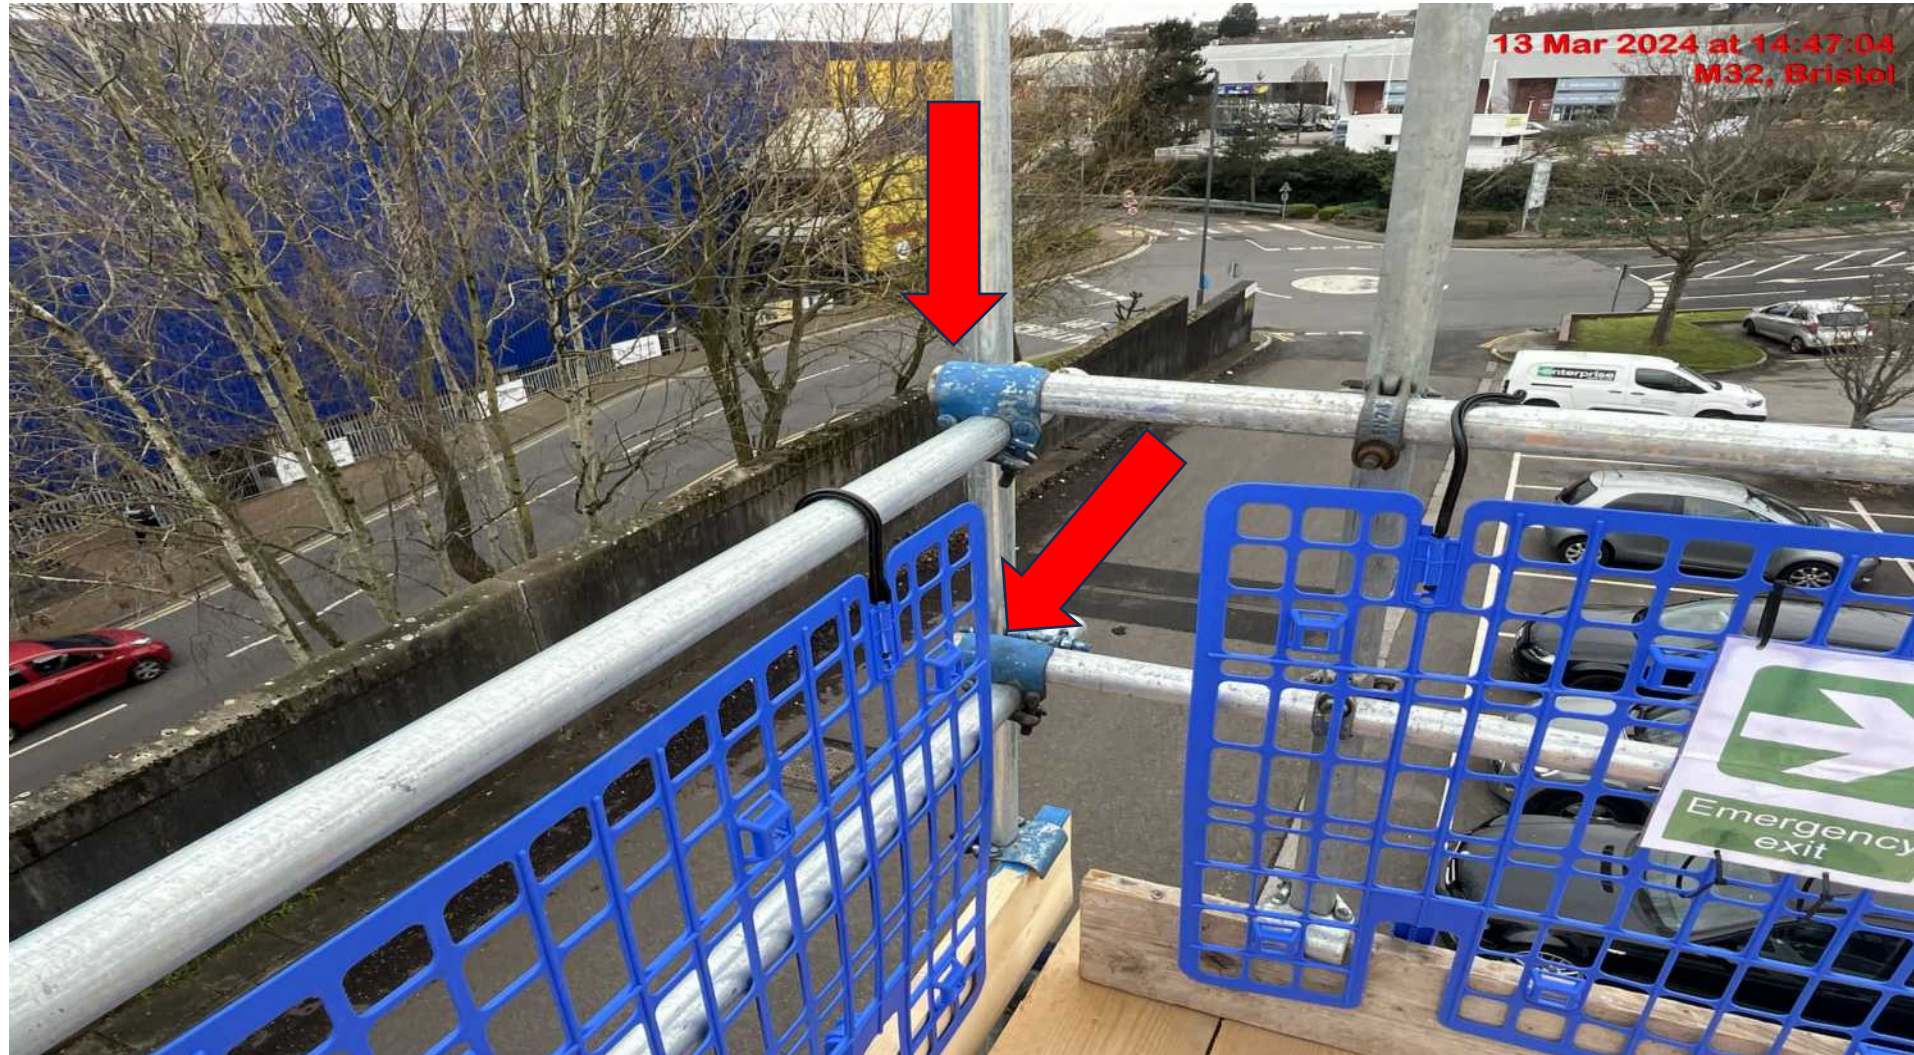
EAS 003

Notes: Single Fittings have been used as opposed to Double Couplers in order to secure the Handrails.

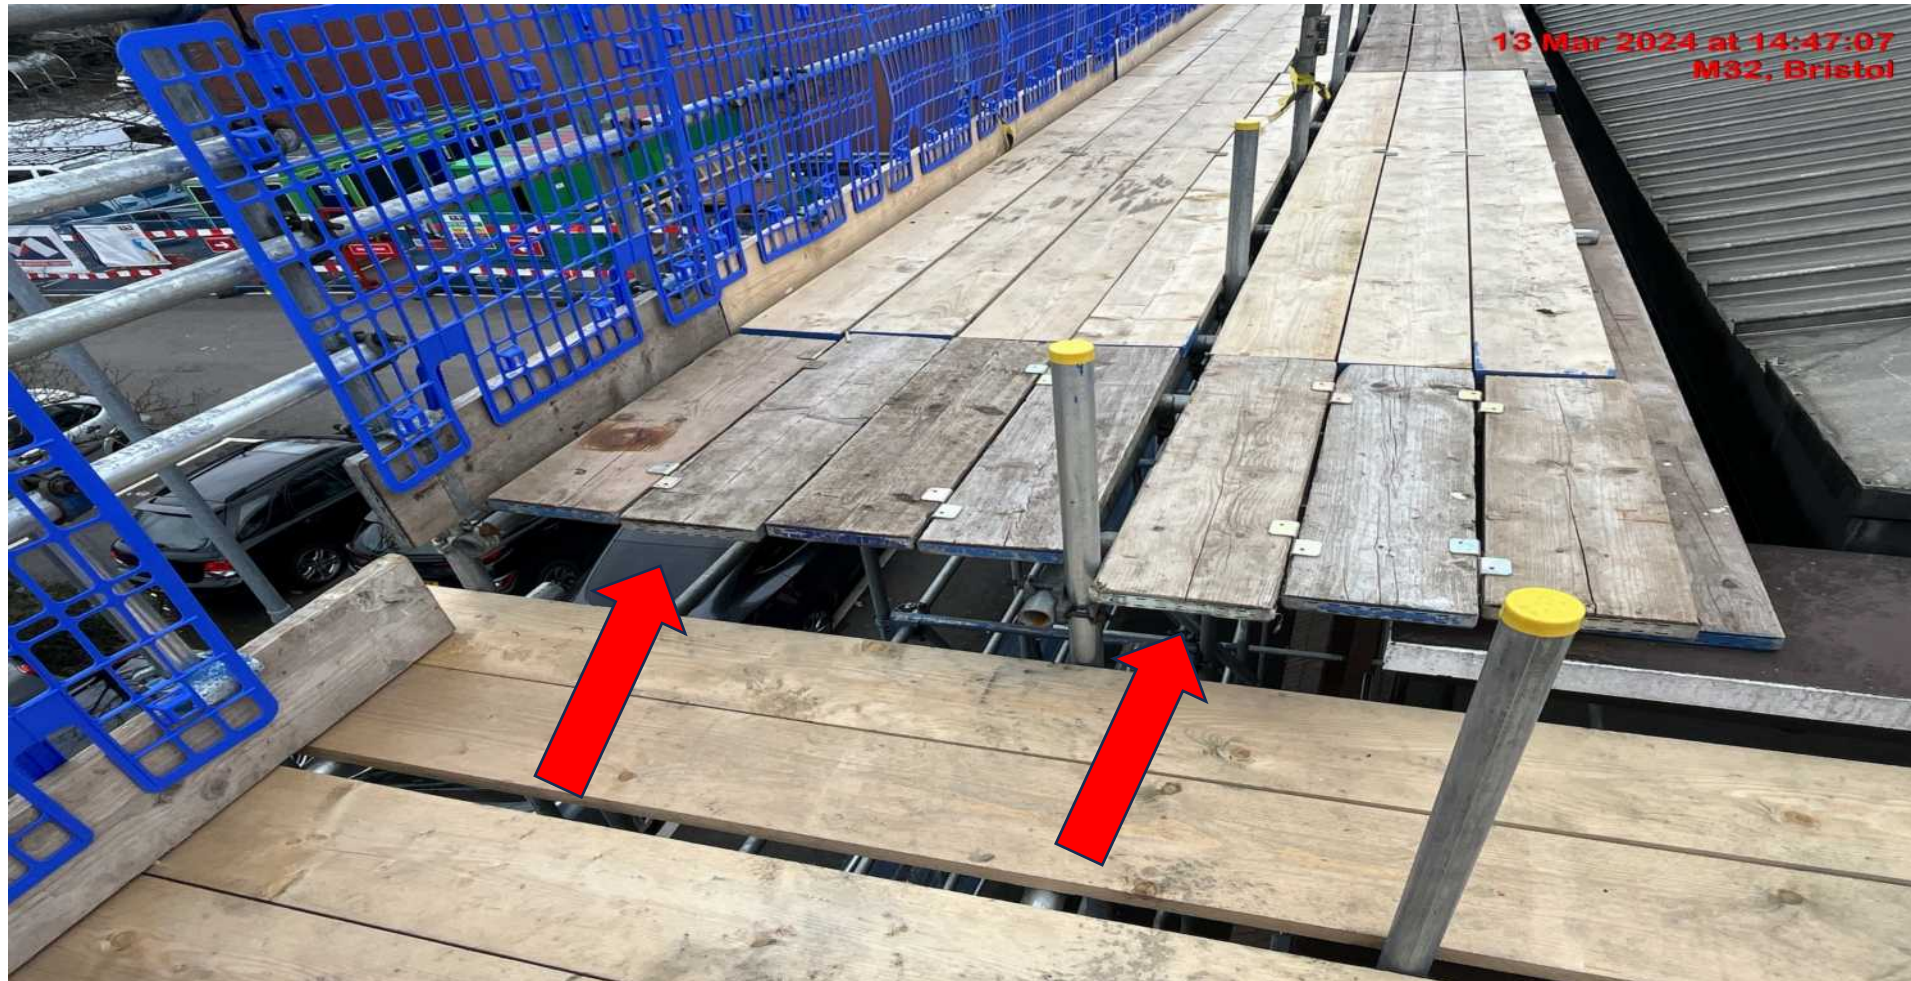
EAS 003

Void needs to be eliminated to stop objects falling from height.

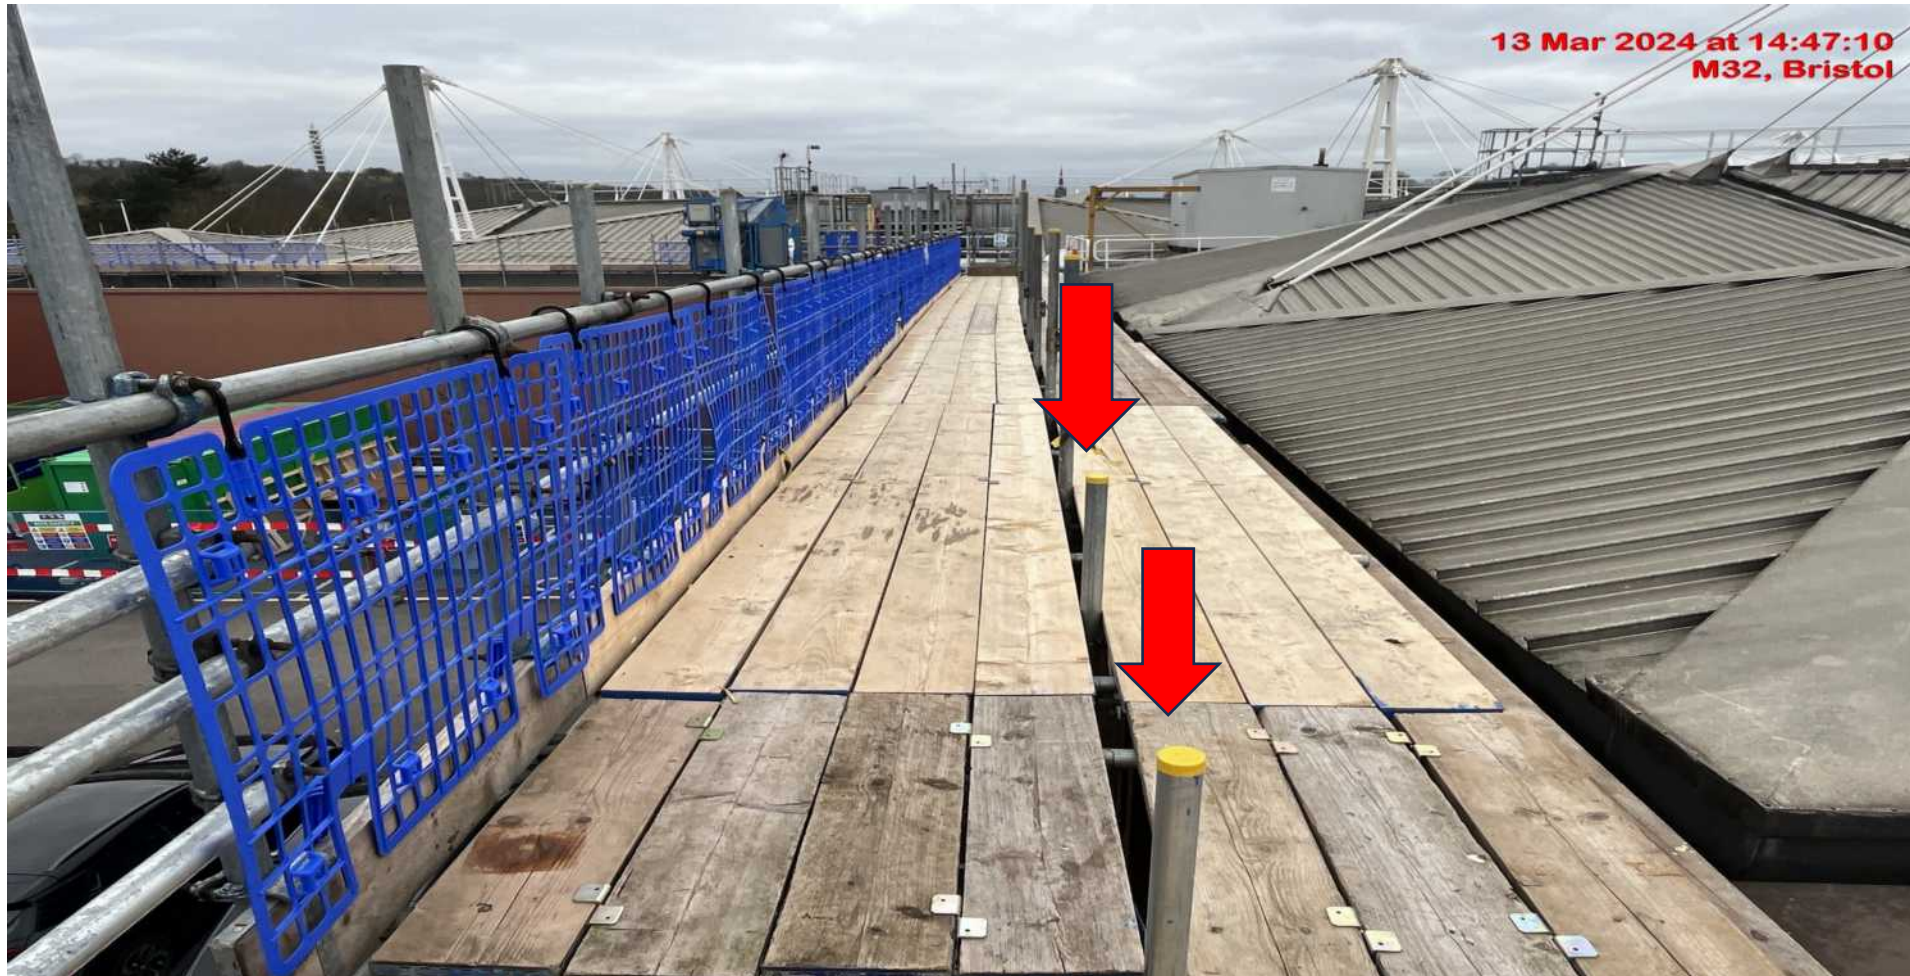
EAS 003

Protruding Tubes on the Working Lift are a hazard and need to be cut flush to same height as Working Lift or raised 1m above Working Lift.

Single Fittings have been used as opposed to Double Couplers in order to secure the Handrails.

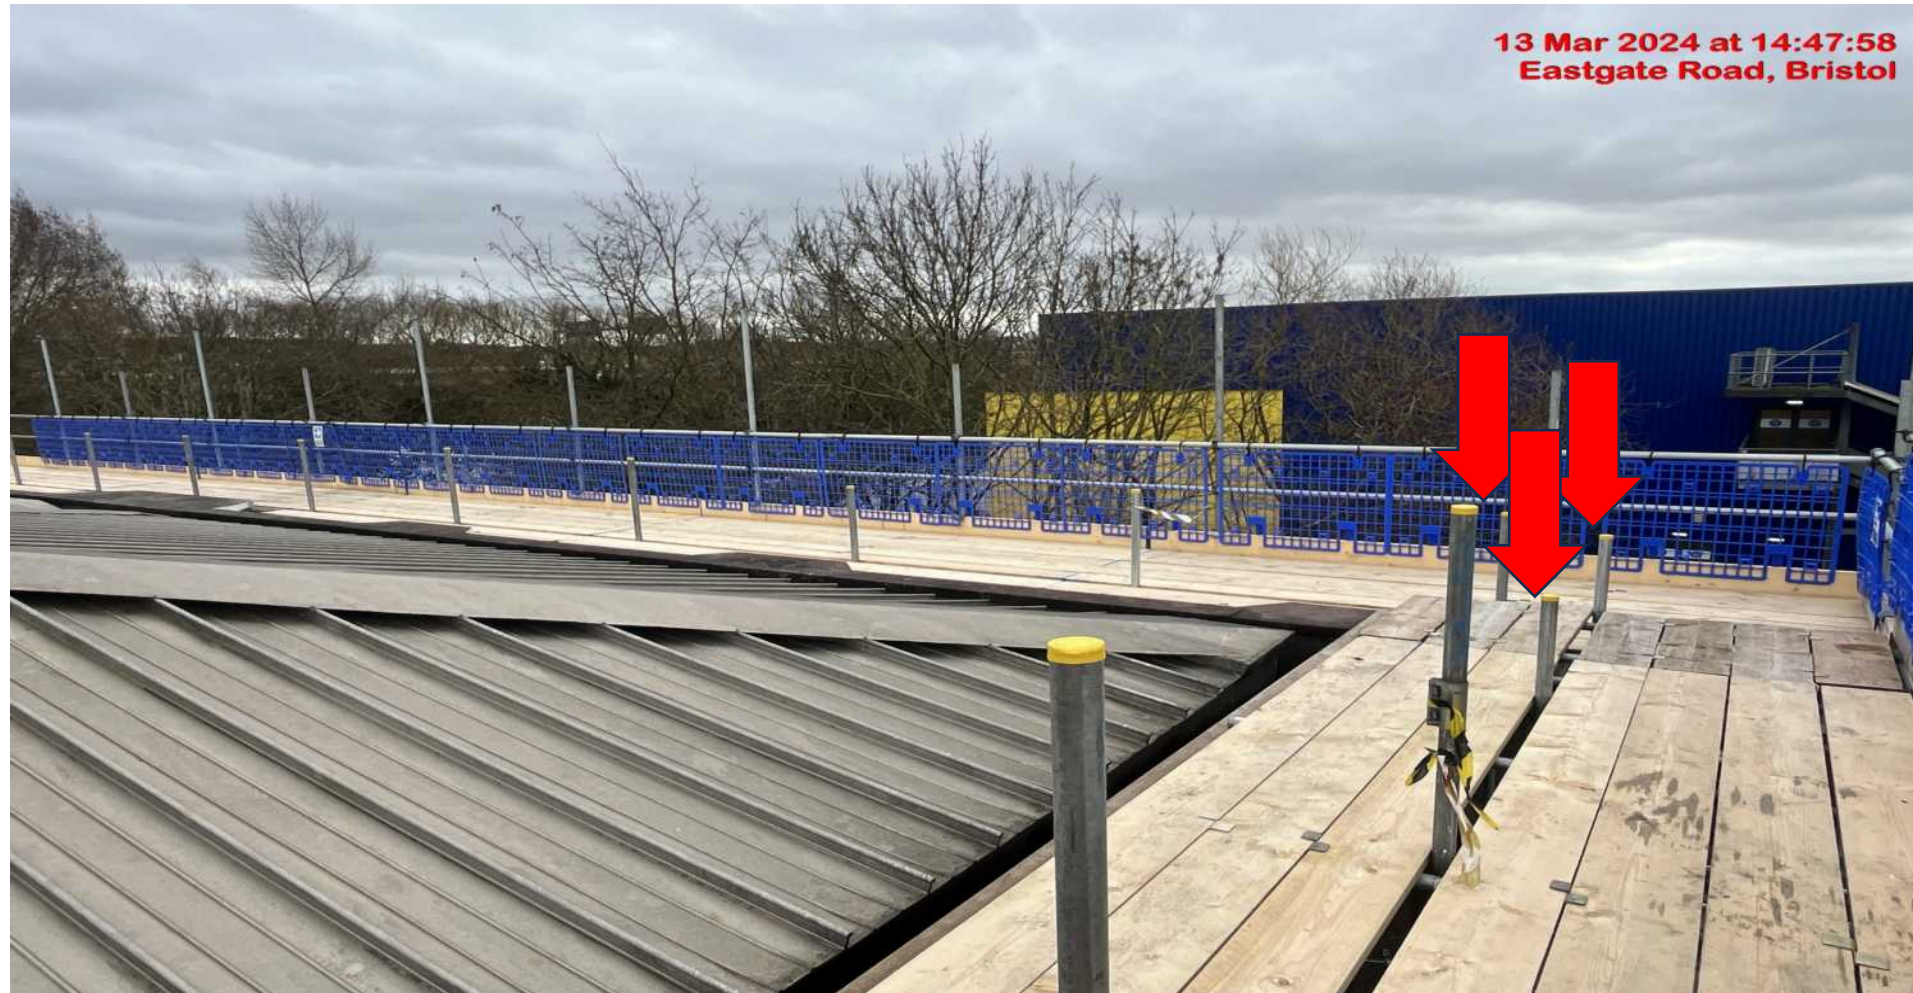
EAS 003

Protruding Tubes on the Working Lift are a hazard and need to be cut flush to same height as Working Lift or raised 1m above Working Lift.

Single Fittings have been used as opposed to Double Couplers in order to secure the Handrails.

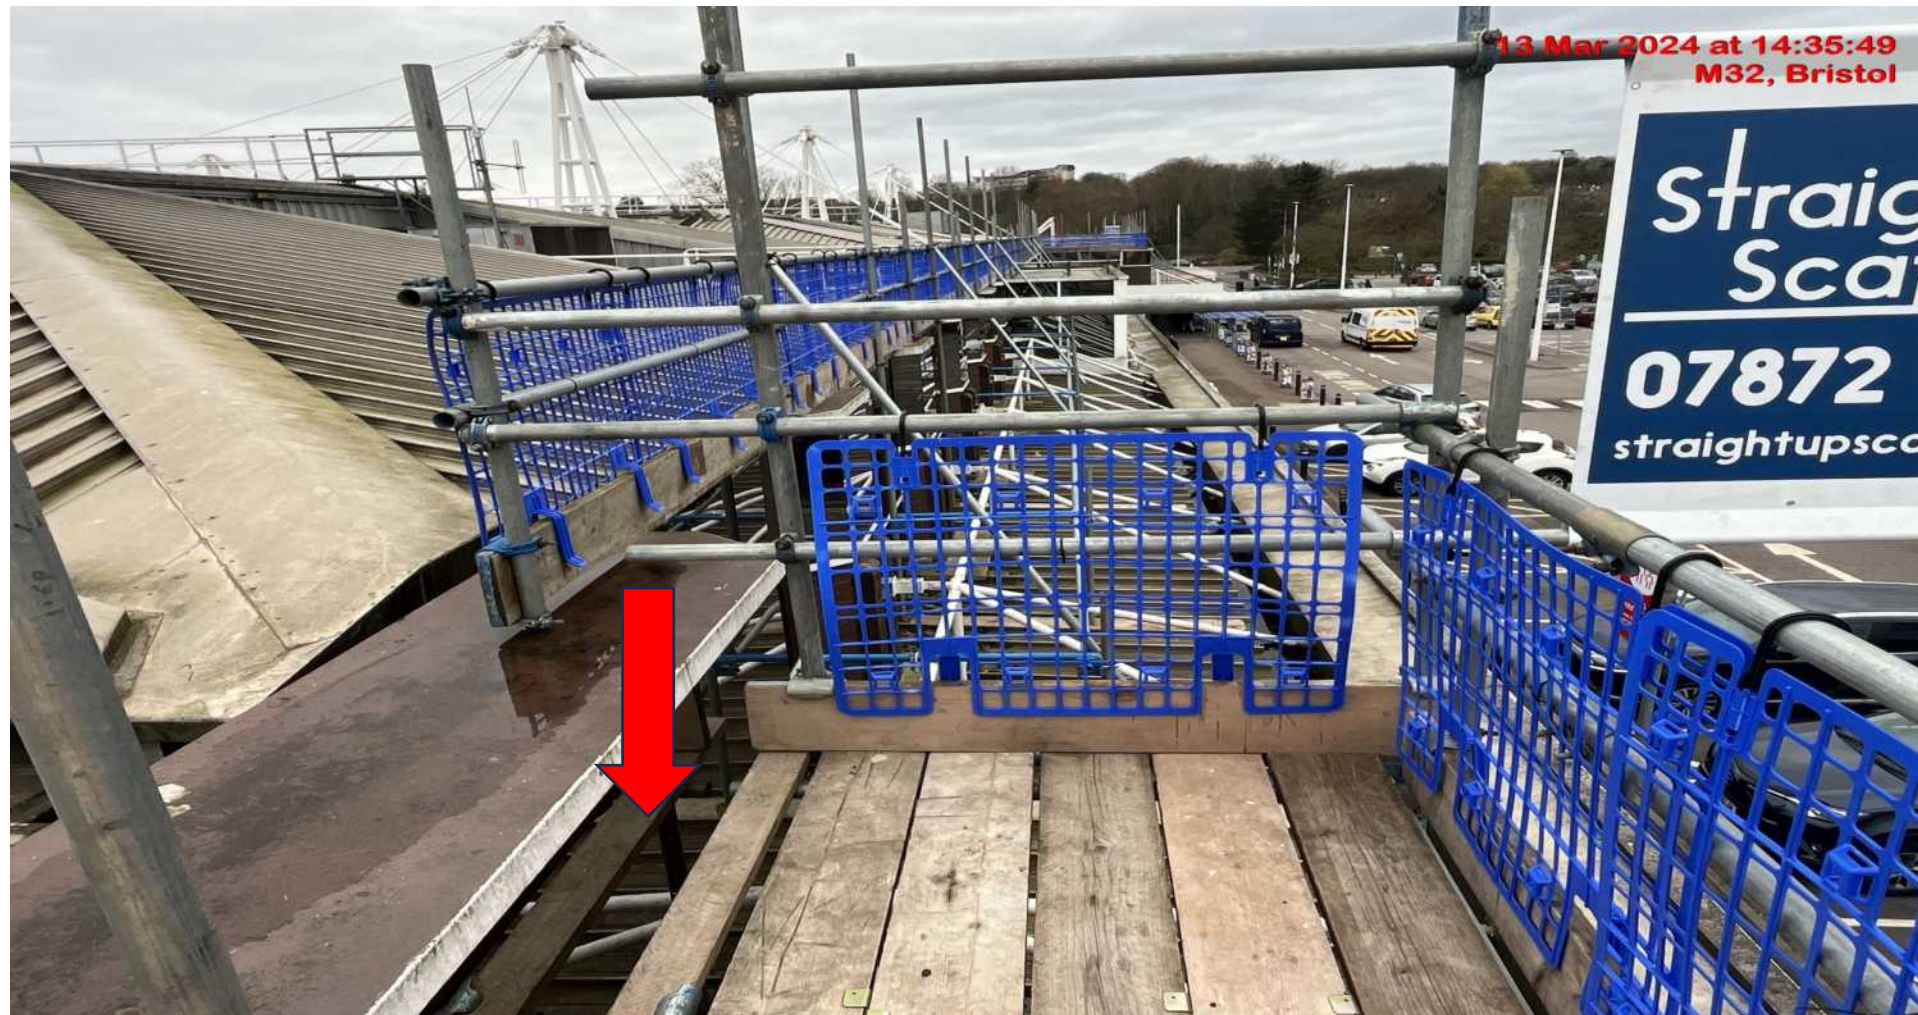
EAS 004

Void needs to be eliminated on Working Lift.

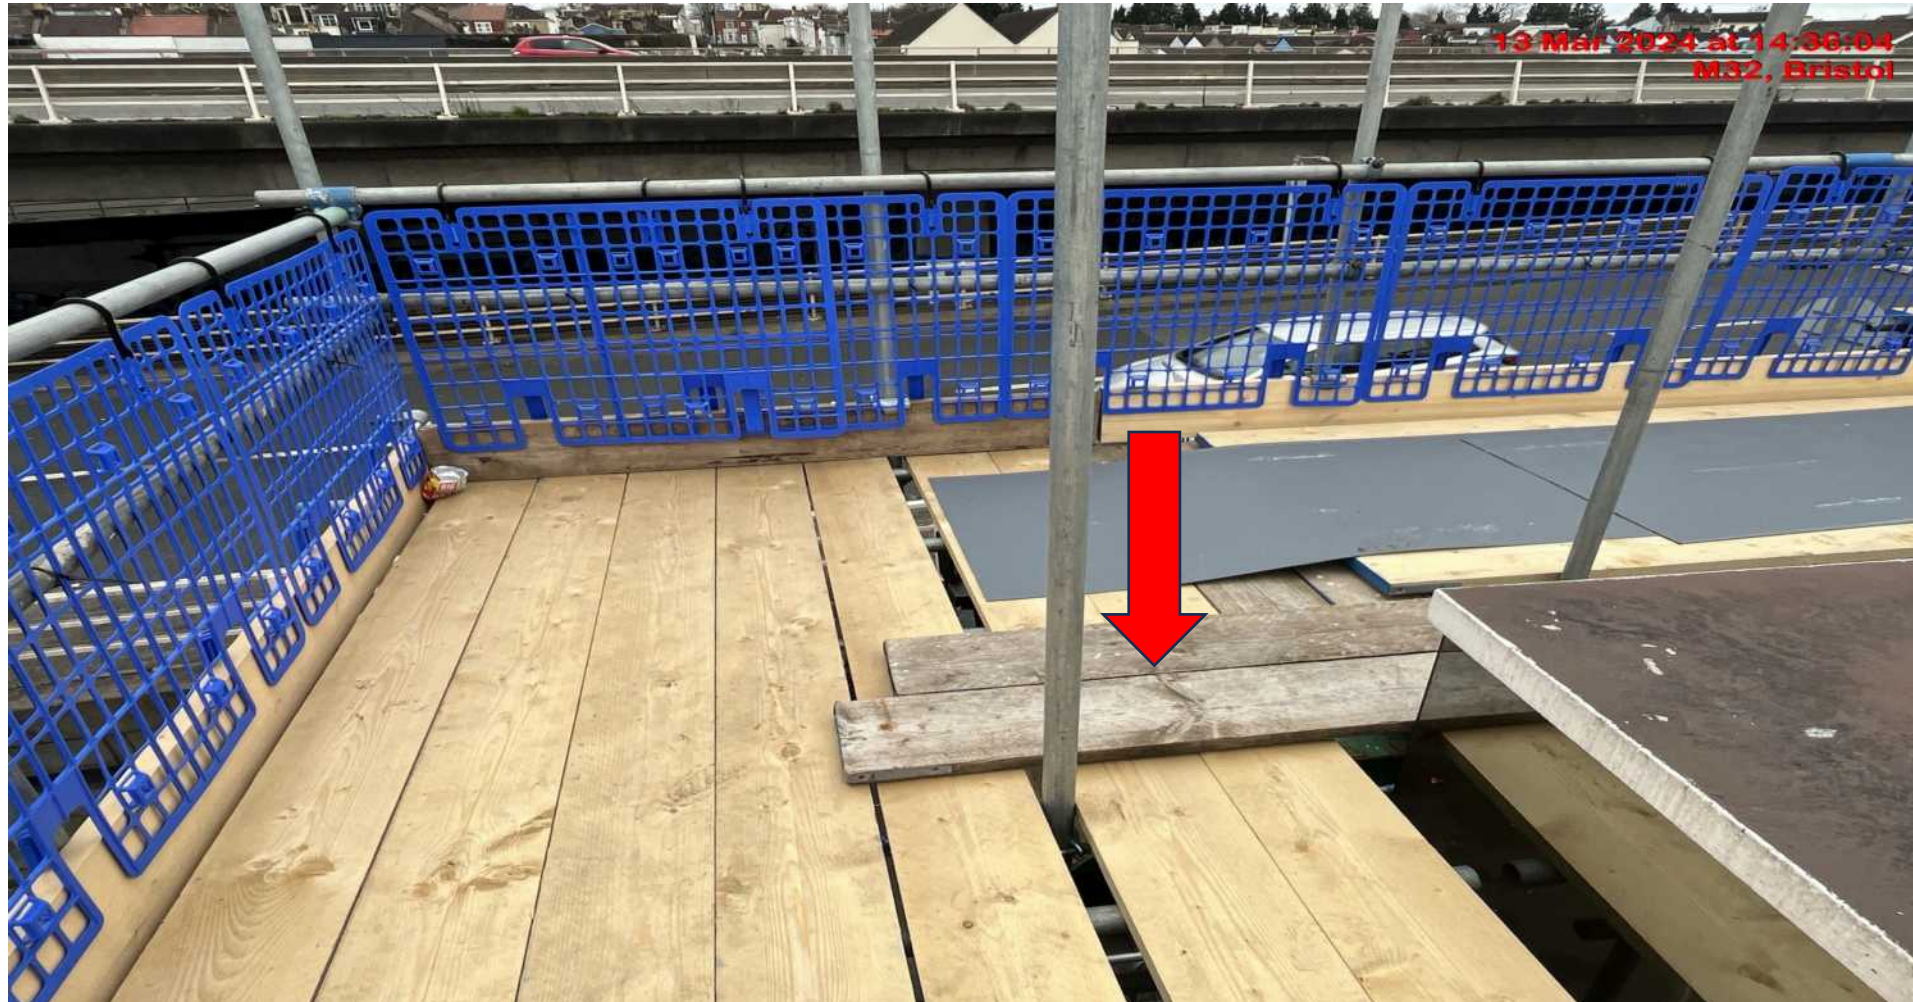
EAS 004

Lapped Boards are a potential tripping hazard on the Working Lift.
