Cymru Scaffold Inspections

Tesco, Eastgate Rd, Eastville, Bristol BS5 6XU

Wednesday 13th March 2024

INSPECTION OF: Site Scaffolds & Scaffold Management on Site

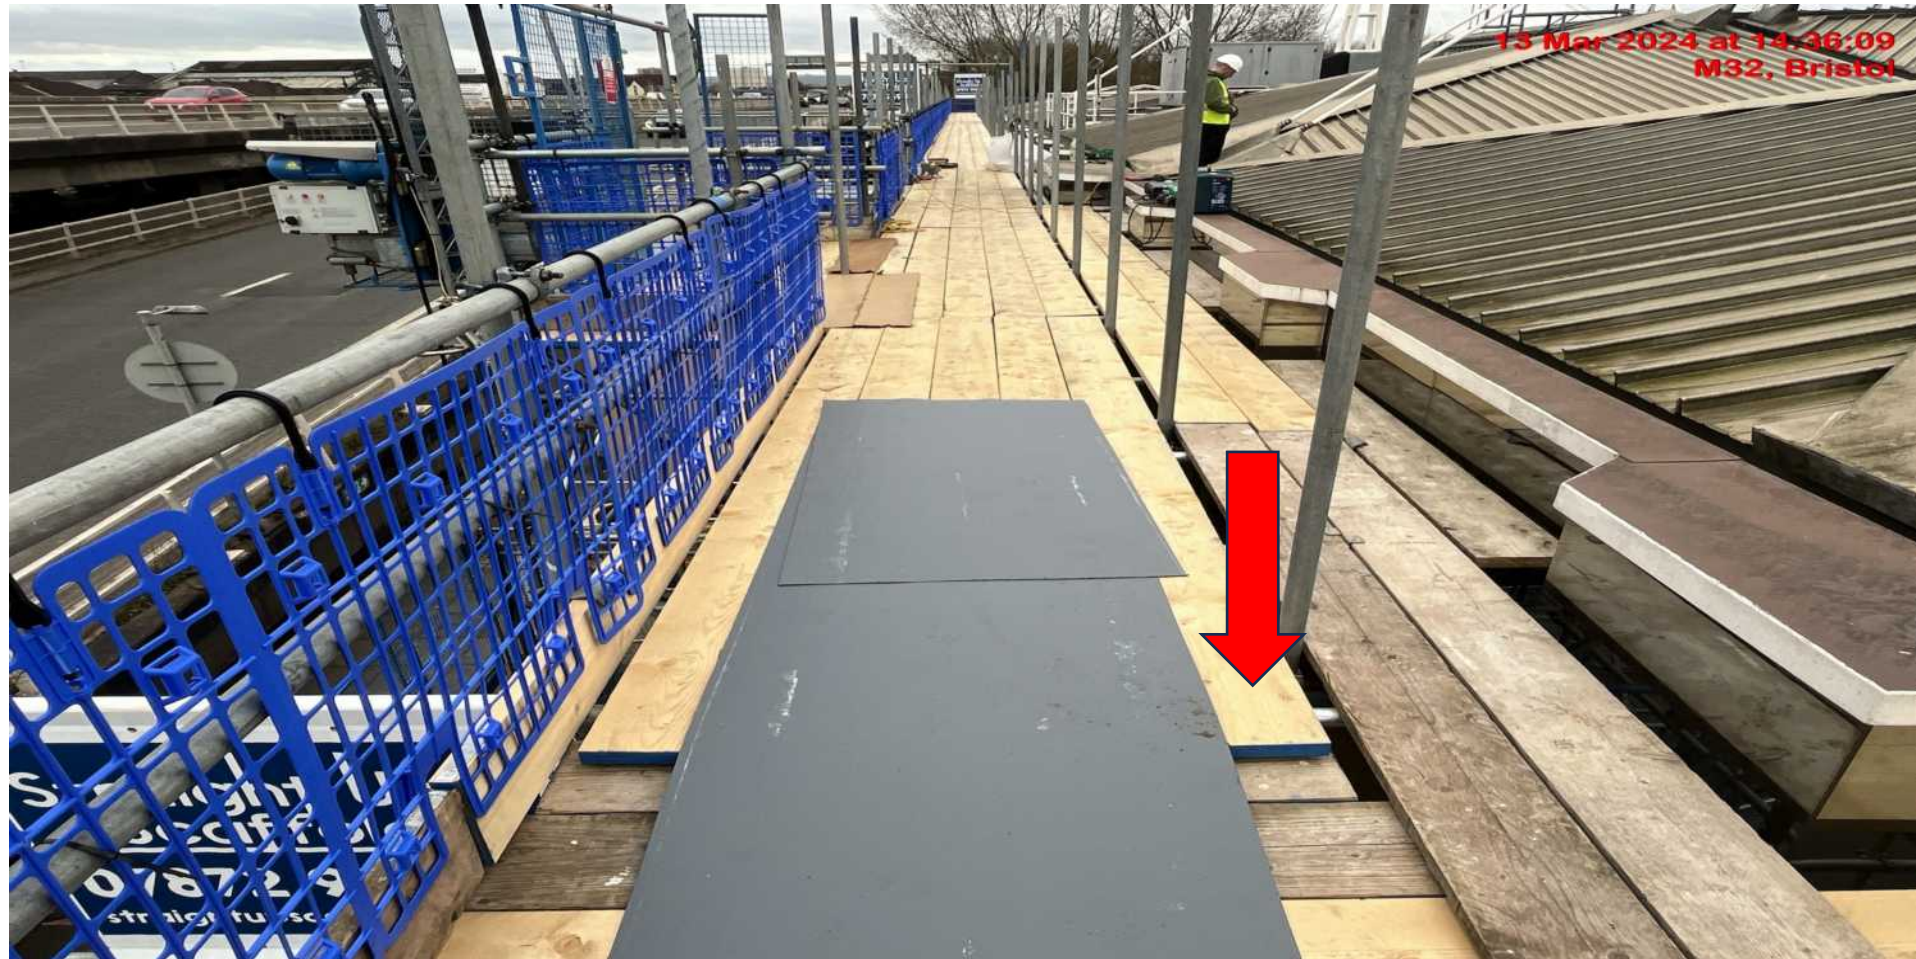
EAS 004

Lapped Boards are a potential tripping hazard on the Working Lift.

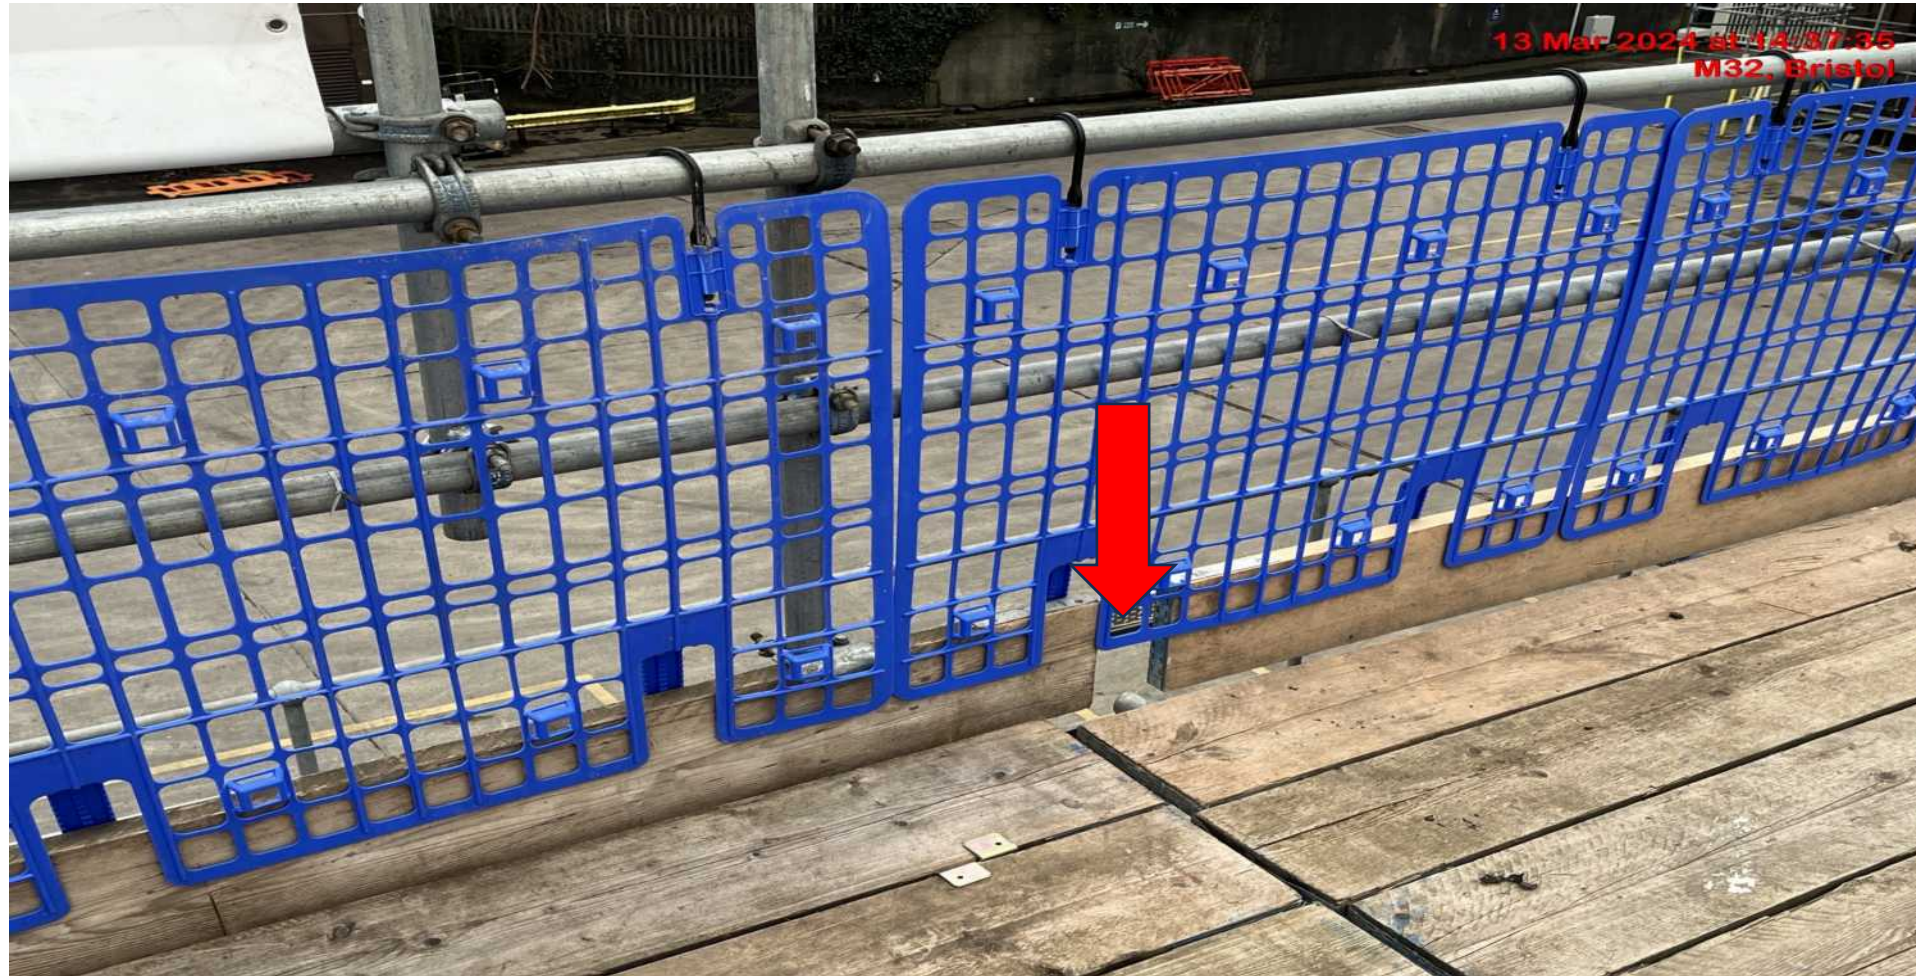
EAS 004

Void needs to be eliminated on Working Lift.

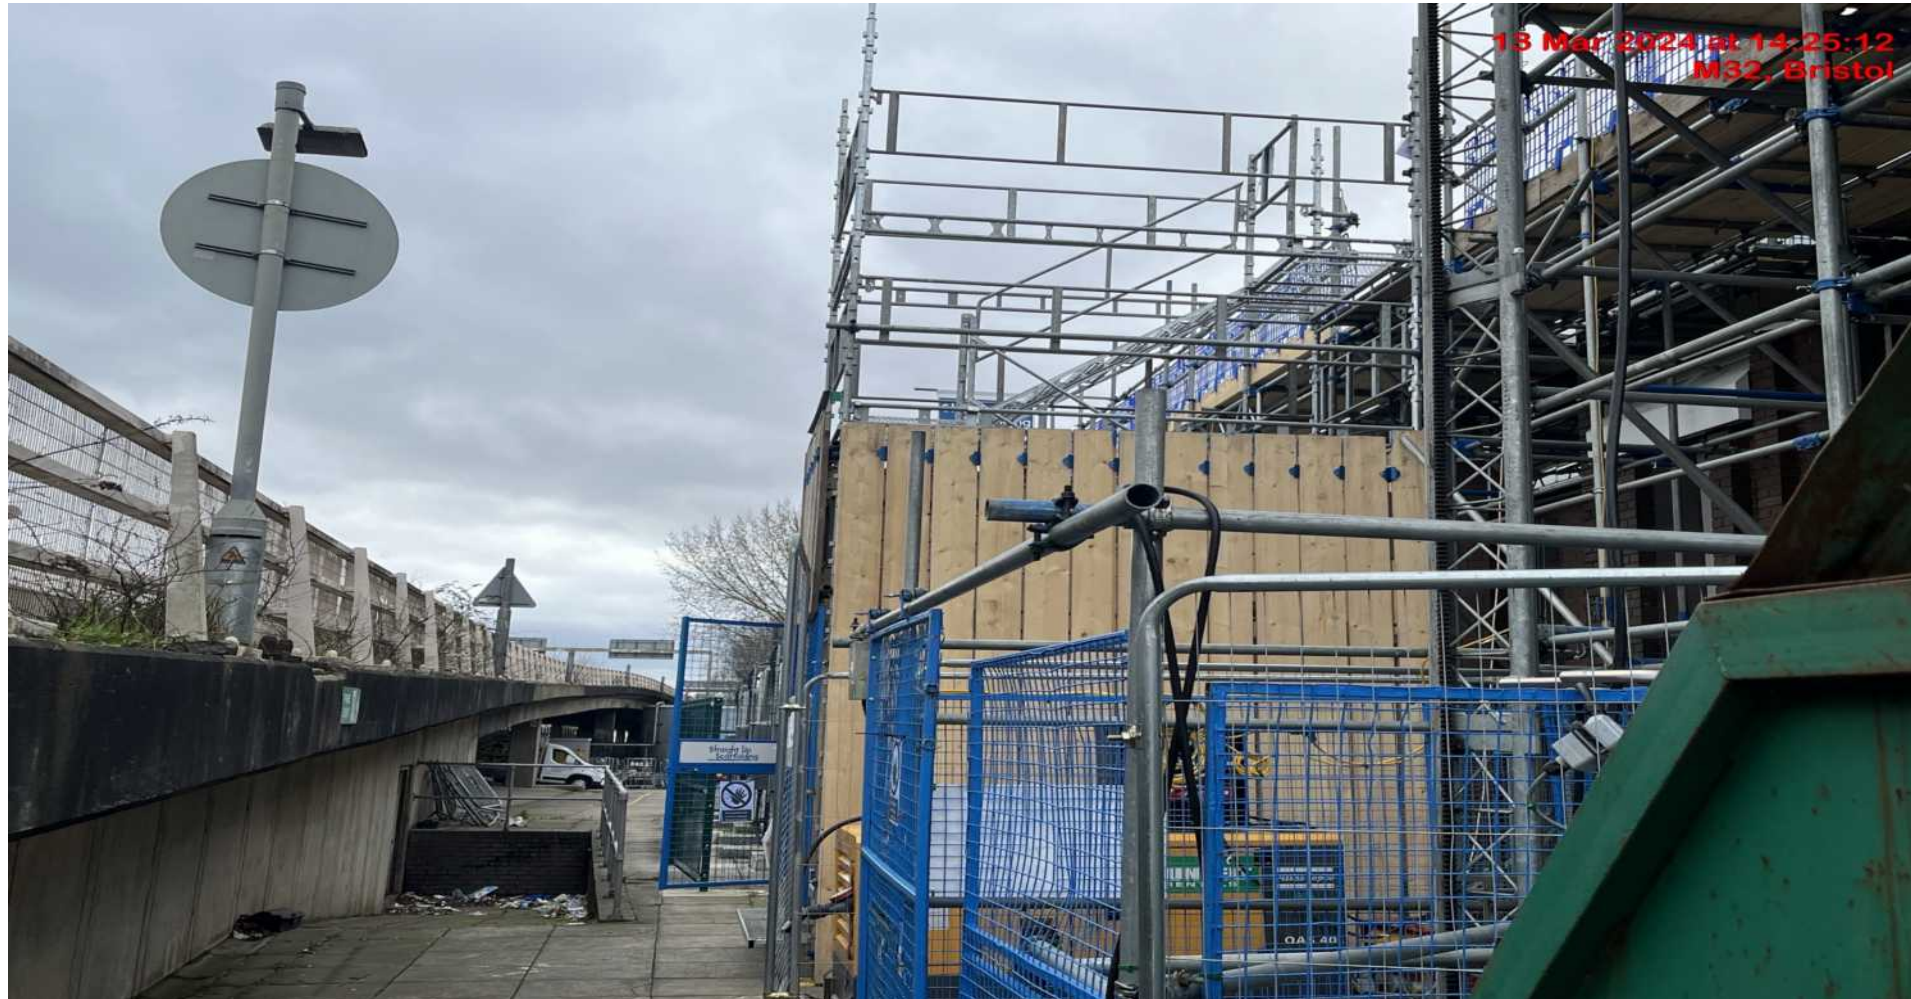
EAS 005

Notes: Handover Certificate needs to be in place for the Haki Staircase, Haki Staircase is free of Defect and Damage
Toeboard is required for Haki staircase Landing.
