Cymru Scaffold Inspections

Tesco, Eastgate Rd, Eastville, Bristol BS5 6XU

Wednesday 13th March 2024

INSPECTION OF: Site Scaffolds & Scaffold Management on Site

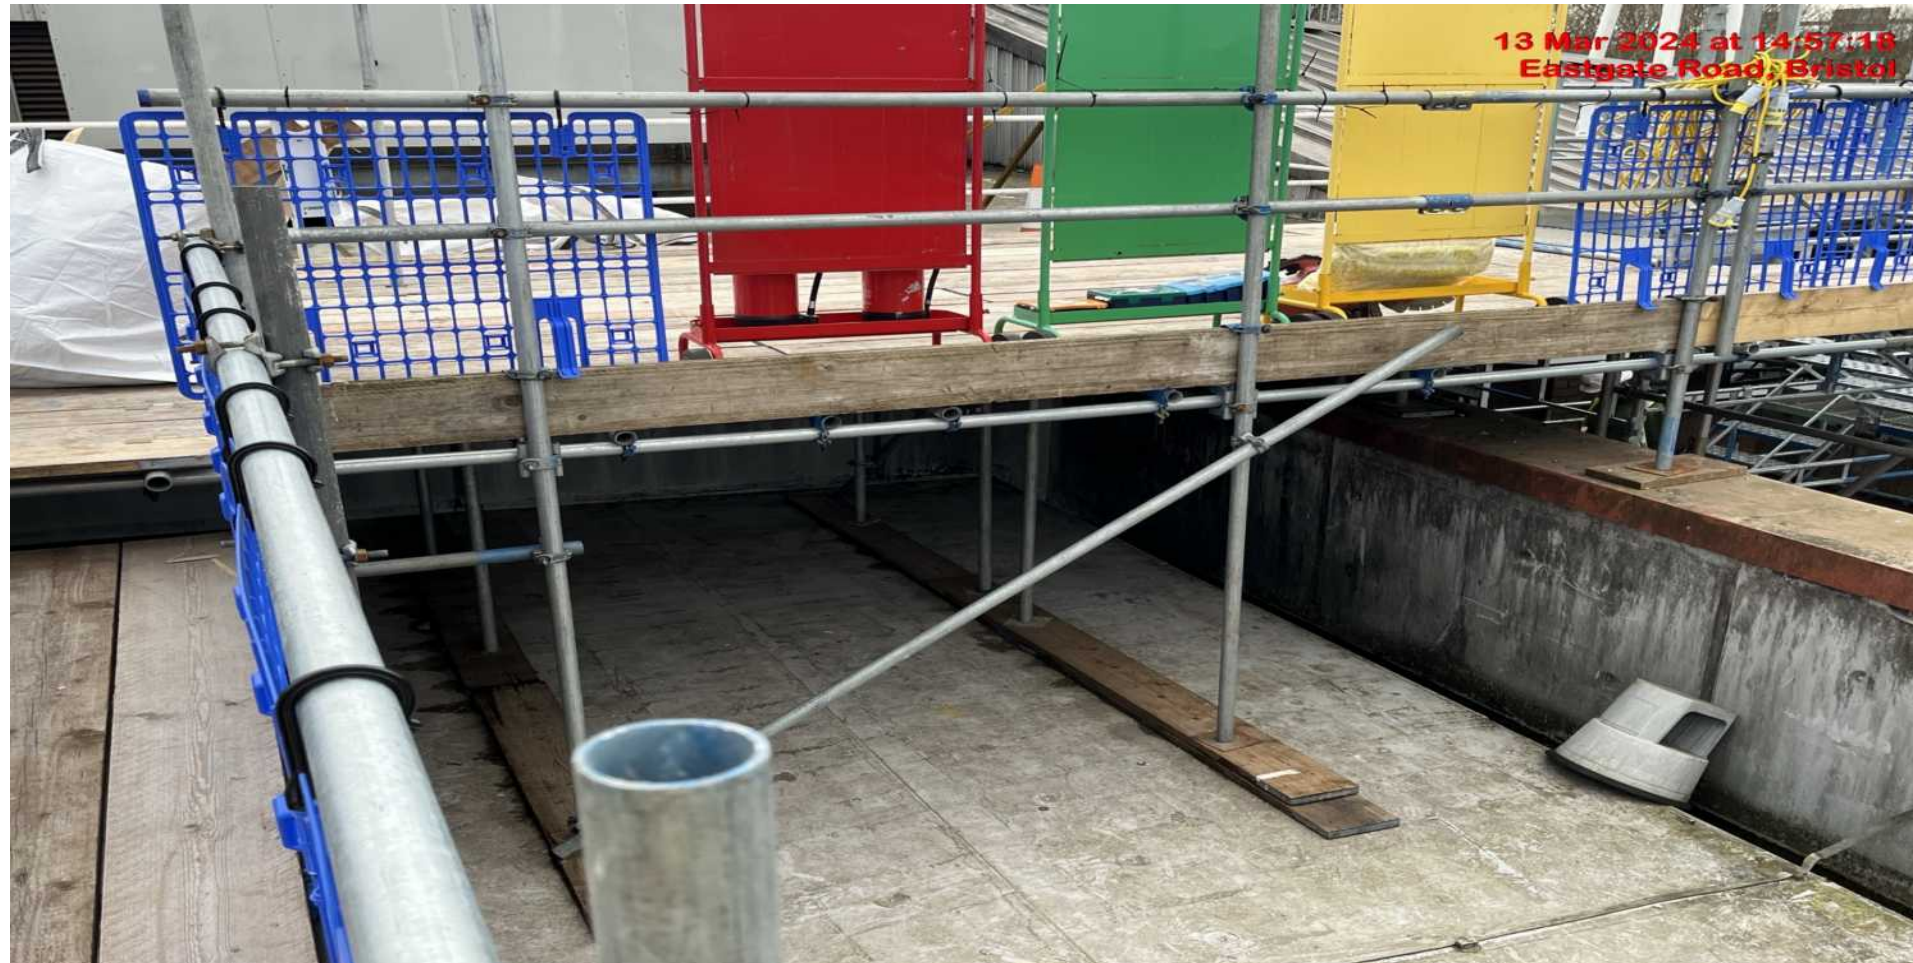
EAS 001

Independent Access Scaffold, Car Park & Store Entrance Elevation

Status of Scaffold: **Passed with observations**

Notes: Scaffold was erected in order to meet requirements of TG20:21. Alloy beams have been Laced and Braced sufficiently. Scaffold has been Tied into the Building in order to prevent movement. Protection Fans in place in order to meet Project Requirements. Working Lifts are free of Debris and waste materials.

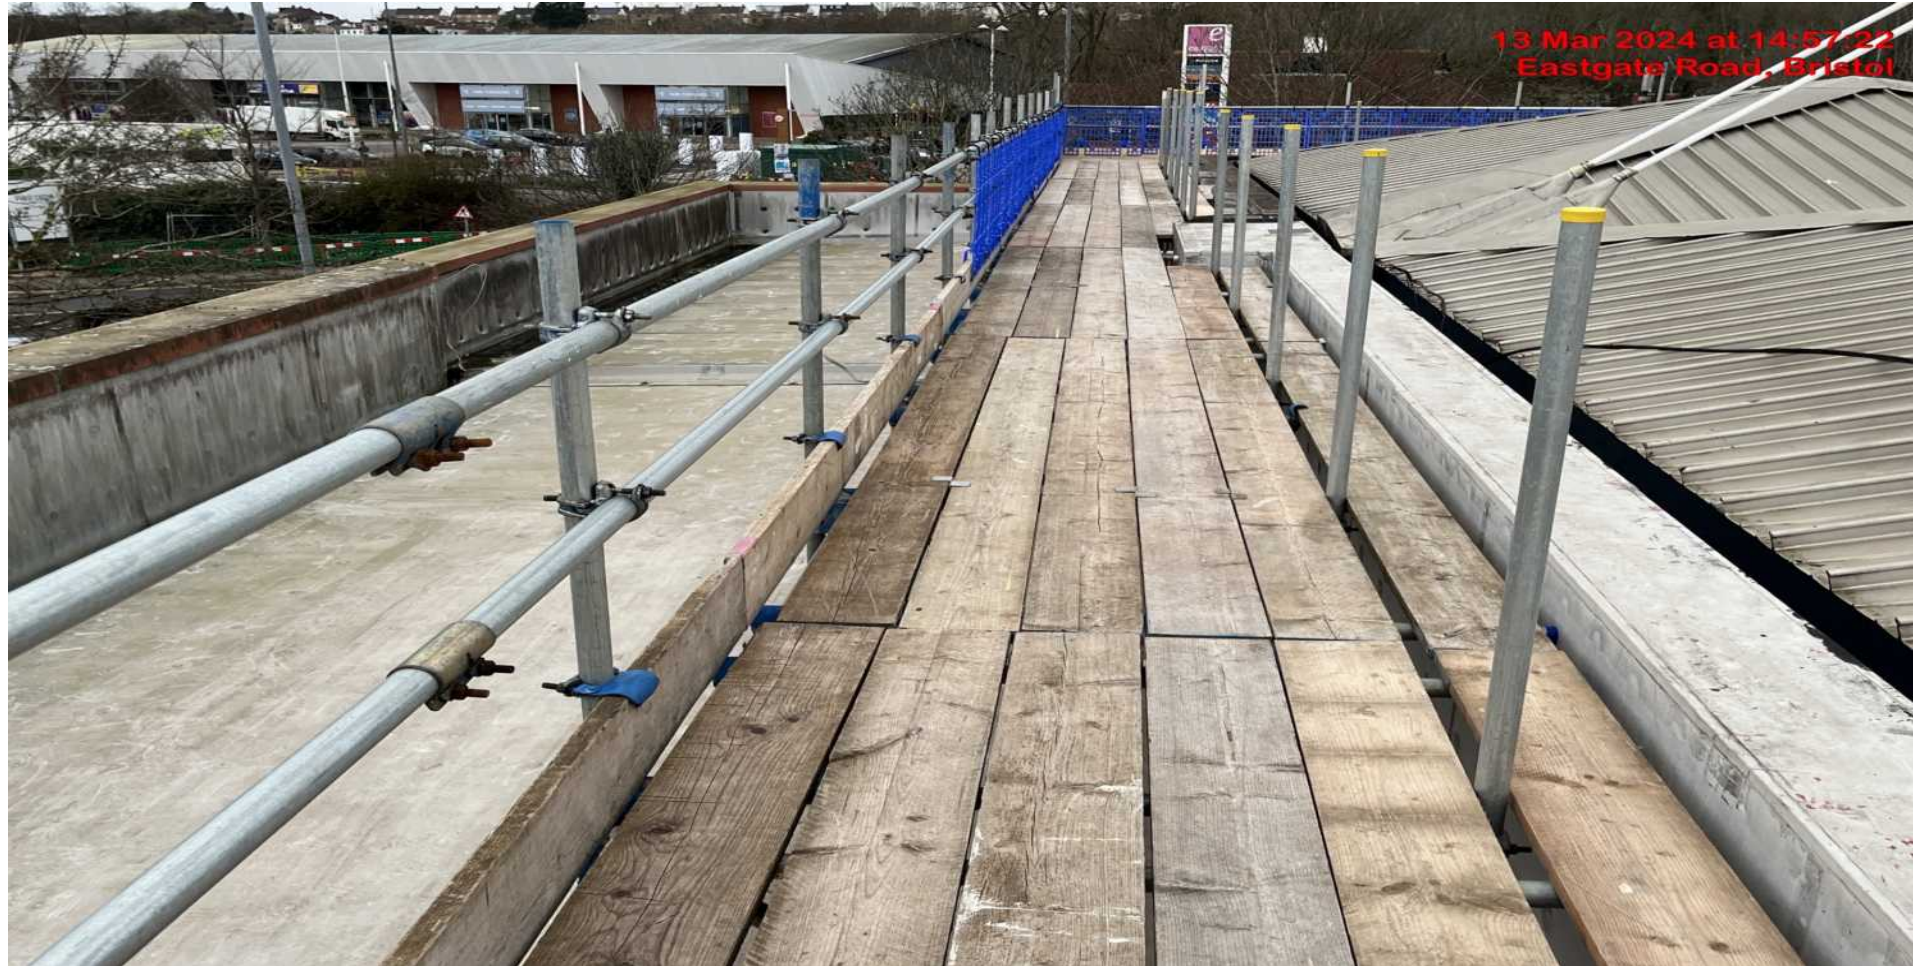
EAS 001

Independent Access Scaffold, Car Park & Store Entrance Elevation

Status of Scaffold: **Passed with observations**

Notes: Scaffold was erected in order to meet requirements of TG20:21. Alloy beams have been Laced and Braced sufficiently. Scaffold has been Tied into the Building in order to prevent movement. Protection Fans in place in order to meet Project Requirements. Working Lifts are free of Debris and waste materials.

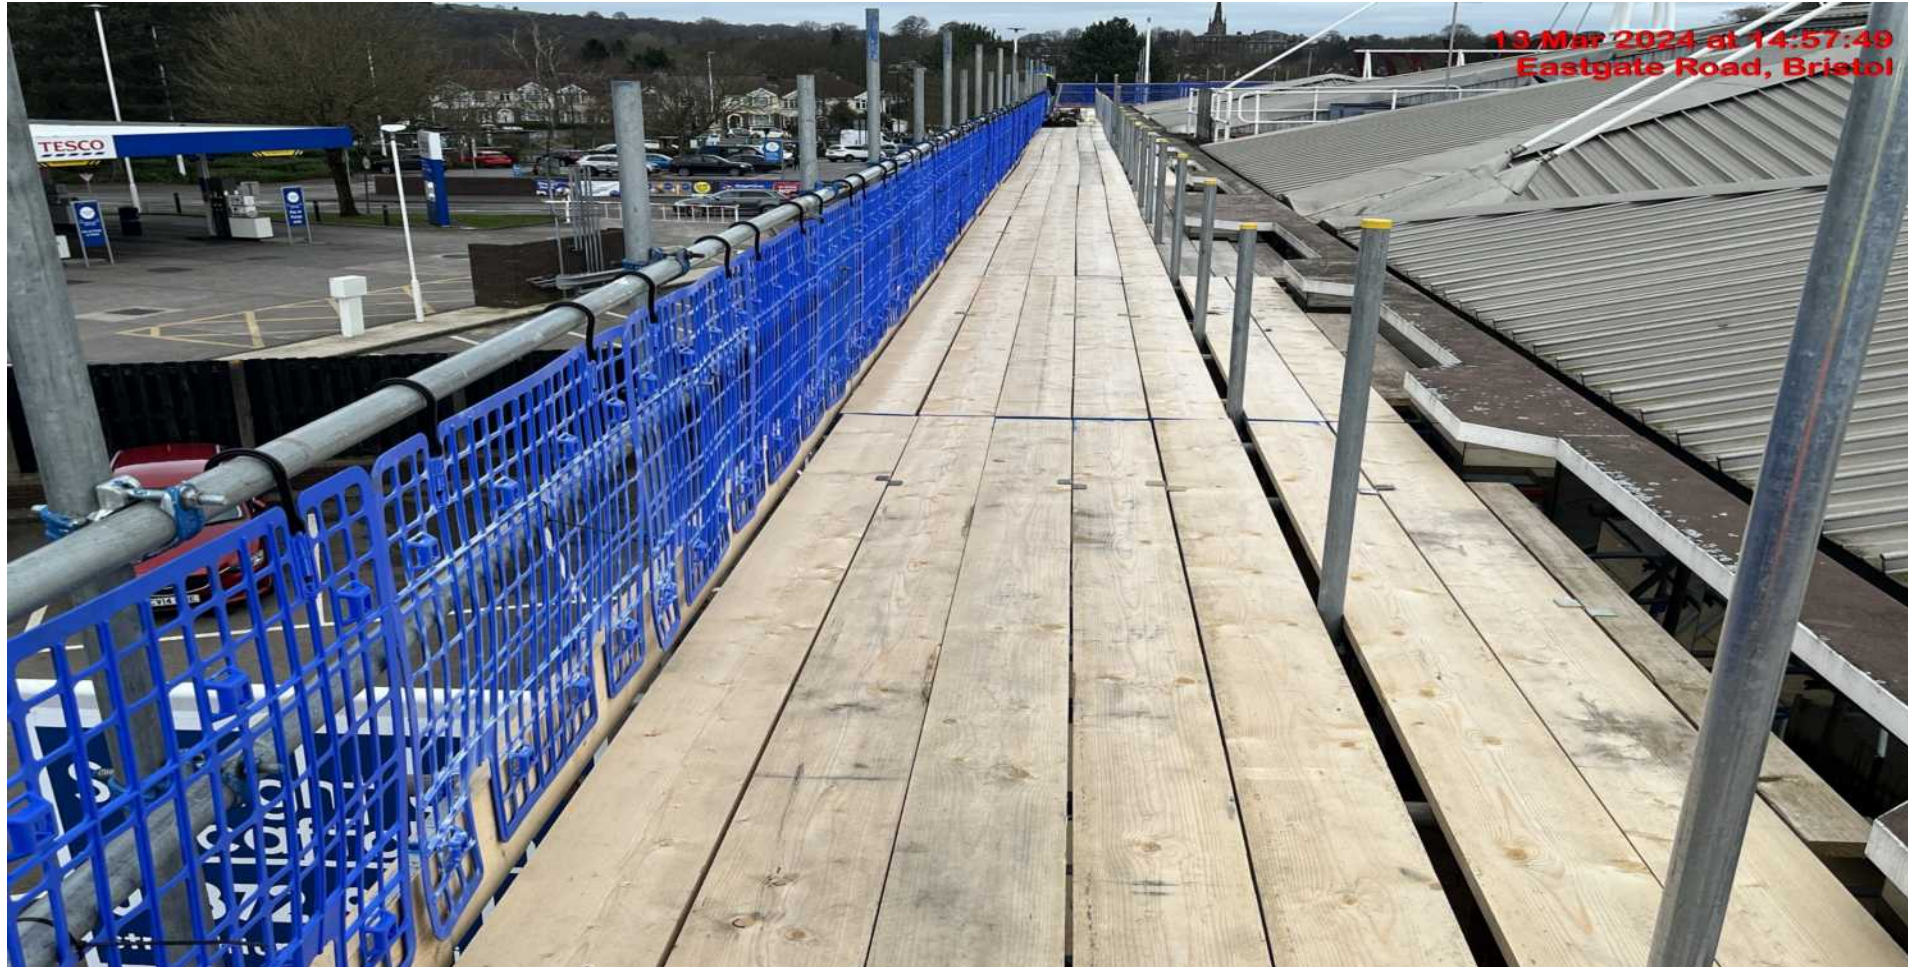
EAS 001

Independent Access Scaffold, Car Park & Store Entrance Elevation

Status of Scaffold: Passed with observations

Notes: Scaffold was erected in order to meet requirements of TG20:21. Alloy beams have been Laced and Braced sufficiently. Scaffold has been Tied into the Building in order to prevent movement. Protection Fans in place in order to meet Project Requirements. Working Lifts are free of Debris and waste materials.

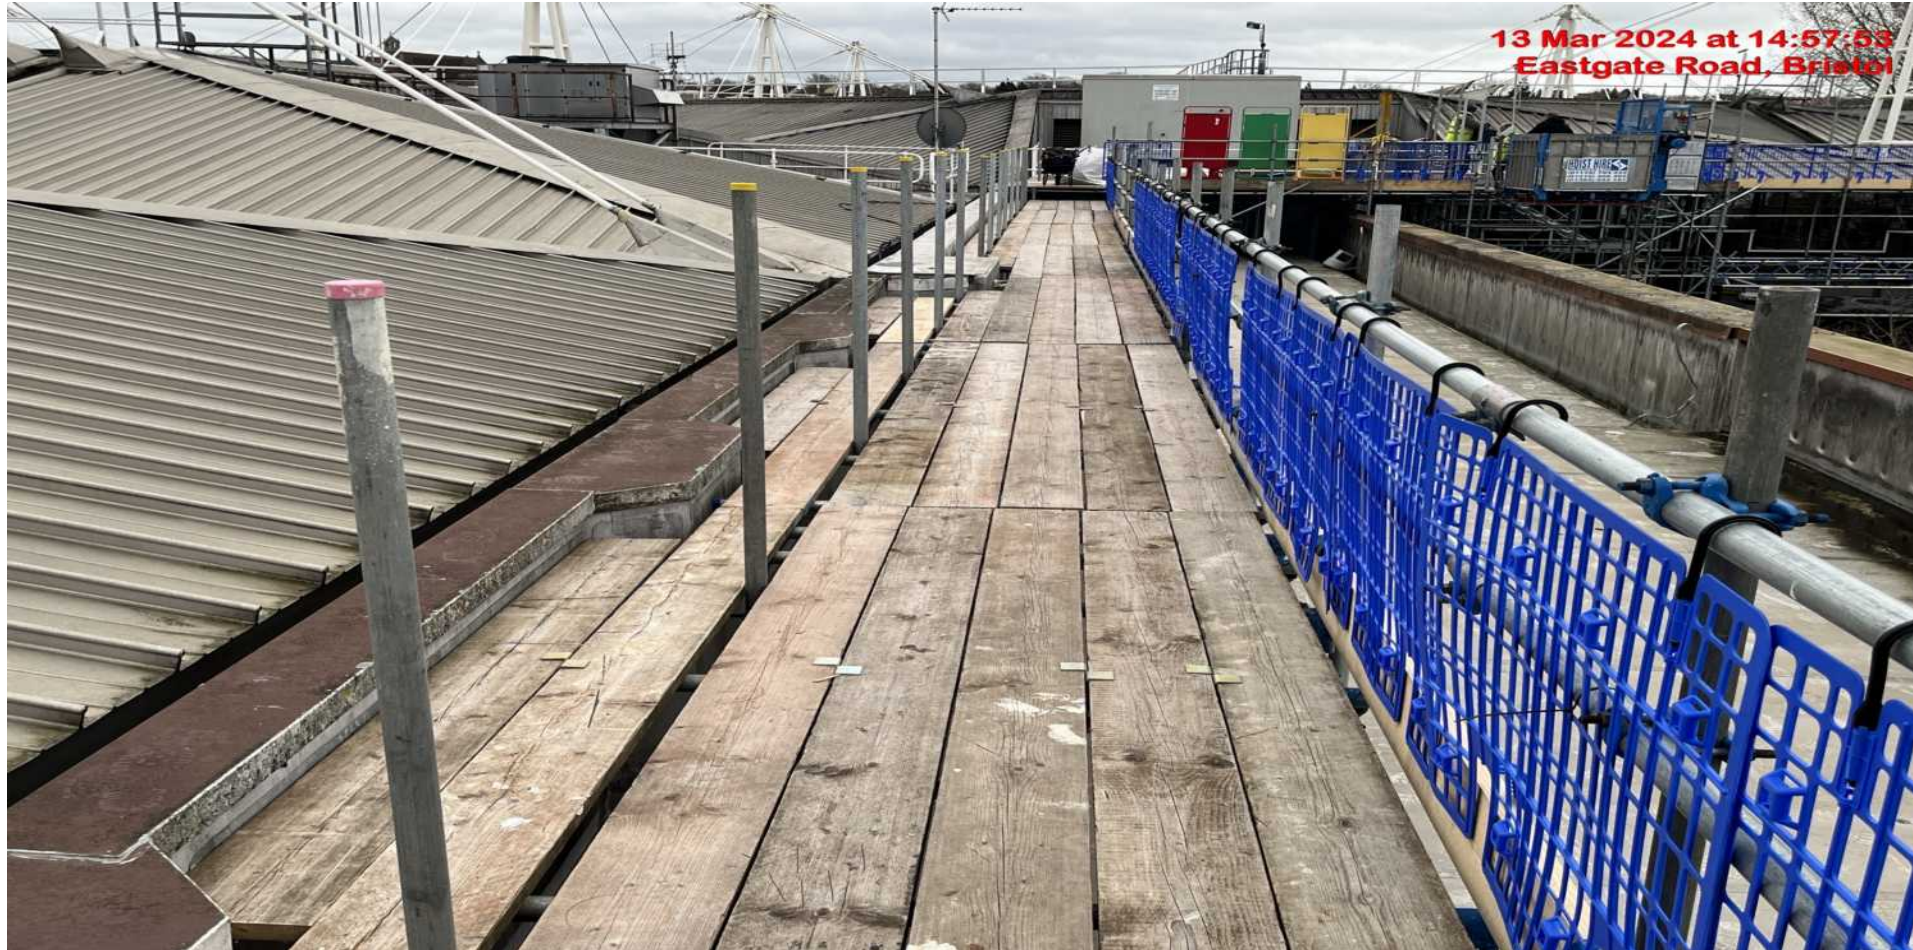
EAS 001

Independent Access Scaffold, Car Park & Store Entrance Elevation

Scaffold has been Tied into the Building in order to prevent movement. Protection Fans in place in order to meet Project Requirements.

Some of the Scaffold Boards near to the Glass Windows have been placed flush against the Glass, care to be taken when the Dismantle takes place.

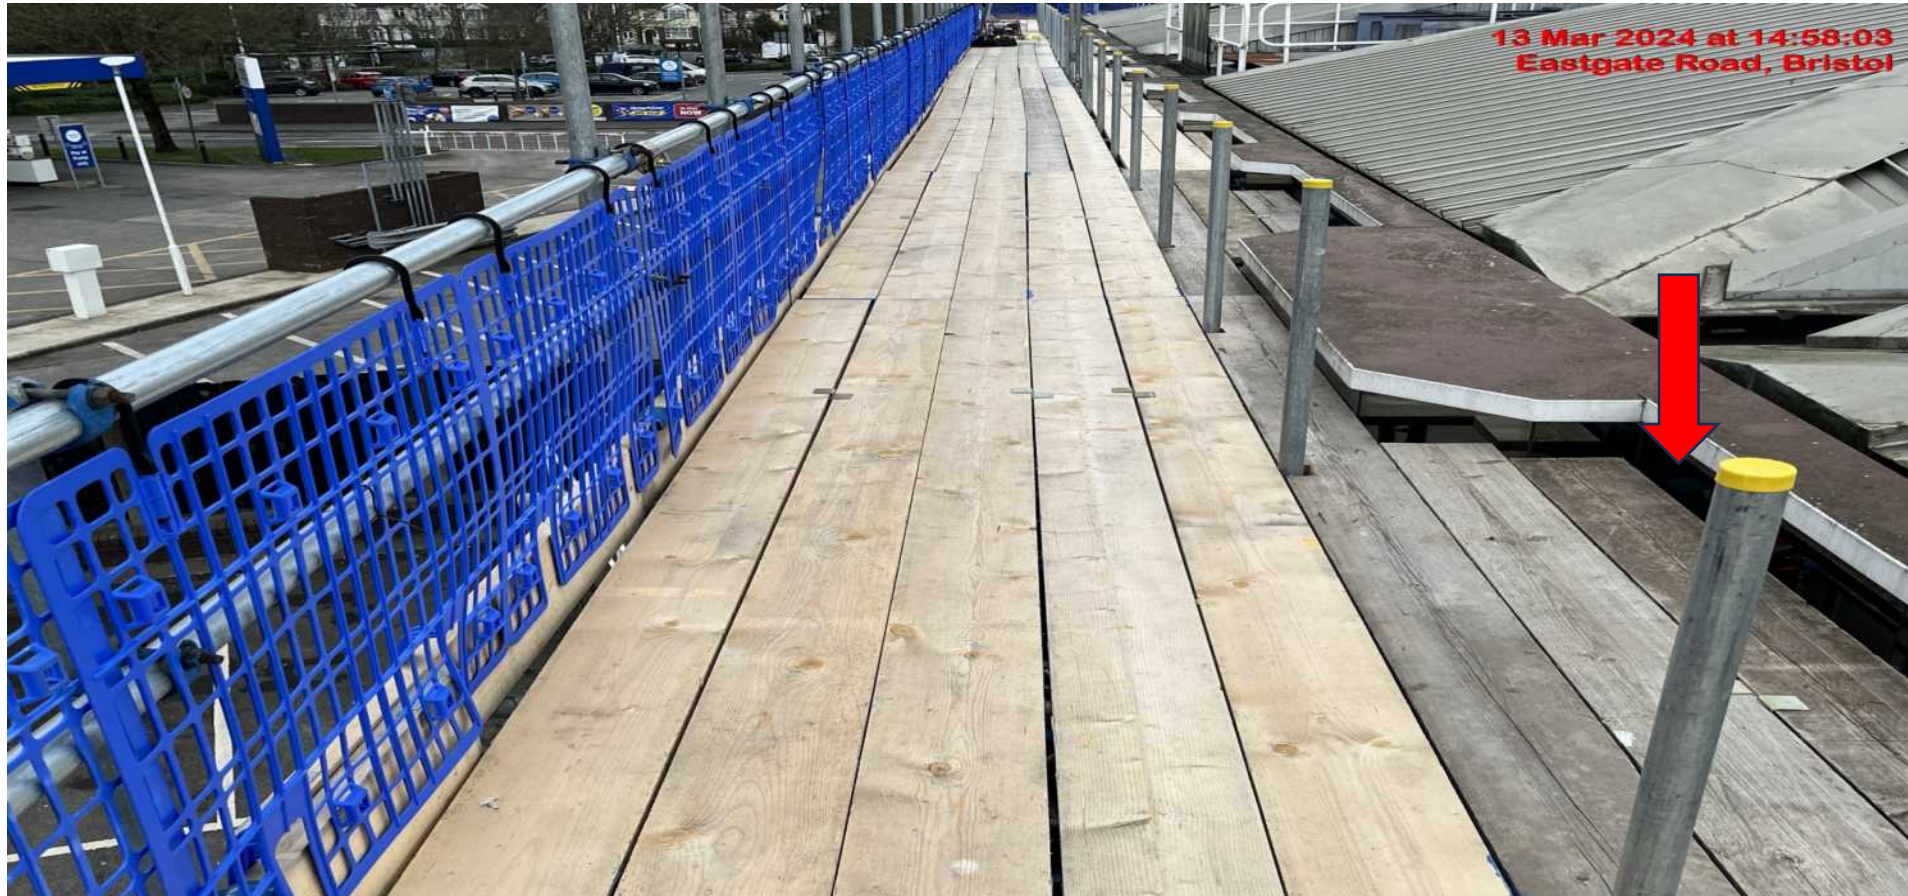
EAS 001

Independent Access Scaffold, Car Park & Store Entrance Elevation

Status of Scaffold: **Passed with observations**

Notes: Scaffold was erected in order to meet requirements of TG20:21. Alloy beams have been Laced and Braced sufficiently. Scaffold has been Tied into the Building in order to prevent movement. Protection Fans in place in order to meet Project Requirements. Working Lifts are free of Debris and waste materials.

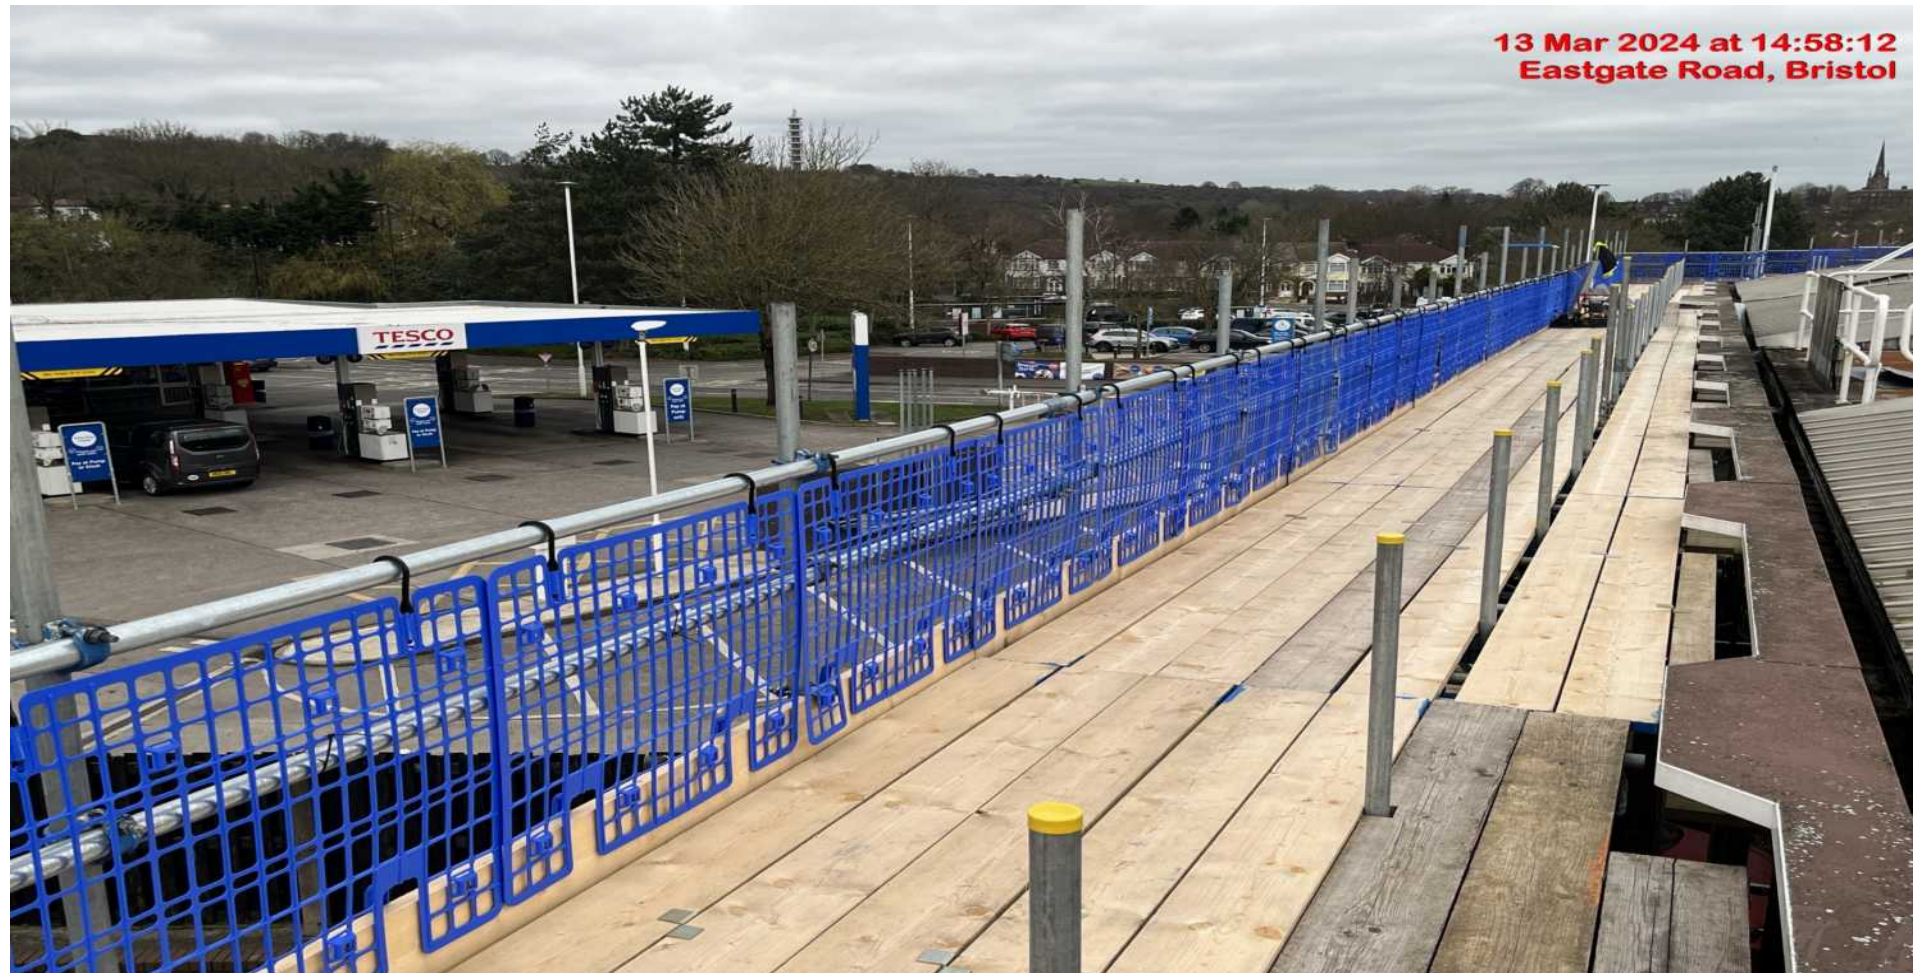
EAS 001

Independent Access Scaffold, Car Park & Store Entrance Elevation

Boards have been secured in order to prevent movement. Working Lifts are free of Debris and waste materials.

Some of the Scaffold Boards near to the Glass Windows have been placed flush against the Glass, care to be taken when the Dismantle takes place.

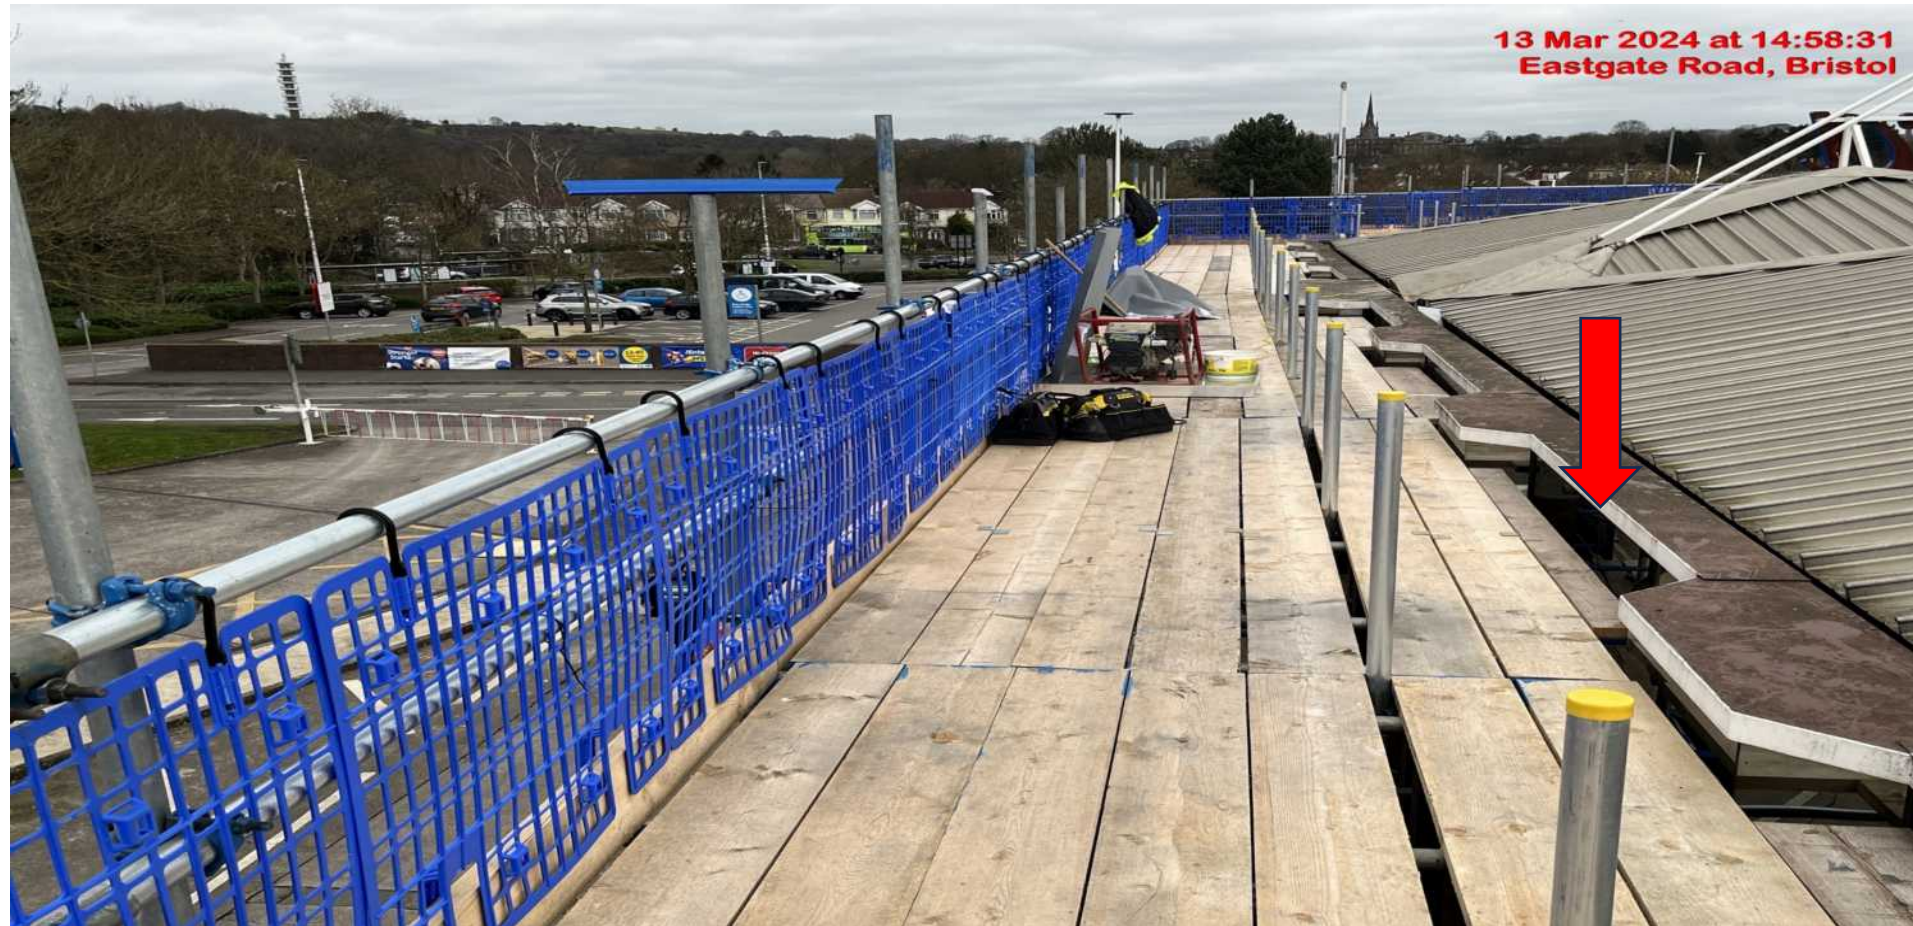
EAS 001

Independent Access Scaffold, Car Park & Store Entrance Elevation

Status of Scaffold: **Passed with observations**

Notes: Scaffold was erected in order to meet requirements of TG20:21. Alloy beams have been Laced and Braced sufficiently. Scaffold has been Tied into the Building in order to prevent movement. Protection Fans in place in order to meet Project Requirements. Working Lifts are free of Debris and waste materials.

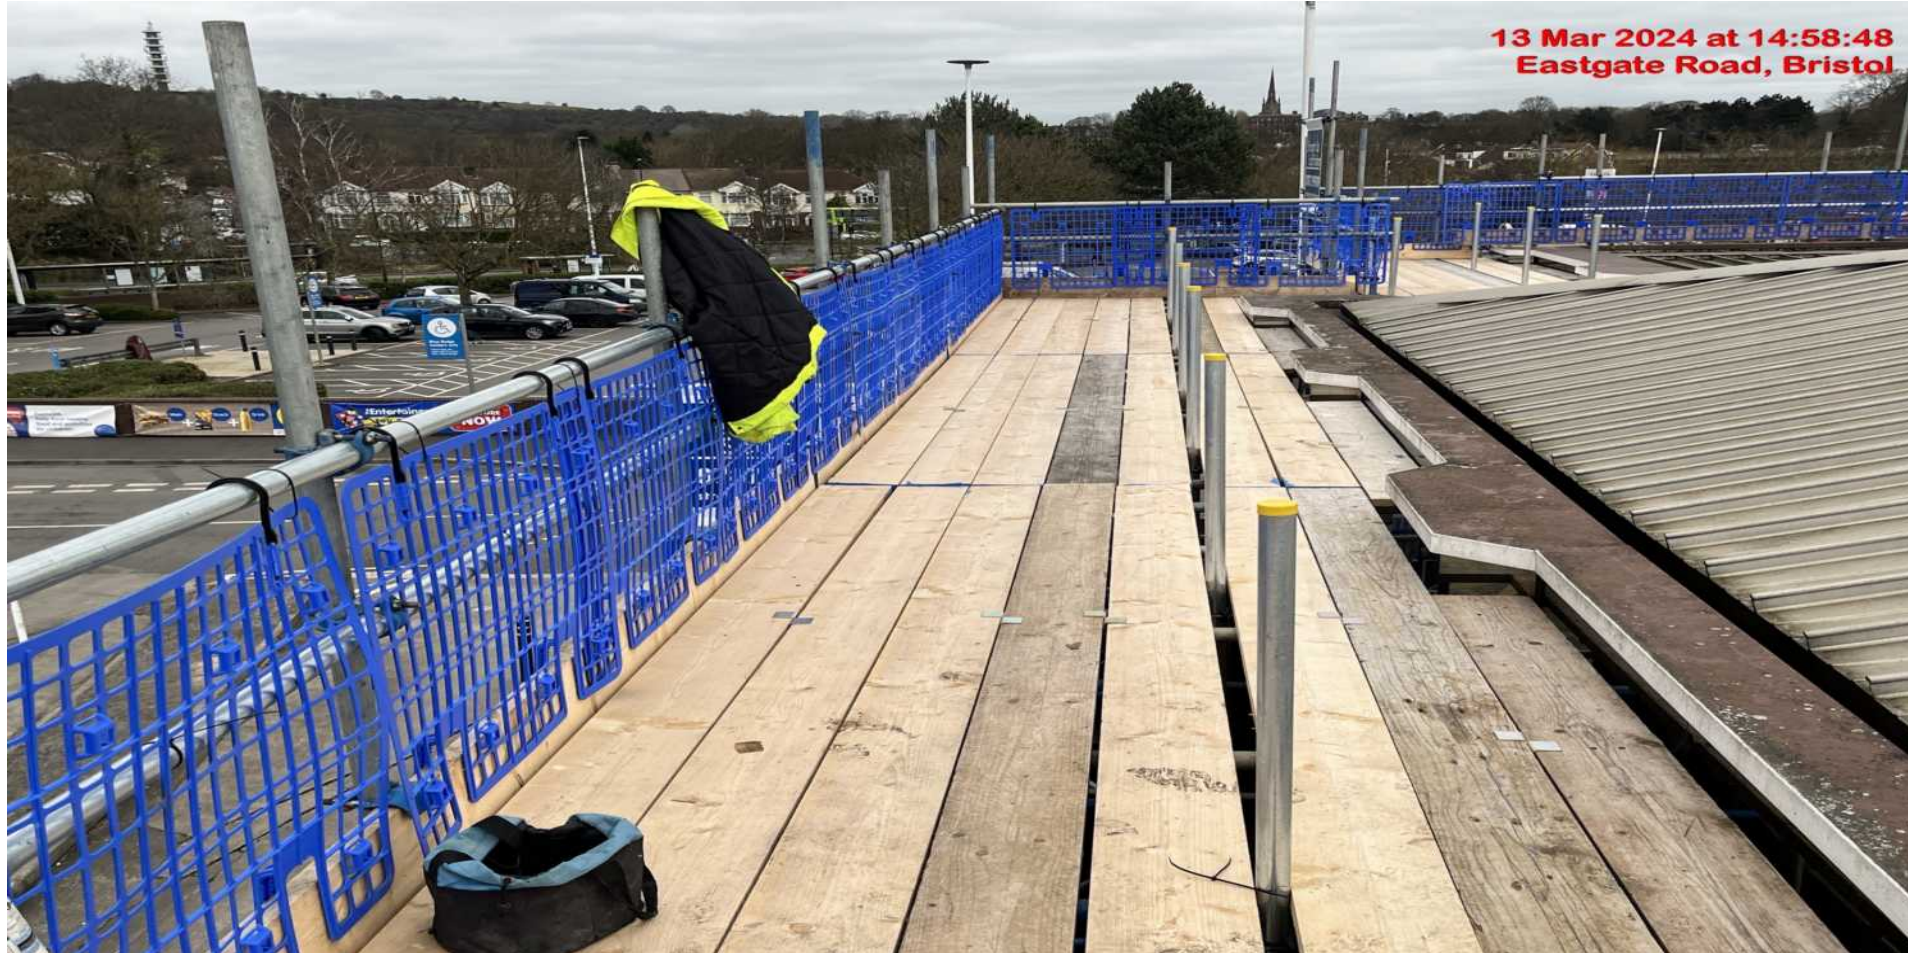
EAS 001

Independent Access Scaffold, Car Park & Store Entrance Elevation

Status of Scaffold: **Passed with observations**

Notes: Scaffold was erected in order to meet requirements of TG20:21. Alloy beams have been Laced and Braced sufficiently. Scaffold has been Tied into the Building in order to prevent movement. Protection Fans in place in order to meet Project Requirements. Void needs to be eliminated, a small piece of Ply Board would be an excellent solution.

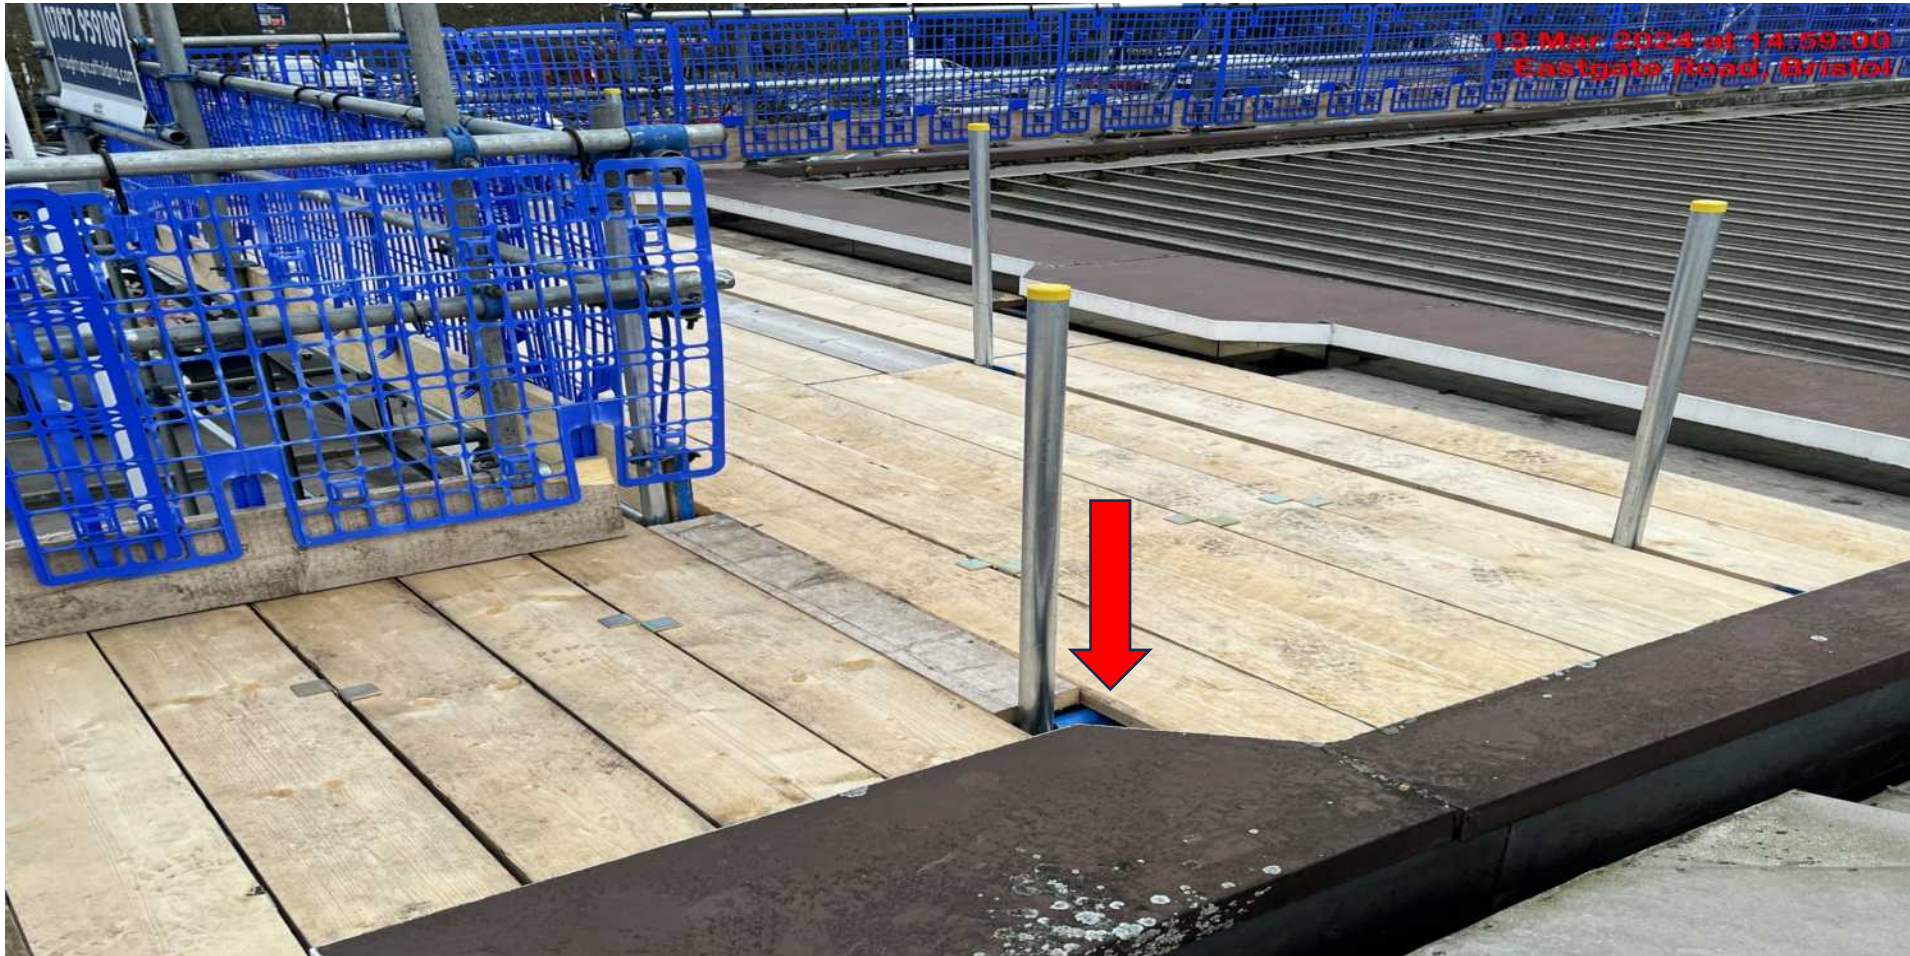
EAS 001

Independent Access Scaffold, Car Park & Store Entrance Elevation

Status of Scaffold: Passed with observations

Notes: Scaffold was erected in order to meet requirements of TG20:21. Alloy beams have been Laced and Braced sufficiently. Scaffold has been Tied into the Building in order to prevent movement. Protection Fans in place in order to meet Project Requirements. Void needs to be eliminated. Void needs to be eliminated, a small piece of Ply Board would be an excellent solution.

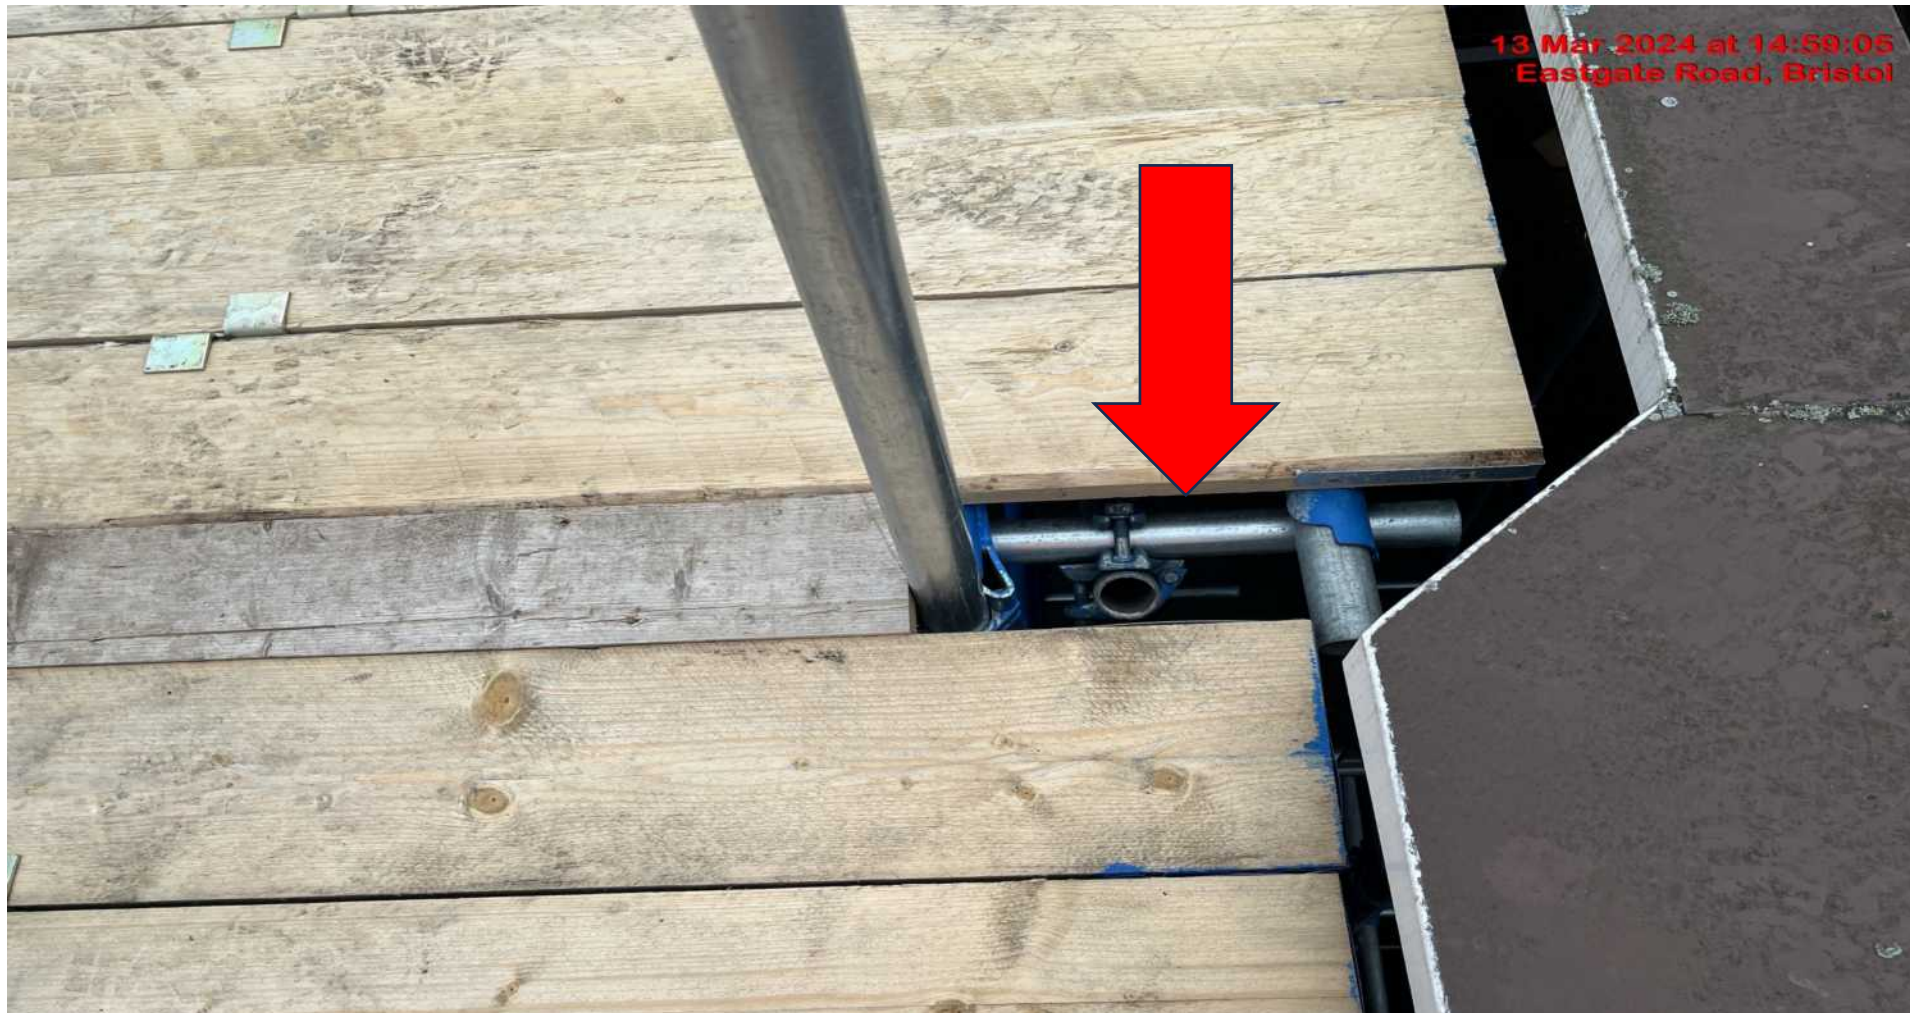
EAS 001

Independent Access Scaffold, Car Park & Store Entrance Elevation

Status of Scaffold: **Passed with observations**

Notes: Scaffold was erected in order to meet requirements of TG20:21. Alloy beams have been Laced and Braced sufficiently. Scaffold has been Tied into the Building in order to prevent movement. Protection Fans in place in order to meet Project Requirements. Boards have been secured in order to prevent movement. Working Lifts are free of Debris and waste materials.

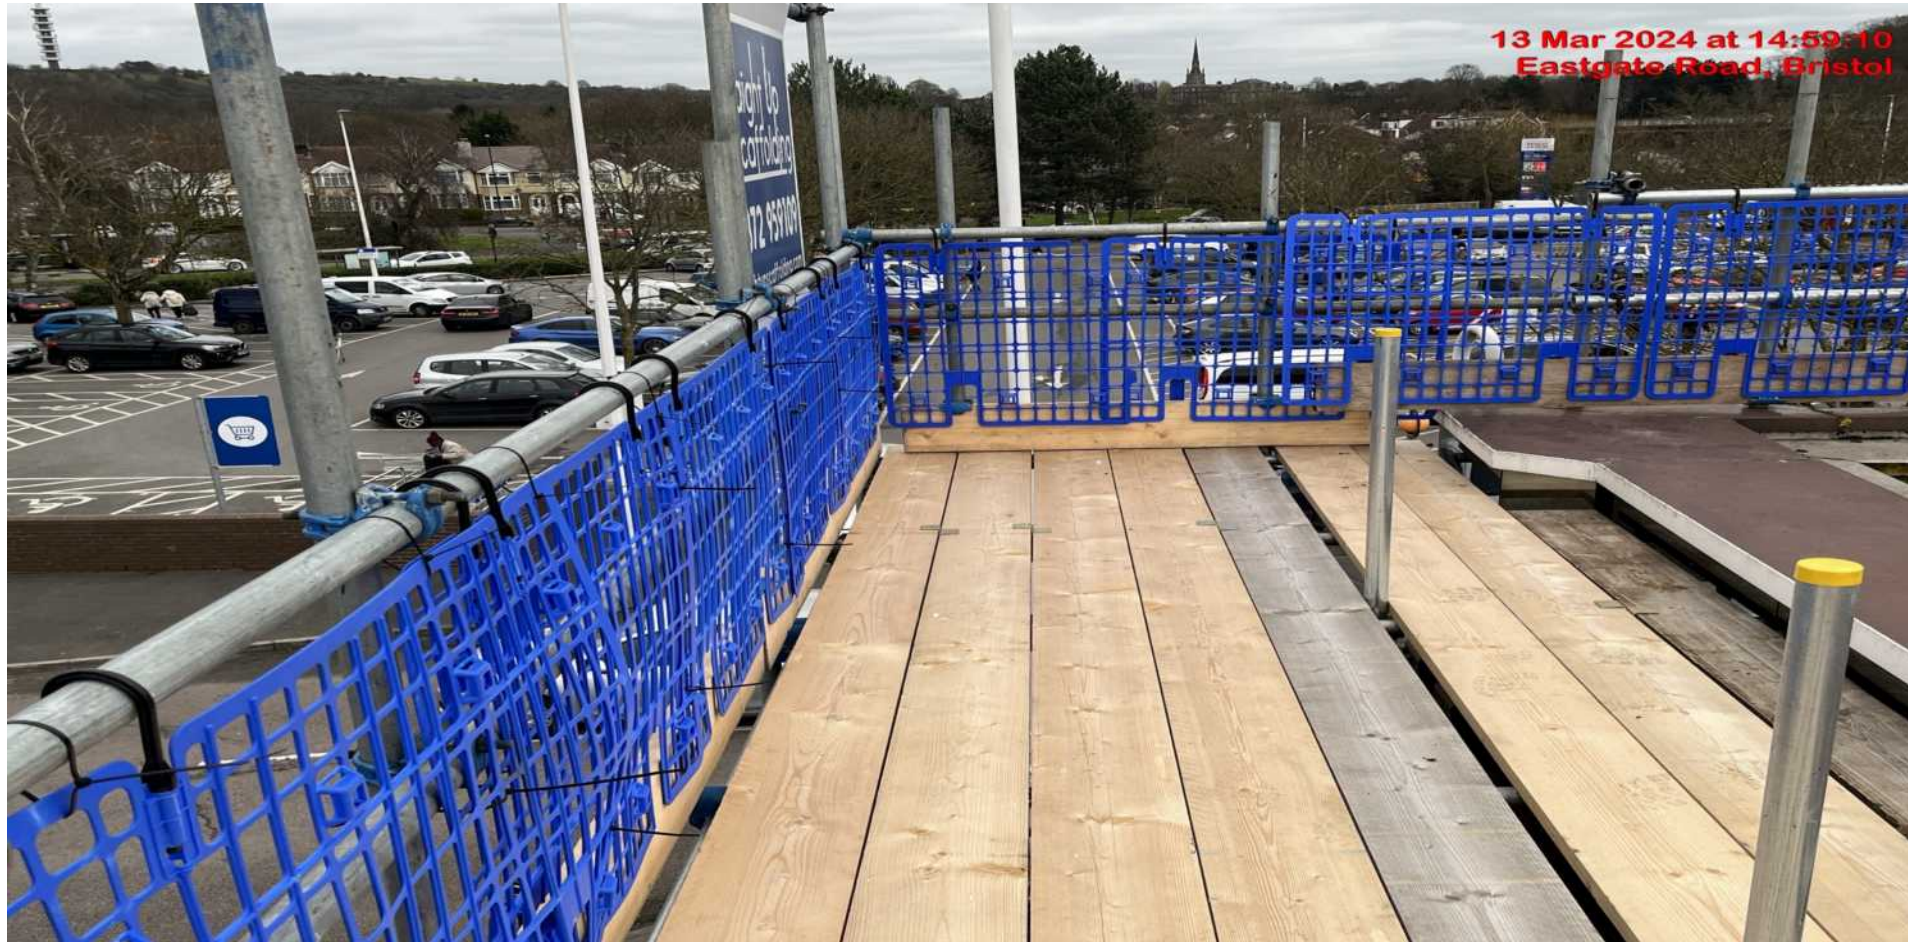
EAS 001

Independent Access Scaffold, Car Park & Store Entrance Elevation

Status of Scaffold: Passed with observations

Notes: Scaffold was erected in order to meet requirements of TG20:21. Alloy beams have been Laced and Braced sufficiently. Scaffold has been Tied into the Building in order to prevent movement. Protection Fans in place in order to meet Project Requirements. Boards have been secured in order to prevent movement. Working Lifts are free of Debris and waste materials.
