Cymru Scaffold Inspections

Tesco, Eastgate Rd, Eastville, Bristol BS5 6XU

Wednesday 13th March 2024

INSPECTION OF: Site Scaffolds & Scaffold Management on Site

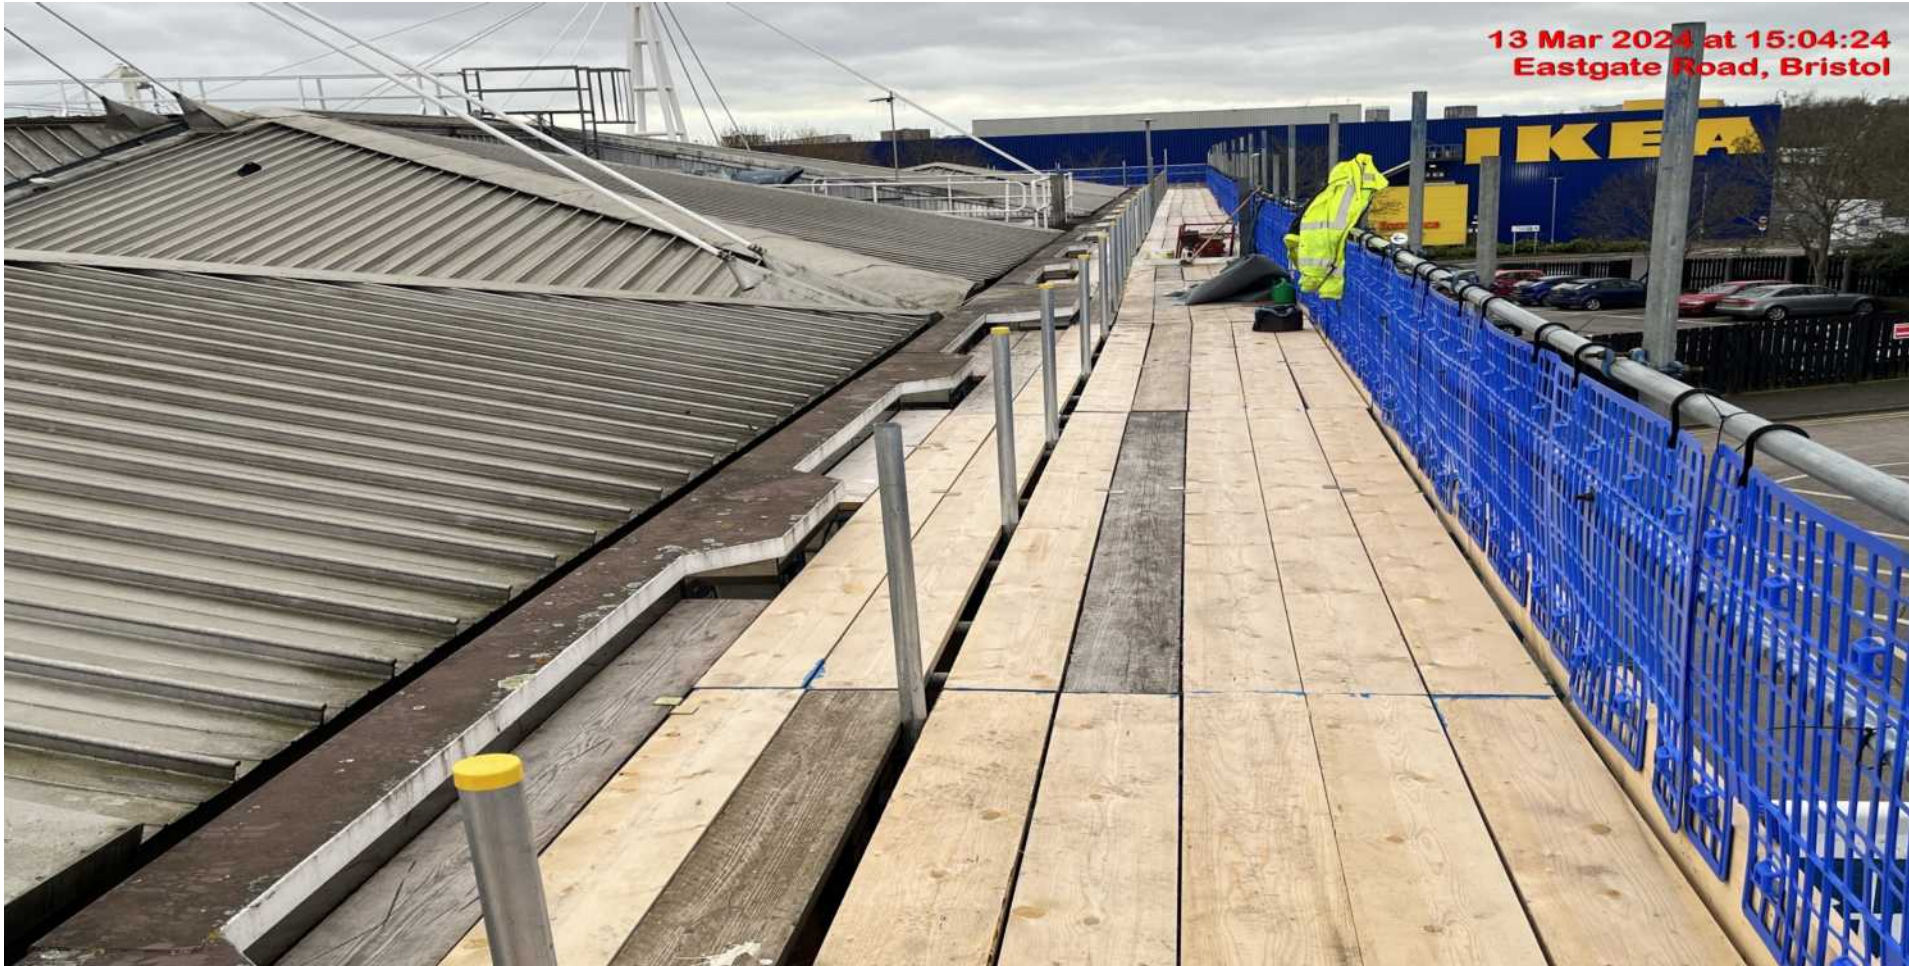
EAS 001

Independent Access Scaffold, Car Park & Store Entrance Elevation

Boards have been secured in order to prevent movement.

Some of the Scaffold Boards near to the Glass Windows have been placed flush against the Glass, care to be taken when the Dismantle takes place.

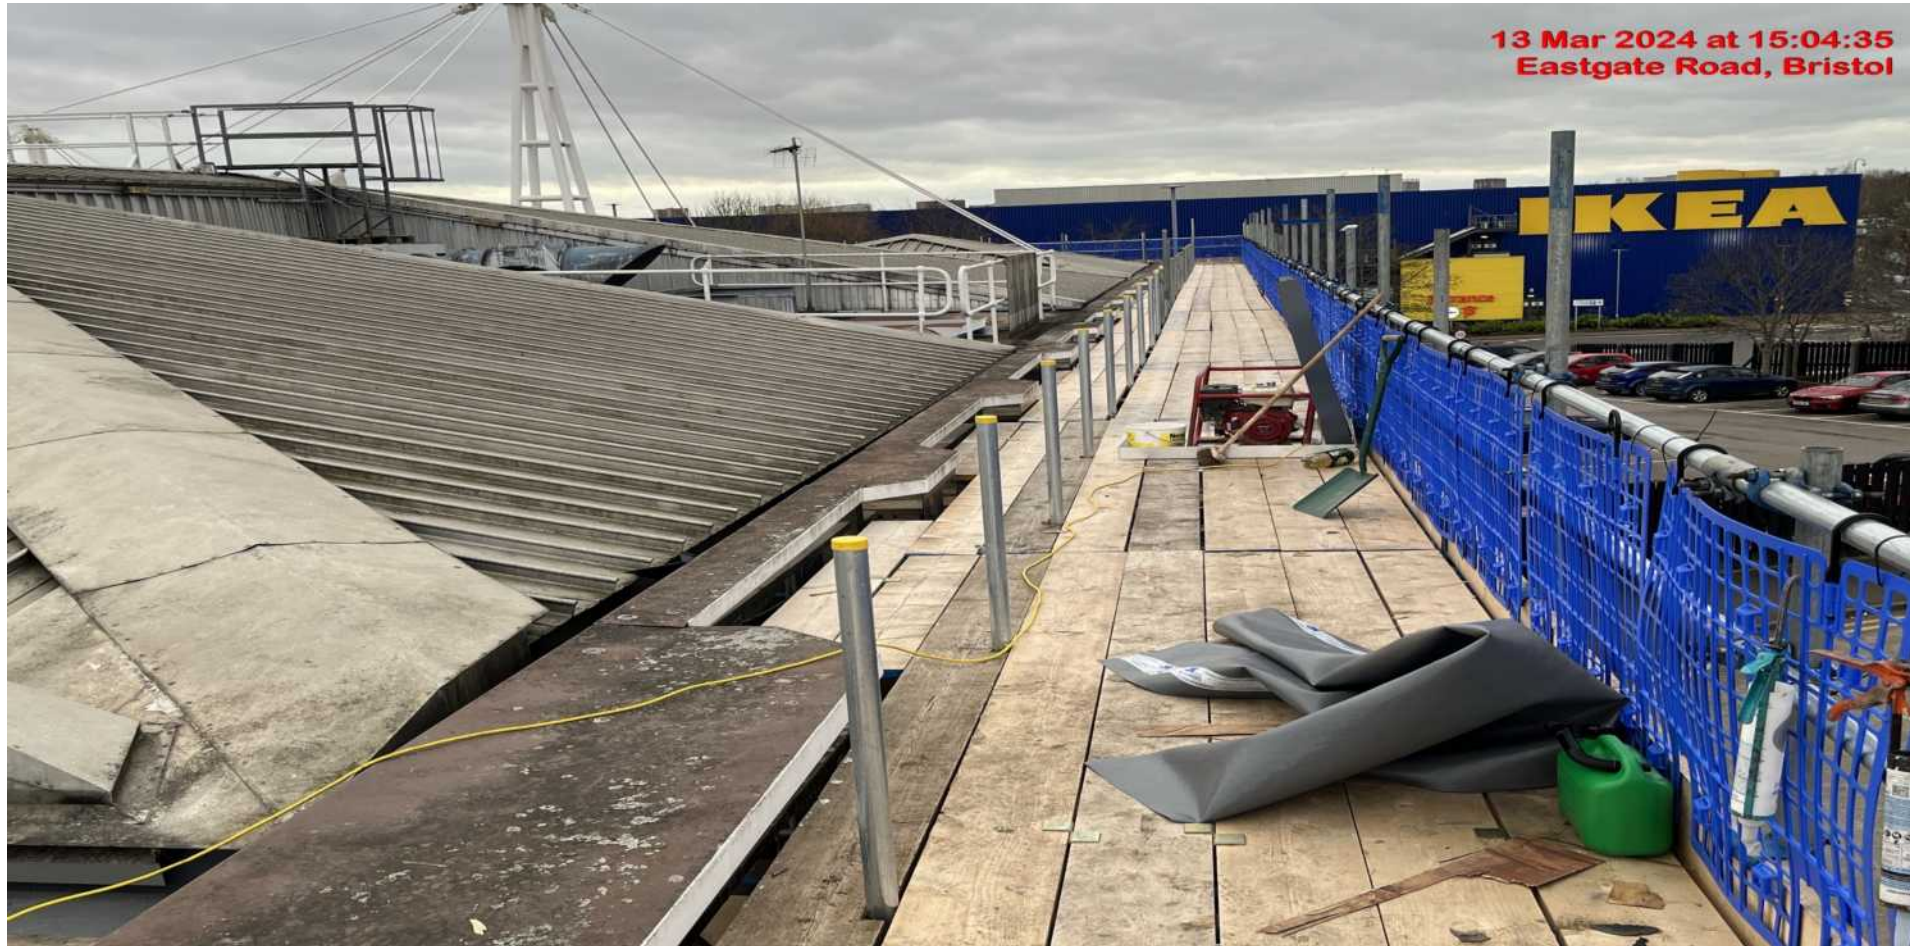
EAS 001

Independent Access Scaffold, Car Park & Store Entrance Elevation

Status of Scaffold: **Passed with observations**

Notes: Scaffold was erected in order to meet requirements of TG20:21. Alloy beams have been Laced and Braced sufficiently. Scaffold has been Tied into the Building in order to prevent movement. Working Lifts are free of Debris and waste materials. Sufficient quantities of Brickguards have been provided in order to prevent objects falling from Working Lifts.

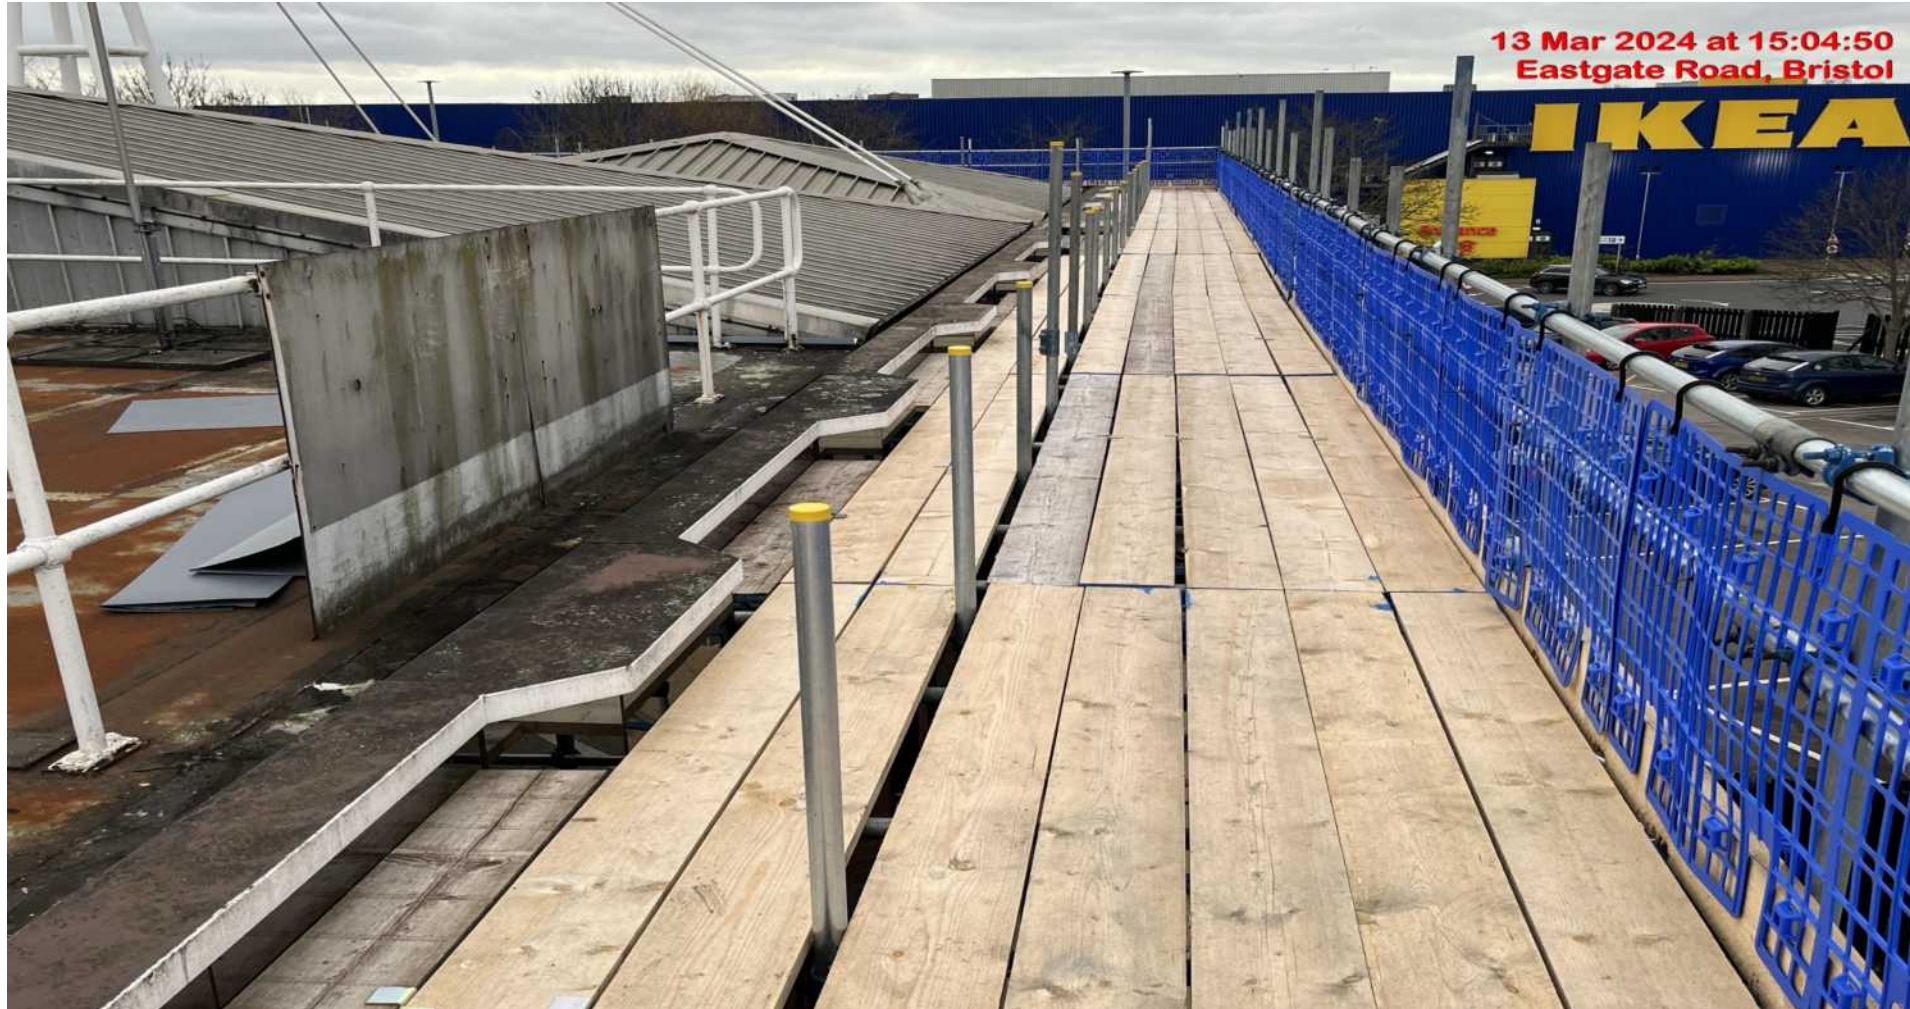
EAS 001

Independent Access Scaffold, Car Park & Store Entrance Elevation

Status of Scaffold: **Passed with observations**

Notes: Scaffold was erected in order to meet requirements of TG20:21. Alloy beams have been Laced and Braced sufficiently. Scaffold has been Tied into the Building in order to prevent movement. Protection Fans in place in order to meet Project Requirements. Working Lift was free of Debris and Waste Materials at the time of the Scaffold Inspections.

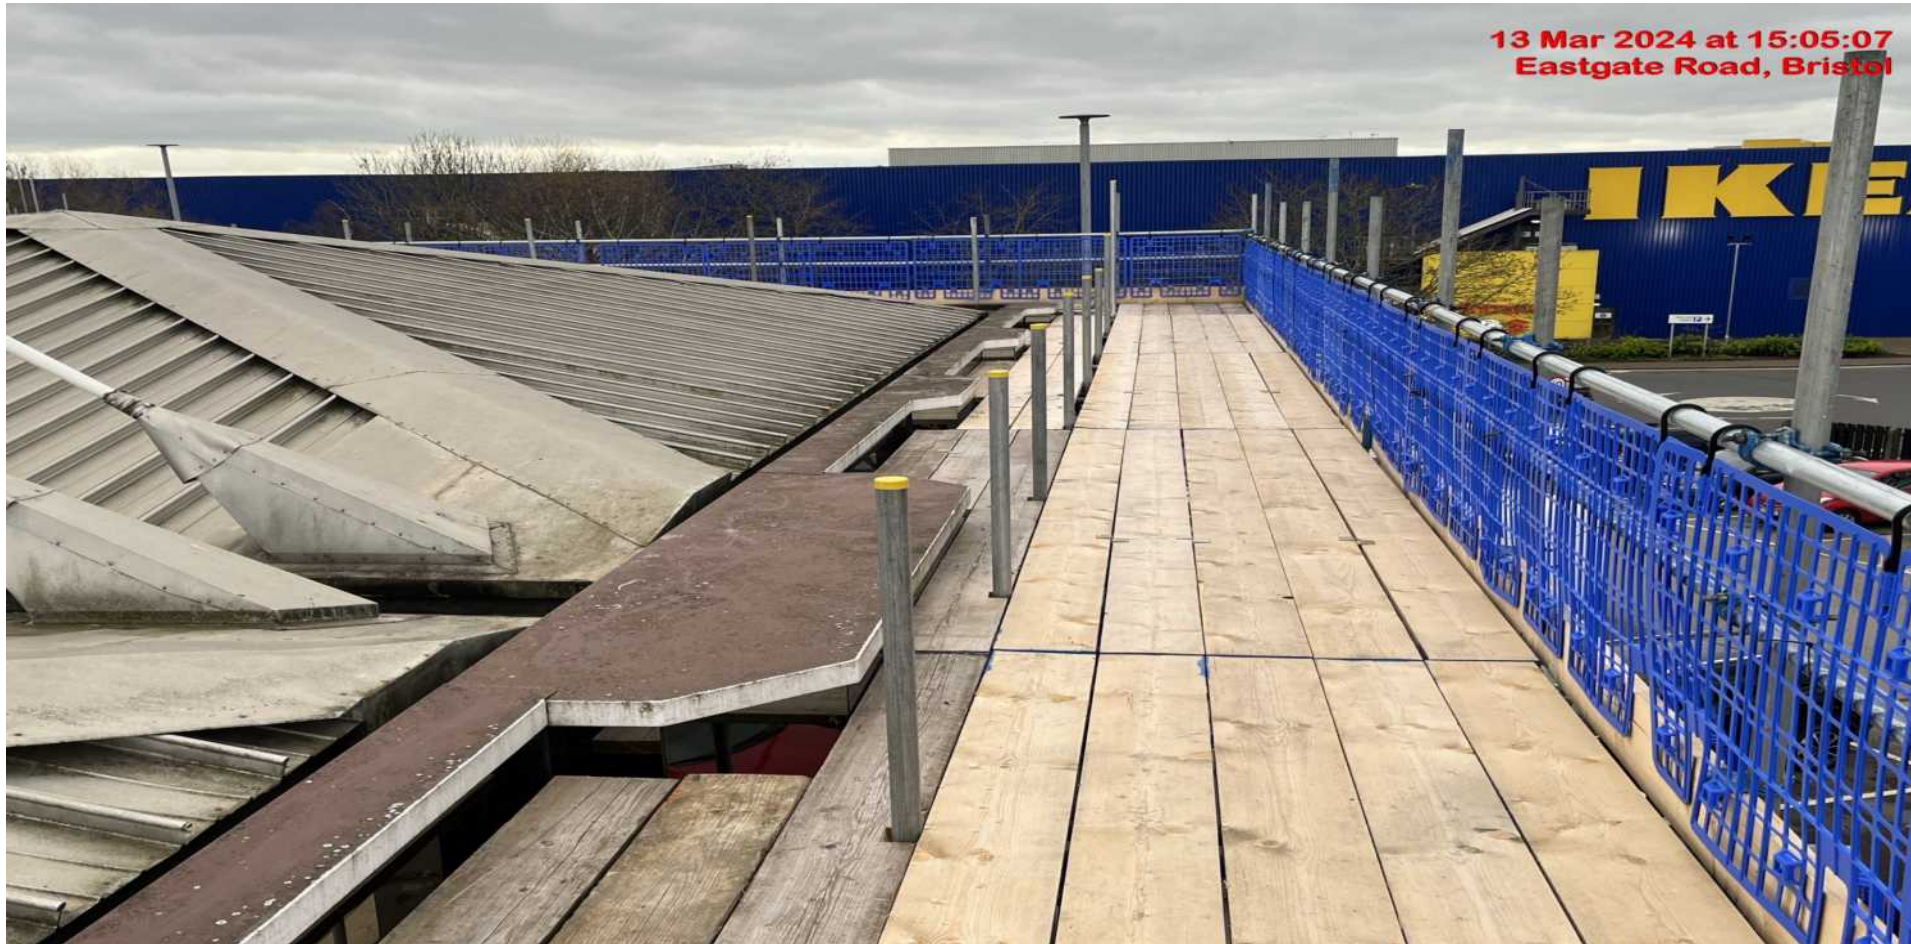
EAS 001

Independent Access Scaffold, Car Park & Store Entrance Elevation

Notes: Scaffold was erected in order to meet requirements of TG20:21.

Alloy Beams have been Laced and Braced sufficiently in order to meet requirements of TG20:21.

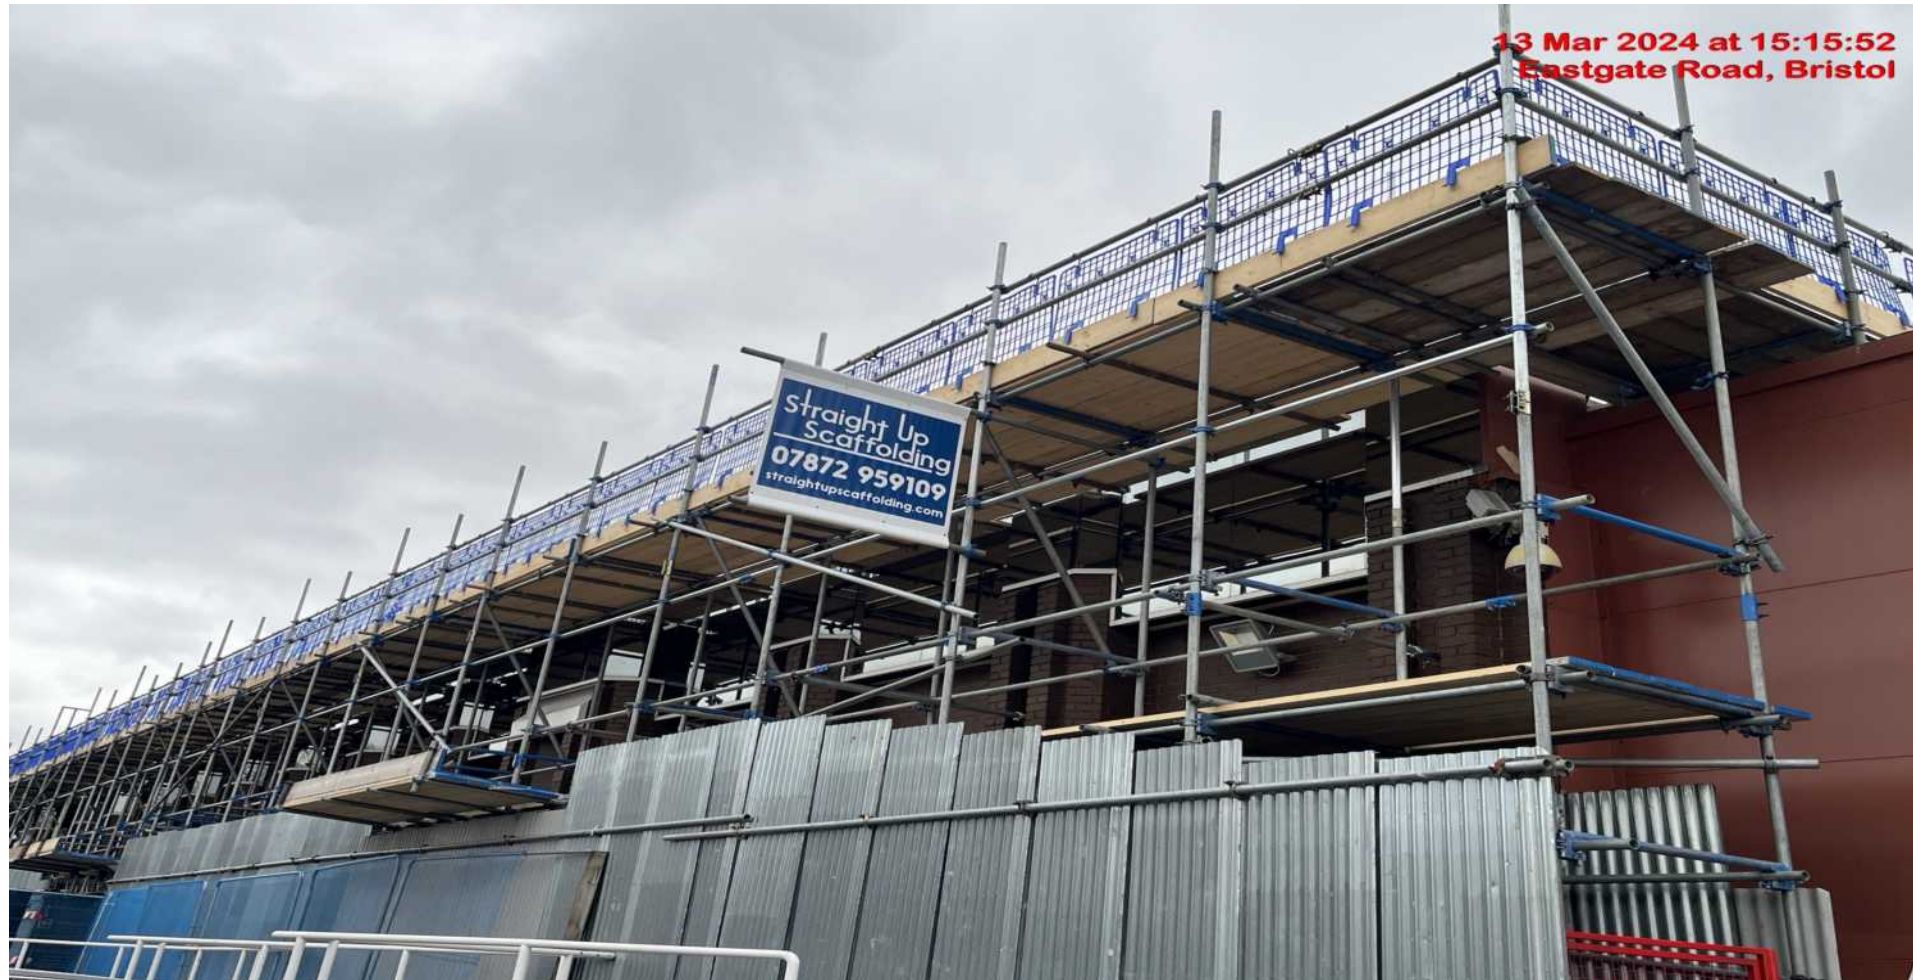
EAS 001

Independent Access Scaffold, Car Park & Store Entrance Elevation

Notes: Scaffold was erected in order to meet requirements of TG20:21.

Alloy Beams have been Laced and Braced sufficiently in order to meet requirements of TG20:21.

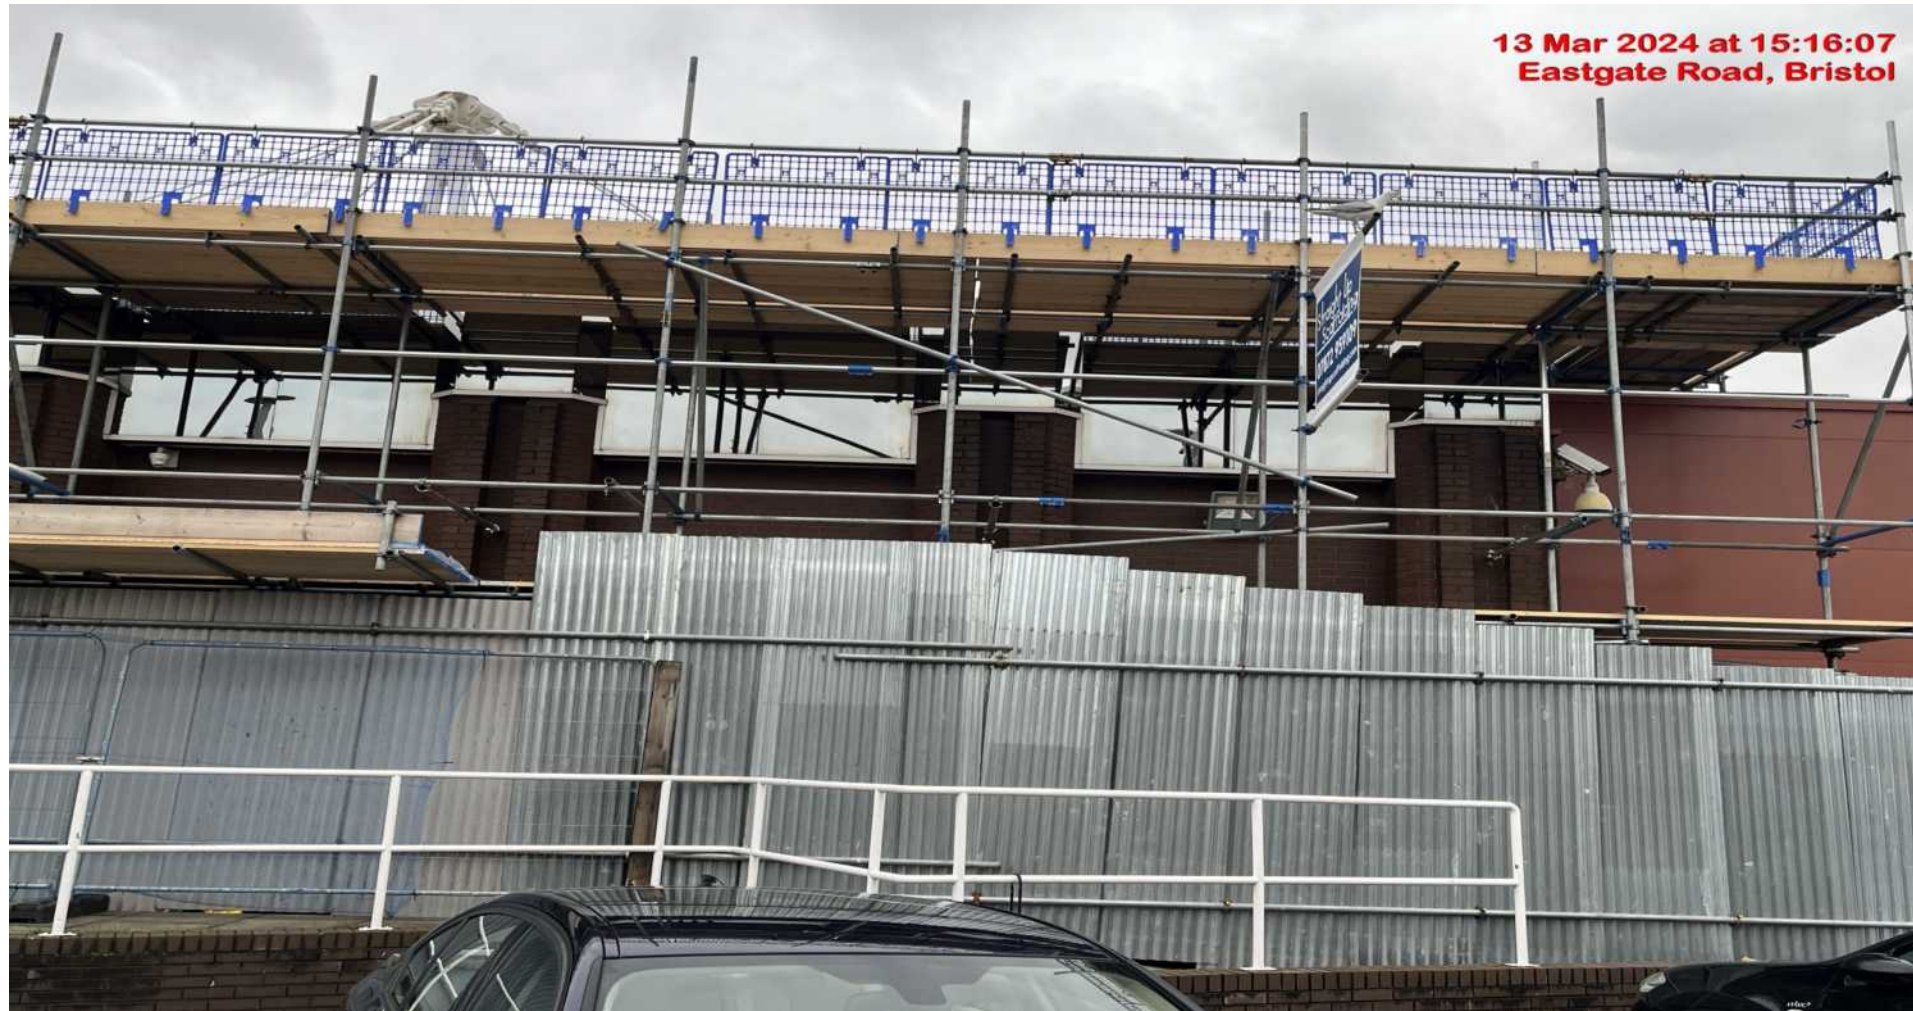
EAS 001

Independent Access Scaffold, Car Park & Store Entrance Elevation

Status of Scaffold: **Passed with observations**

Notes: Scaffold was erected in order to meet requirements of TG20:21. Alloy beams have been Laced and Braced sufficiently. Scaffold has been Tied into the Building in order to prevent movement. Protection Fans in place in order to meet Project Requirements.

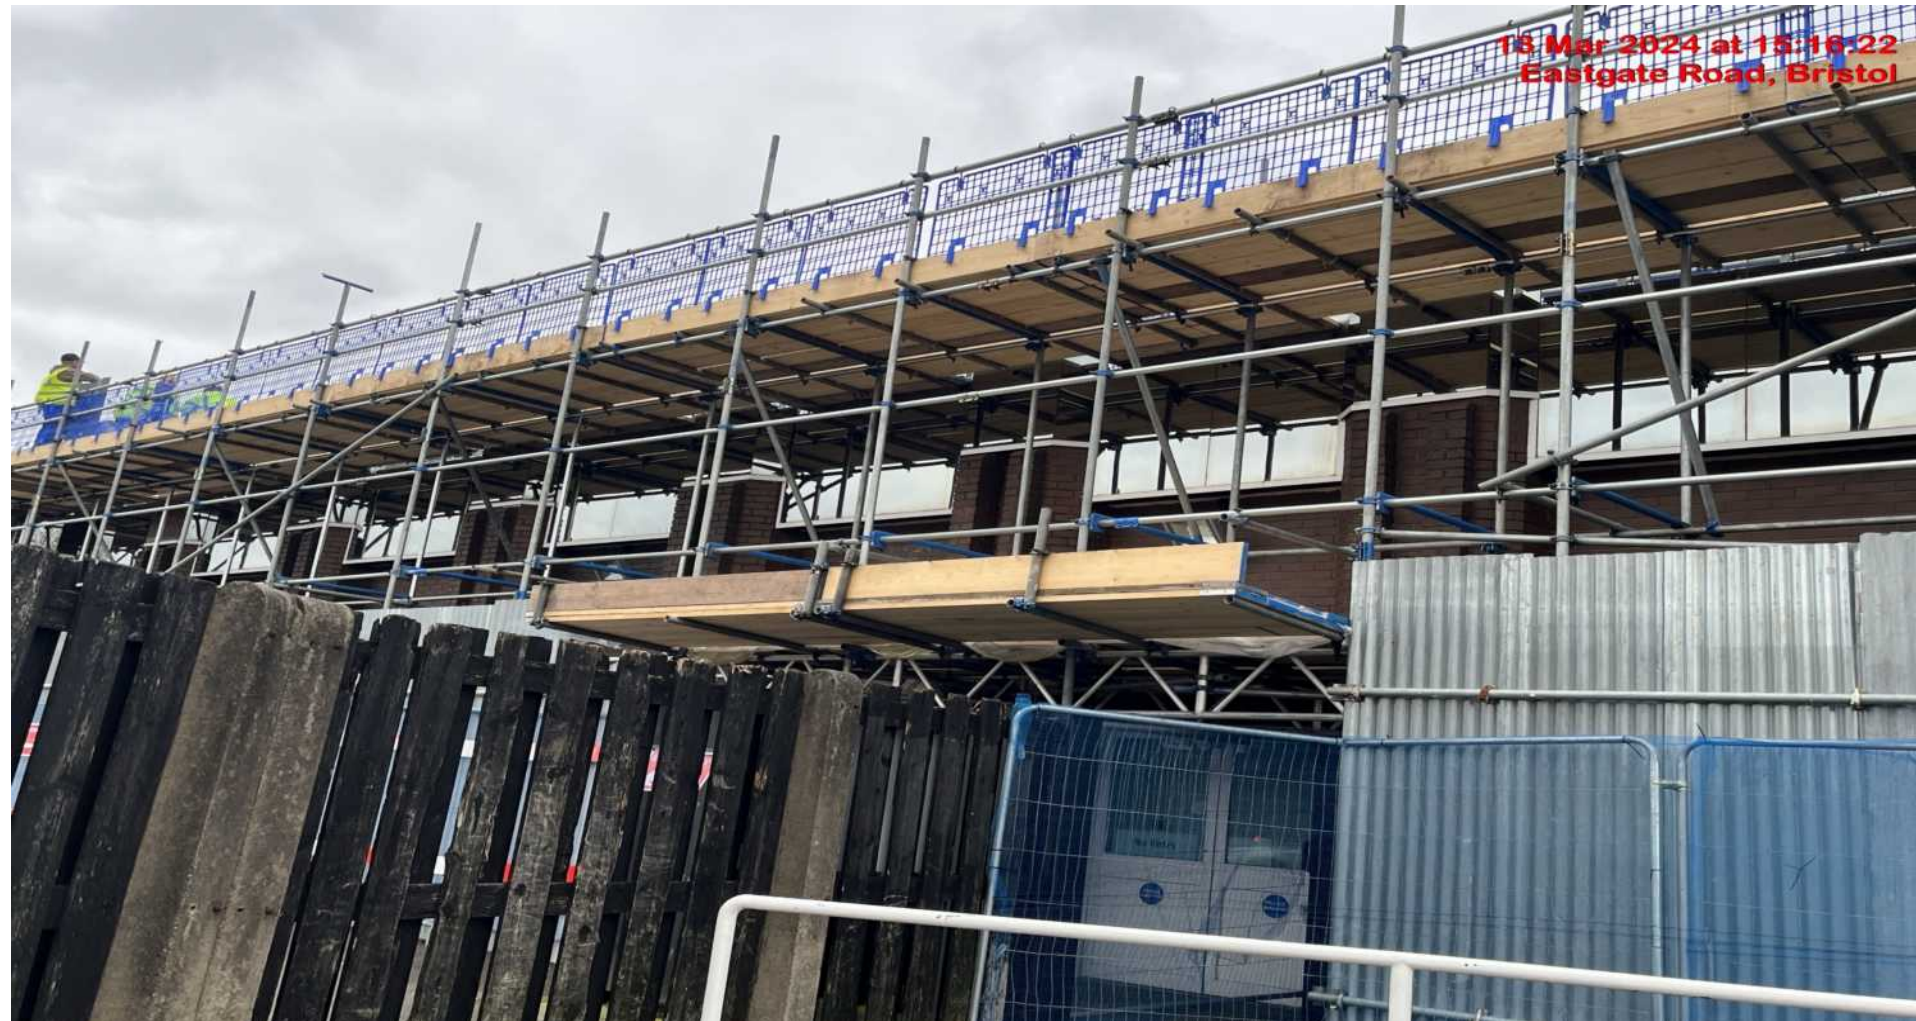
EAS 001

Independent Access Scaffold, Car Park & Store Entrance Elevation

Status of Scaffold: **Passed with observations**

Notes: Scaffold was erected in order to meet requirements of TG20:21. Alloy beams have been Laced and Braced sufficiently. Scaffold has been Tied into the Building in order to prevent movement. Protection Fans in place in order to meet Project Requirements.

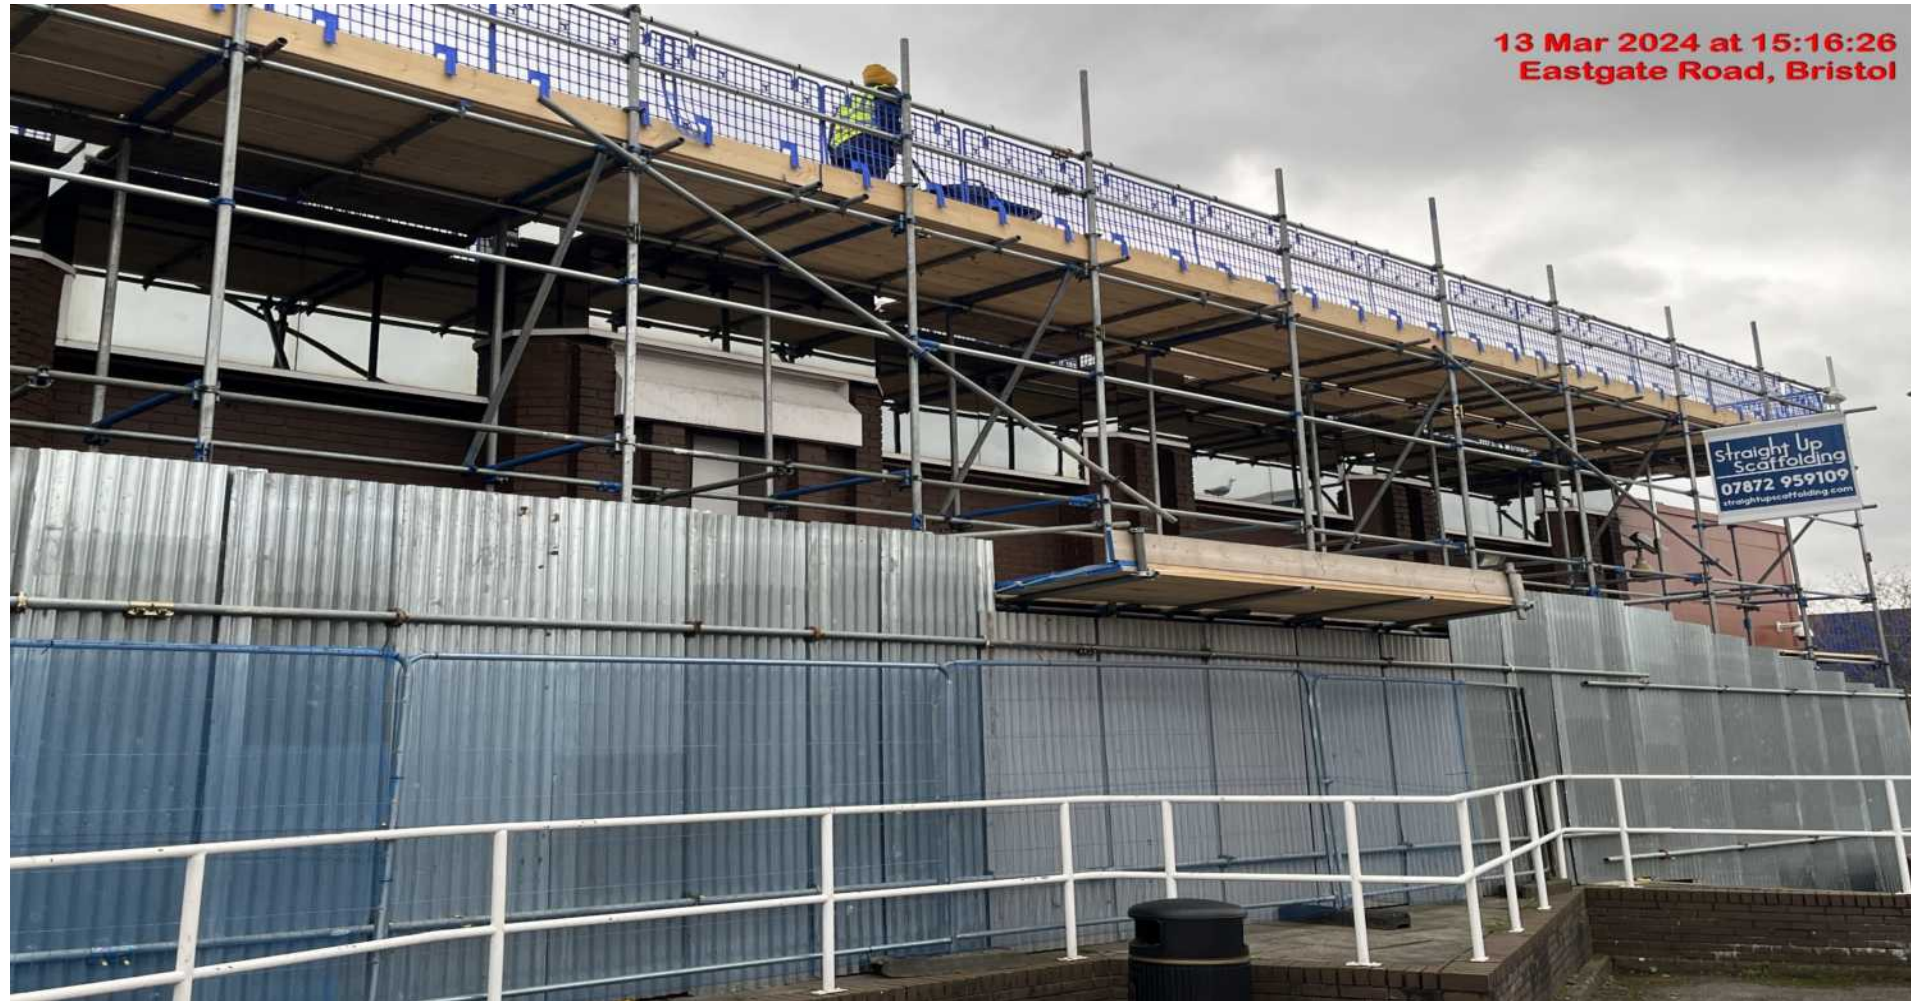
EAS 001

Independent Access Scaffold, Car Park & Store Entrance Elevation

Status of Scaffold: **Passed with observations**

Notes: Scaffold was erected in order to meet requirements of TG20:21. Alloy beams have been Laced and Braced sufficiently. Scaffold has been Tied into the Building in order to prevent movement. Protection Fans in place in order to meet Project Requirements. Sufficient quantities of Brickguards have been provided in order to prevent objects falling from Working Lifts.

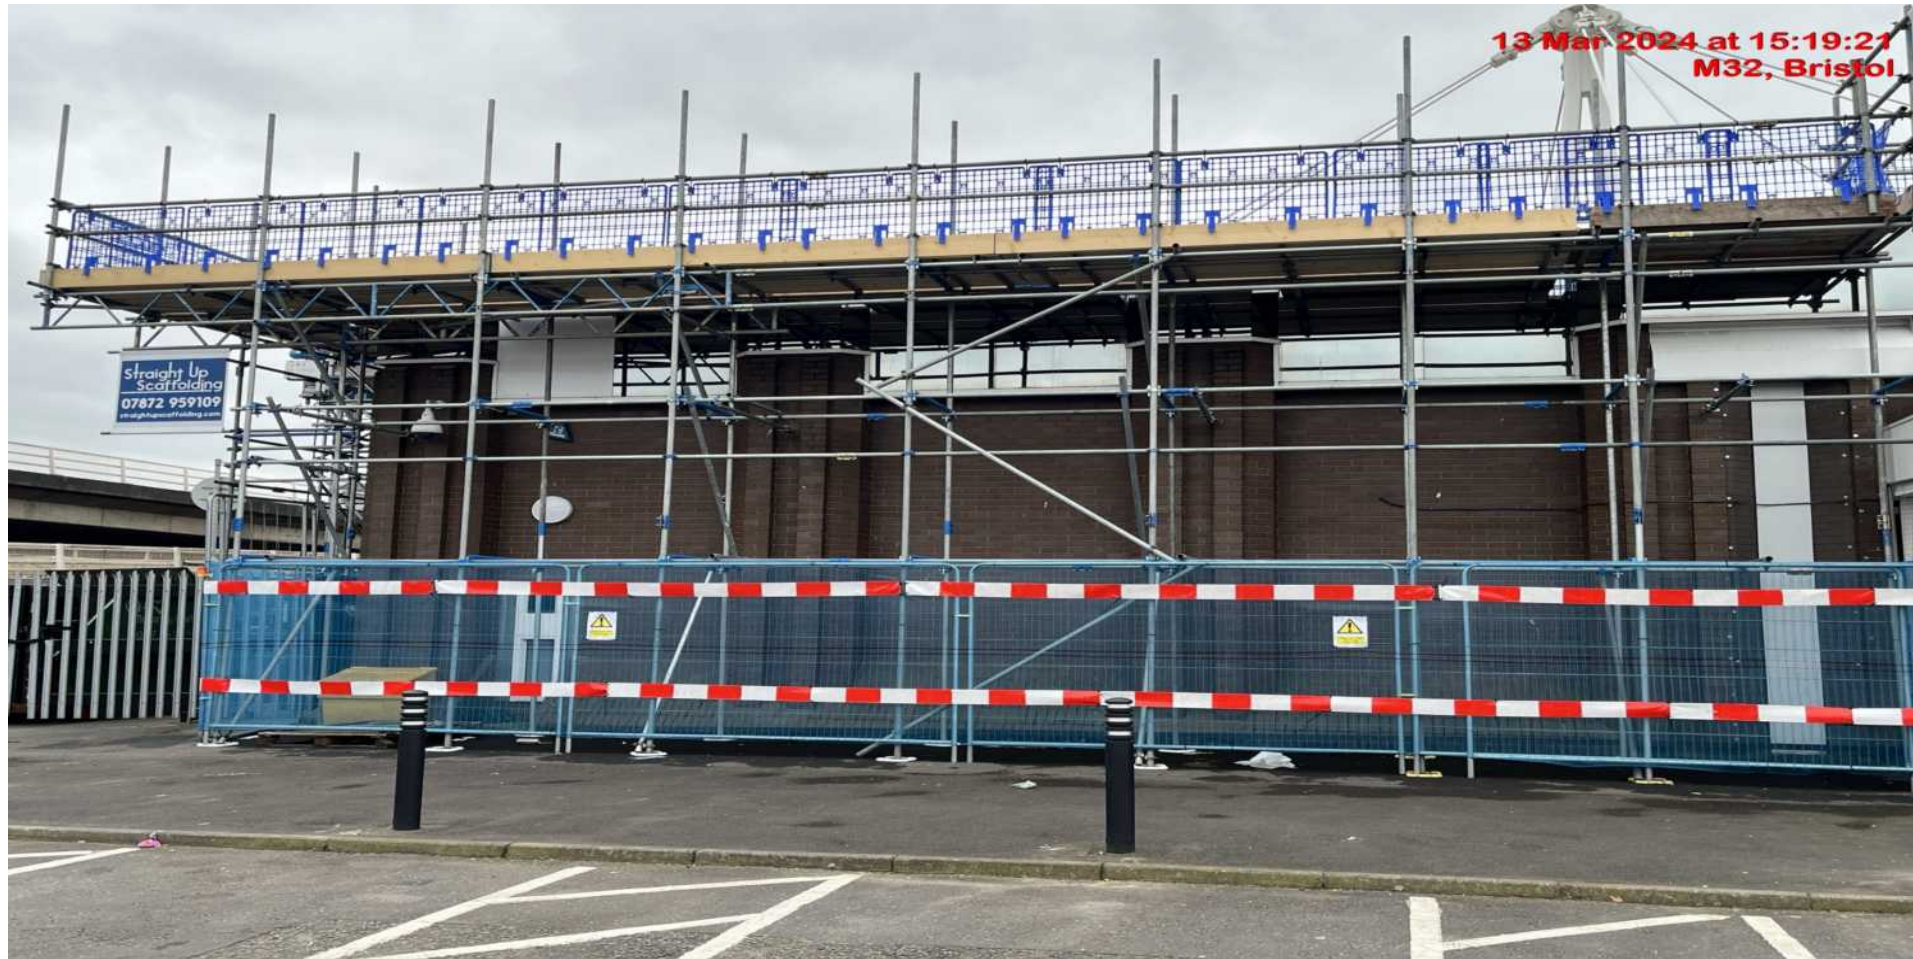
EAS 001

Independent Access Scaffold, Car Park & Store Entrance Elevation

Status of Scaffold: **Passed with observations**

Notes: Scaffold was erected in order to meet requirements of TG20:21. Alloy beams have been Laced and Braced sufficiently. Scaffold has been Tied into the Building in order to prevent movement. Protection Fans in place in order to meet Project Requirements.

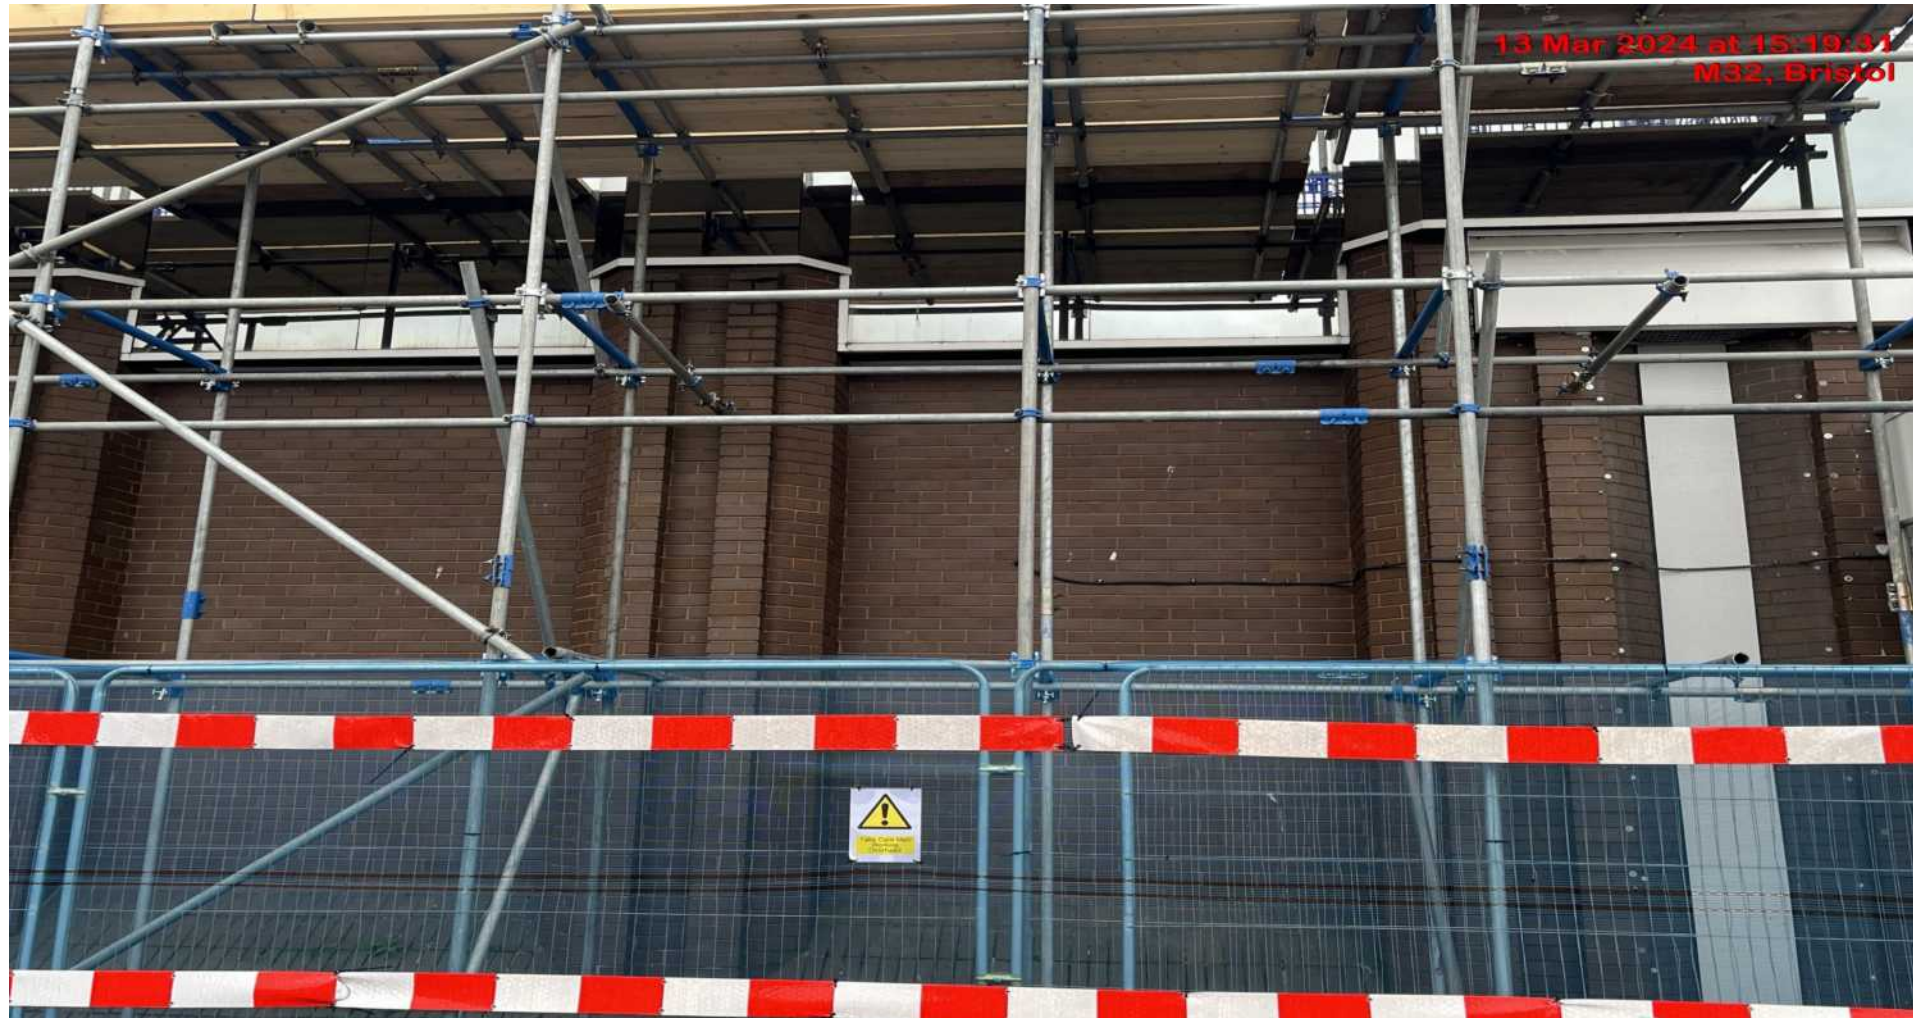
EAS 001

Independent Access Scaffold, Car Park & Store Entrance Elevation

Status of Scaffold: **Passed with observations**

Notes: Scaffold was erected in order to meet requirements of TG20:21. Alloy beams have been Laced and Braced sufficiently. Scaffold has been Tied into the Building in order to prevent movement. Protection Fans in place in order to meet Project Requirements. Sufficient quantities of Brickguards have been provided in order to prevent objects falling from Working Lifts.

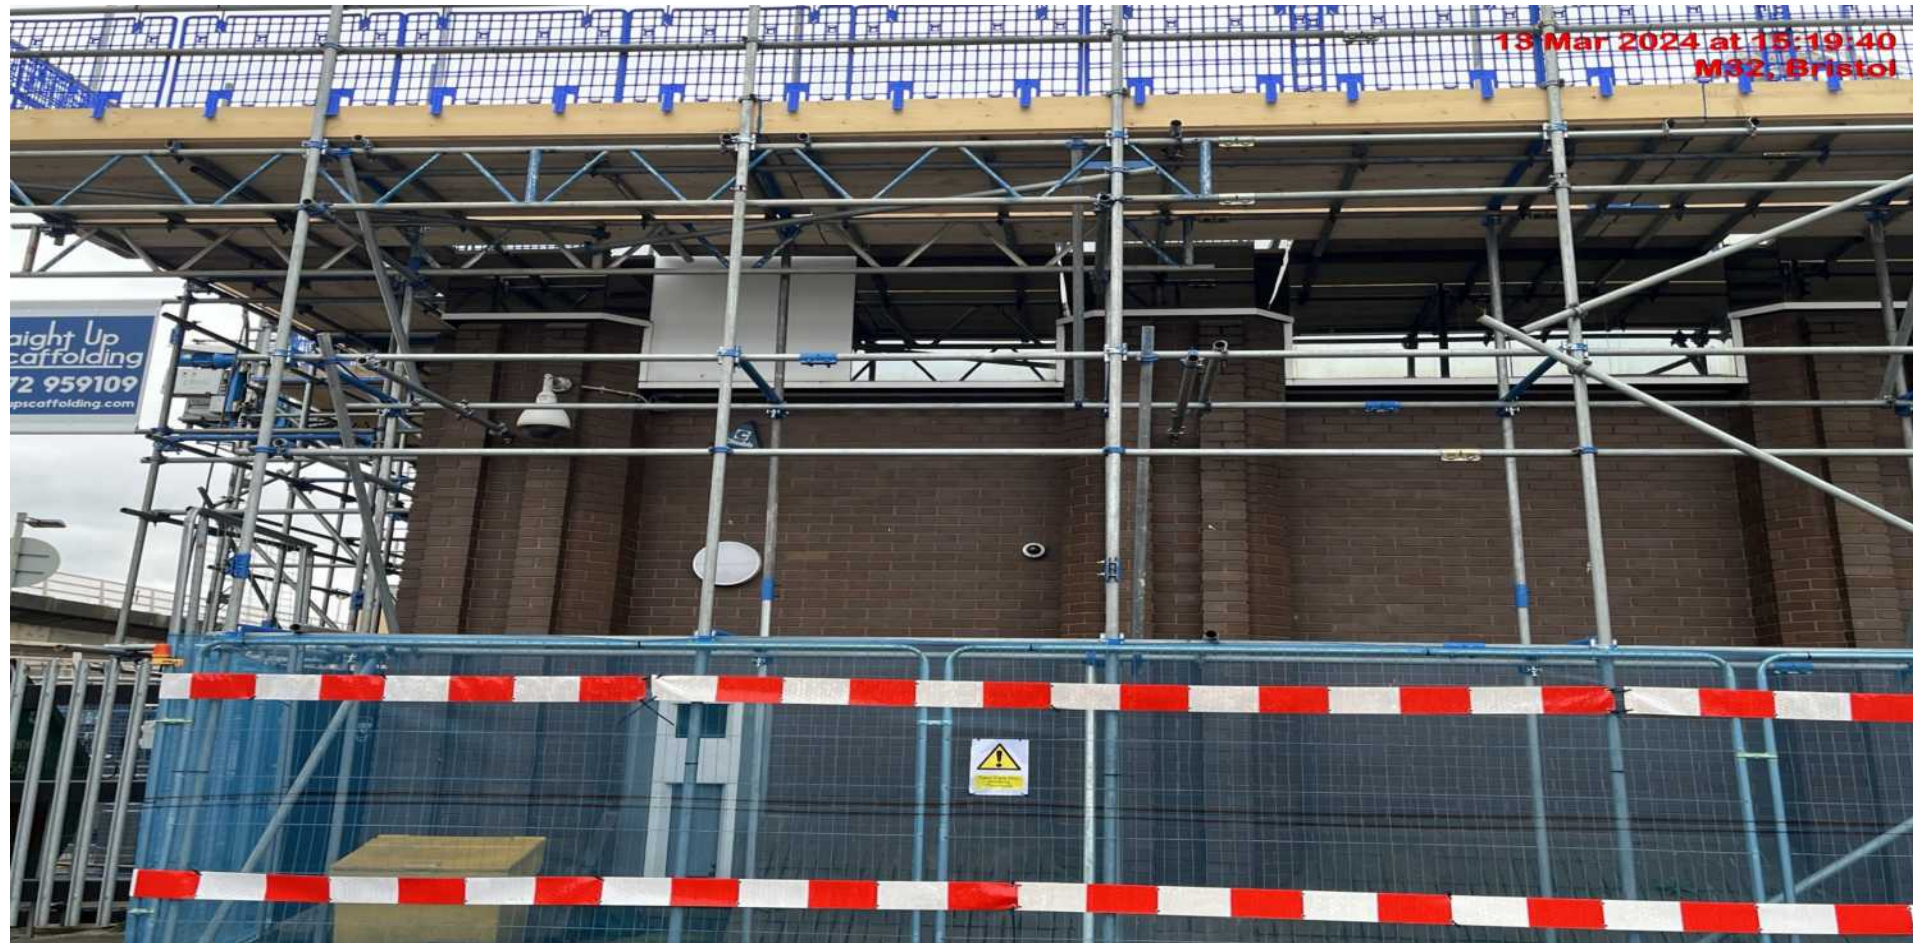
EAS 001

Independent Access Scaffold, Car Park & Store Entrance Elevation

Status of Scaffold: **Passed with observations**

Notes: Scaffold was erected in order to meet requirements of TG20:21. Alloy beams have been Laced and Braced sufficiently. Scaffold has been Tied into the Building in order to prevent movement. Protection Fans in place in order to meet Project Requirements. Sufficient quantities of Brickguards have been provided in order to prevent objects falling from Working Lifts.
