Cymru Scaffold Inspections

Tesco, Eastgate Rd, Eastville, Bristol BS5 6XU

Wednesday 13th March 2024

INSPECTION OF: Site Scaffolds & Scaffold Management on Site

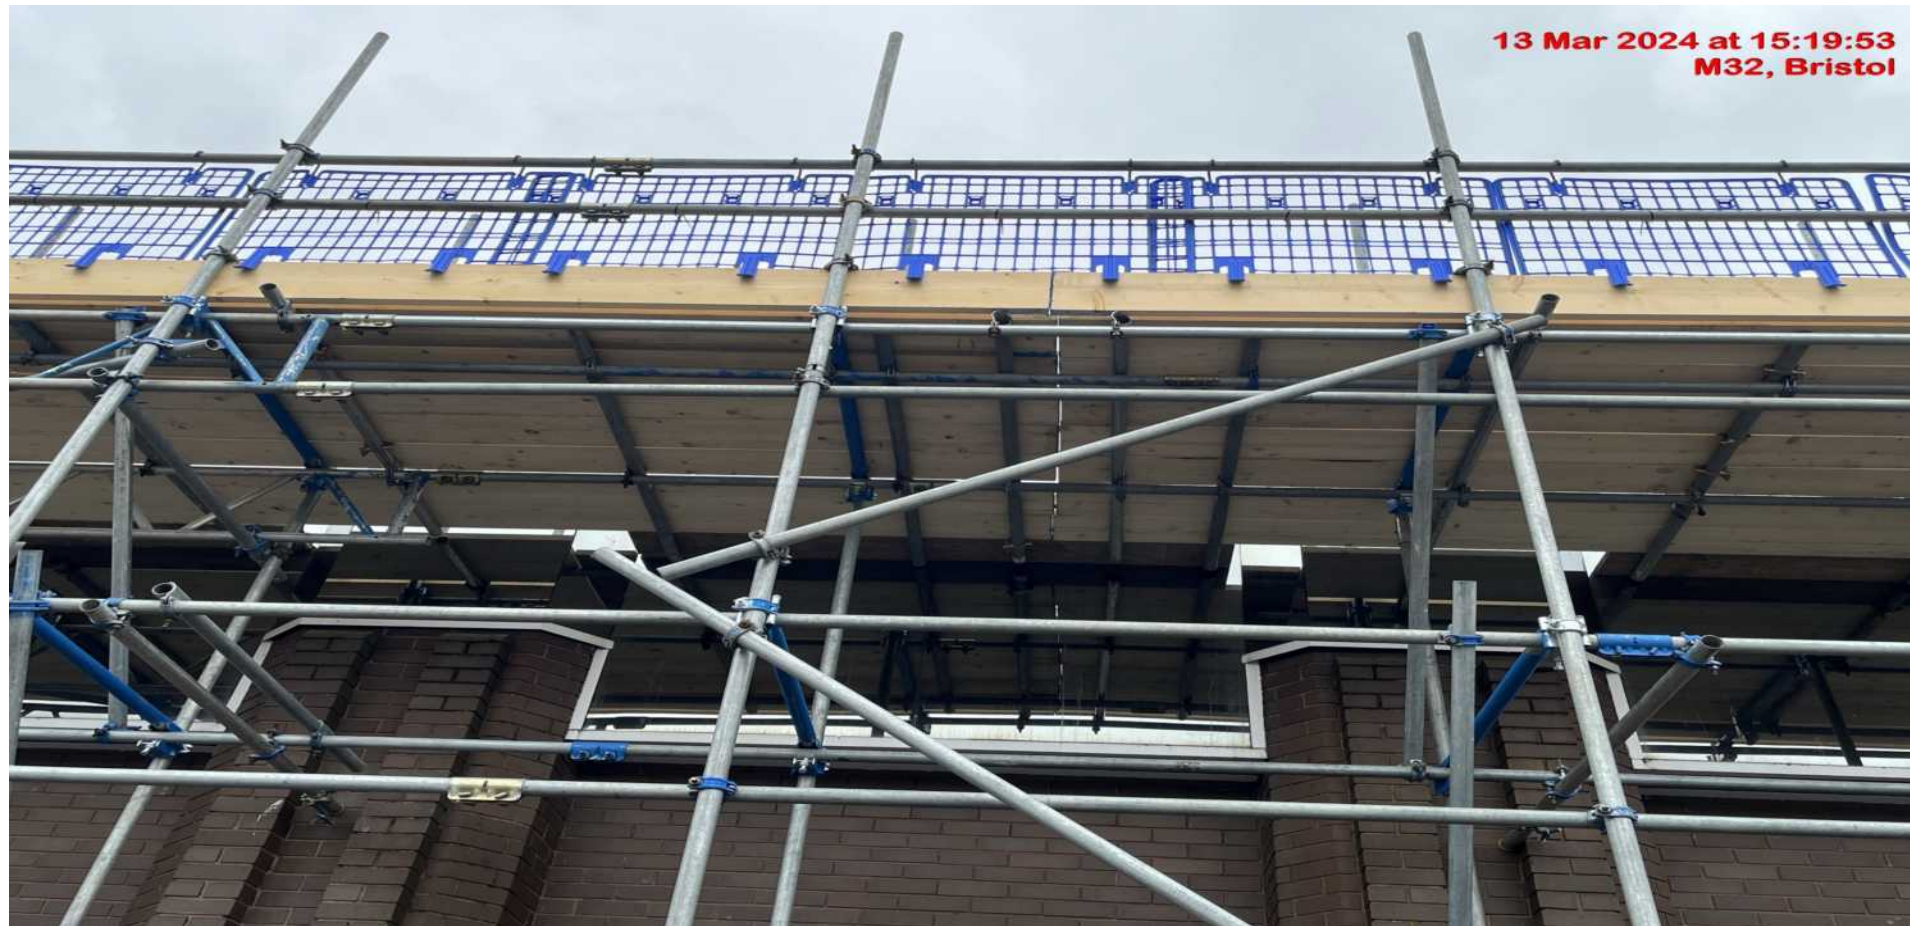
EAS 001

Independent Access Scaffold, Car Park & Store Entrance Elevation

Status of Scaffold: **Passed with observations**

Notes: Scaffold was erected in order to meet requirements of TG20:21. Alloy beams have been Laced and Braced sufficiently. Scaffold has been Tied into the Building in order to prevent movement. Protection Fans in place in order to meet Project Requirements.

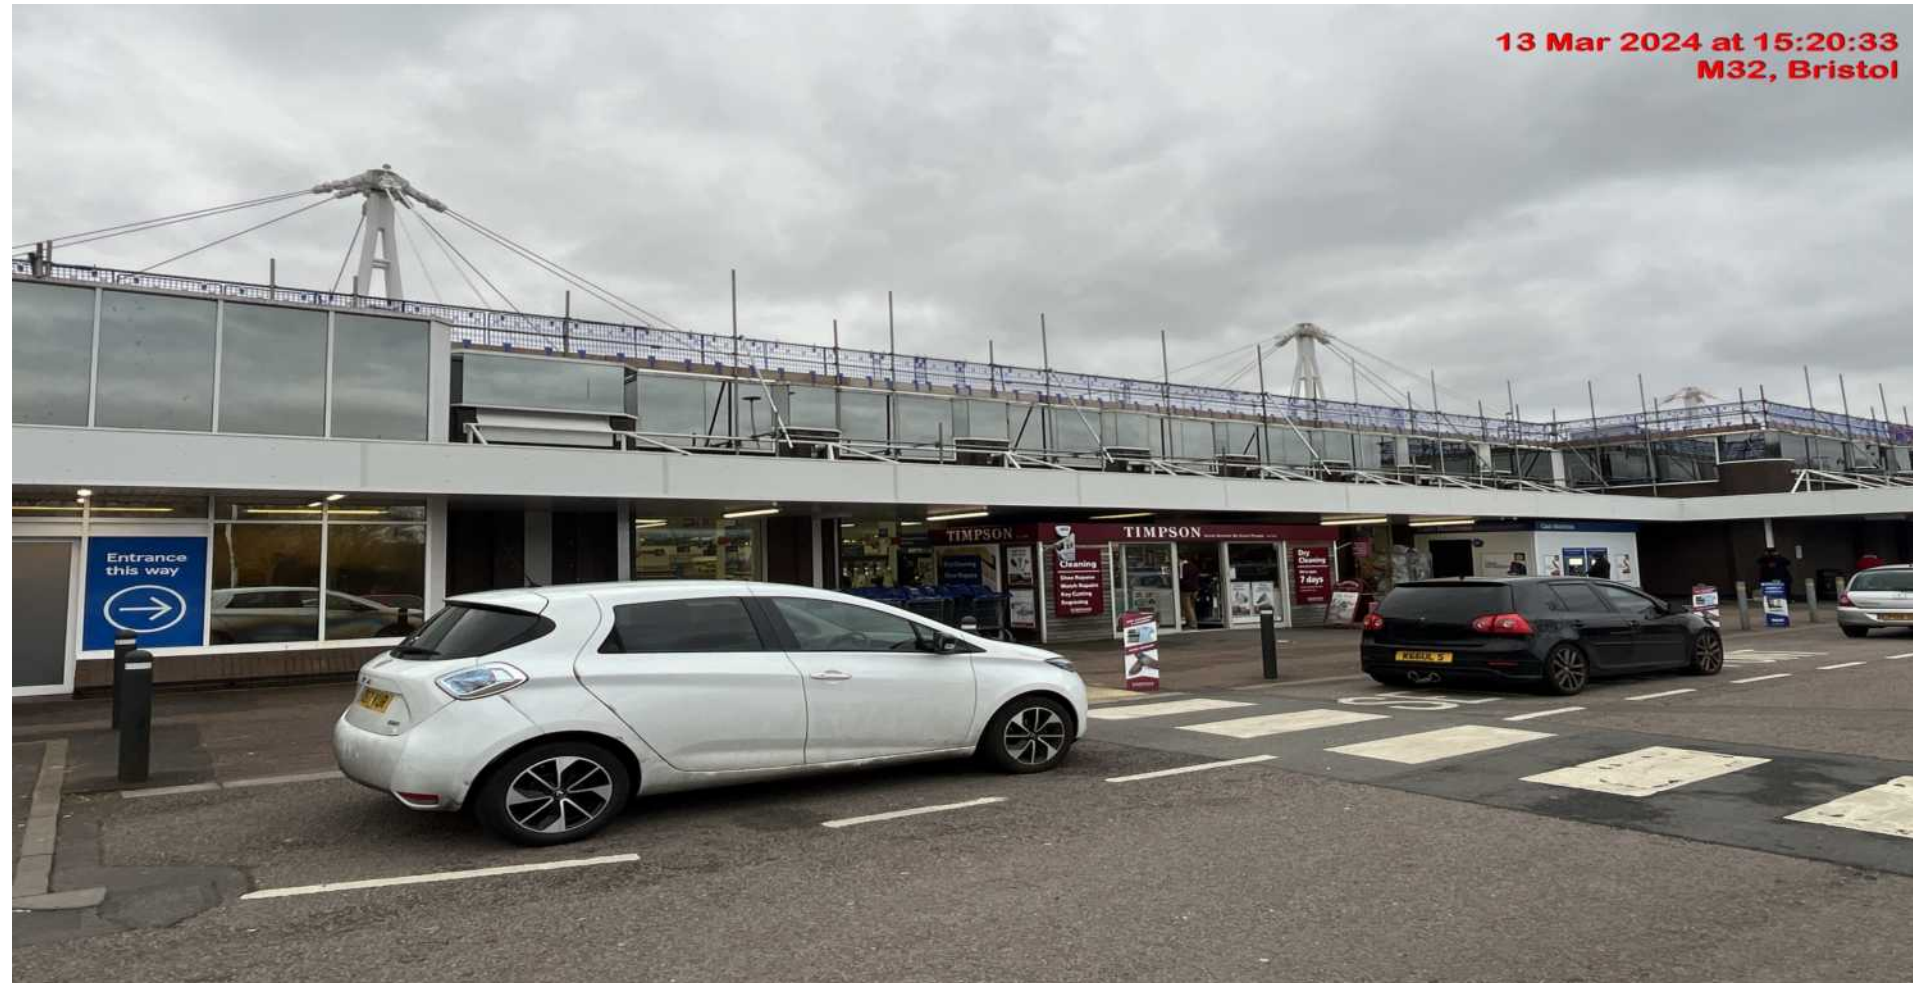
EAS 001

Independent Access Scaffold, Car Park & Store Entrance Elevation

Status of Scaffold: **Passed with observations**

Notes: Scaffold was erected in order to meet requirements of TG20:21. Alloy beams have been Laced and Braced sufficiently. Scaffold has been Tied into the Building in order to prevent movement. Protection Fans in place in order to meet Project Requirements.

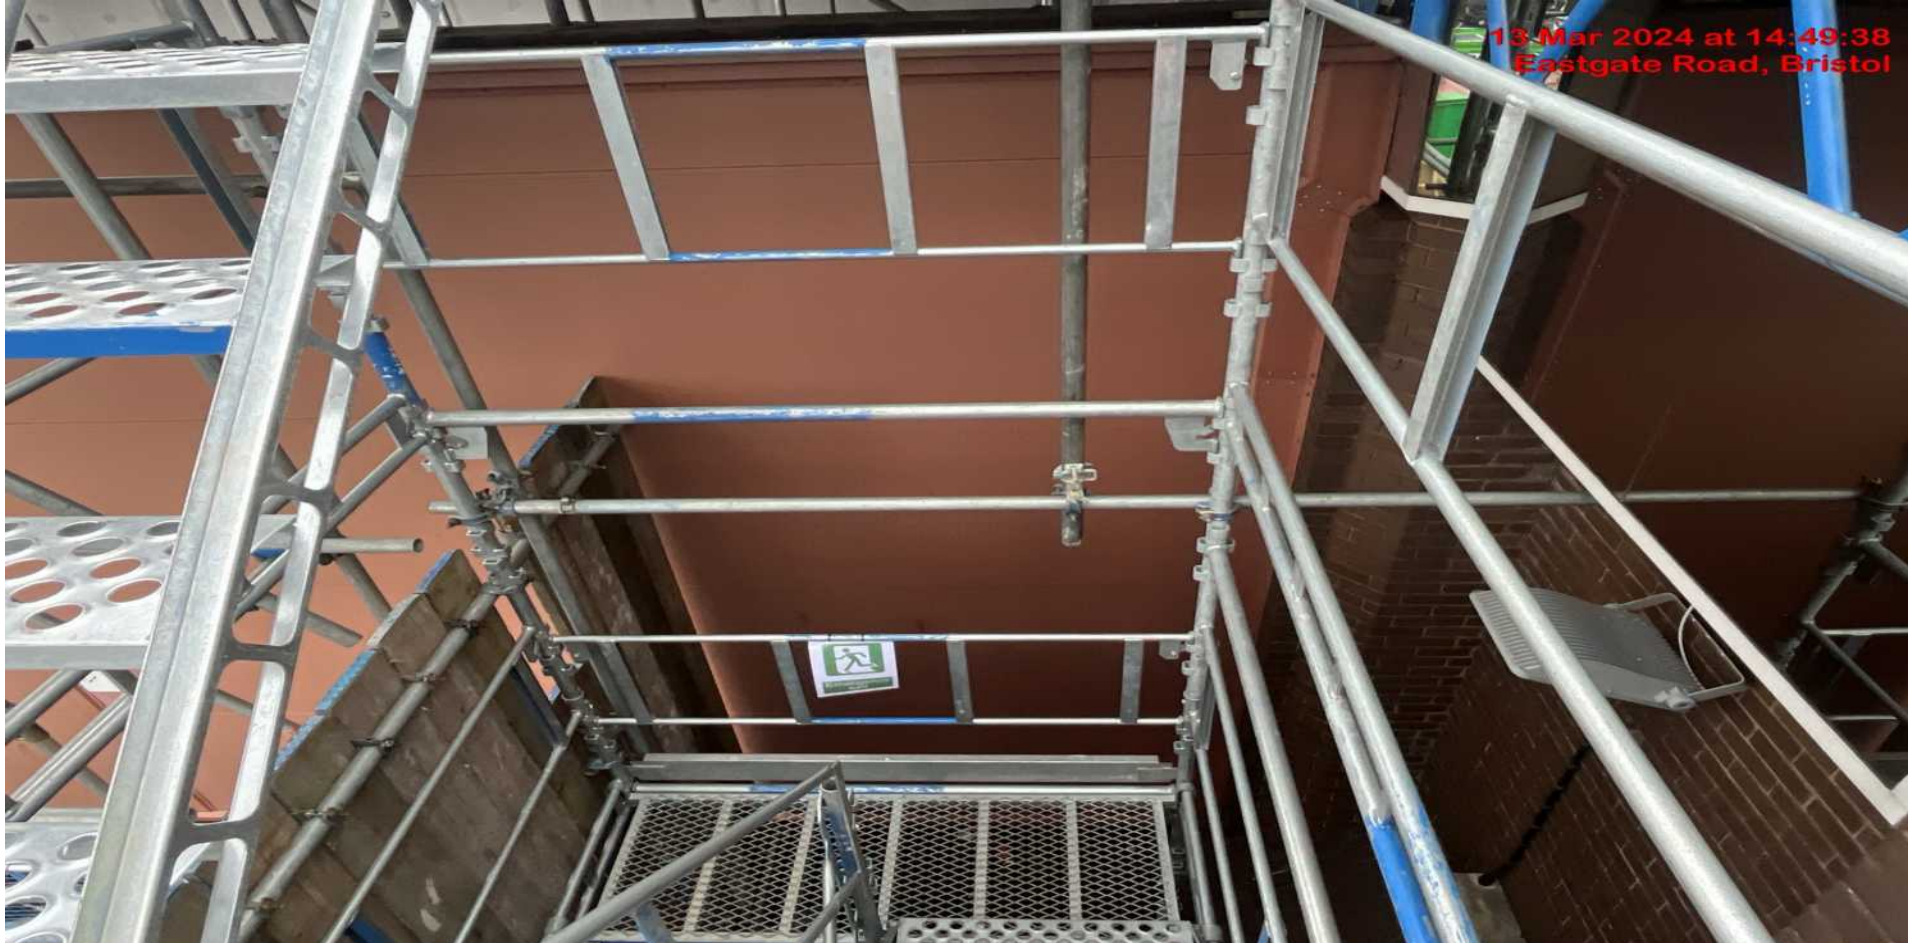
EAS 002

Haki Staircase near Site Cabins

Status of Scaffold: **Passed**

Notes: **Haki Staircase** was erected in order to meet requirements of TG20:21. Staircase is Tied into adjacent building. Staircase was free of damage and defect.

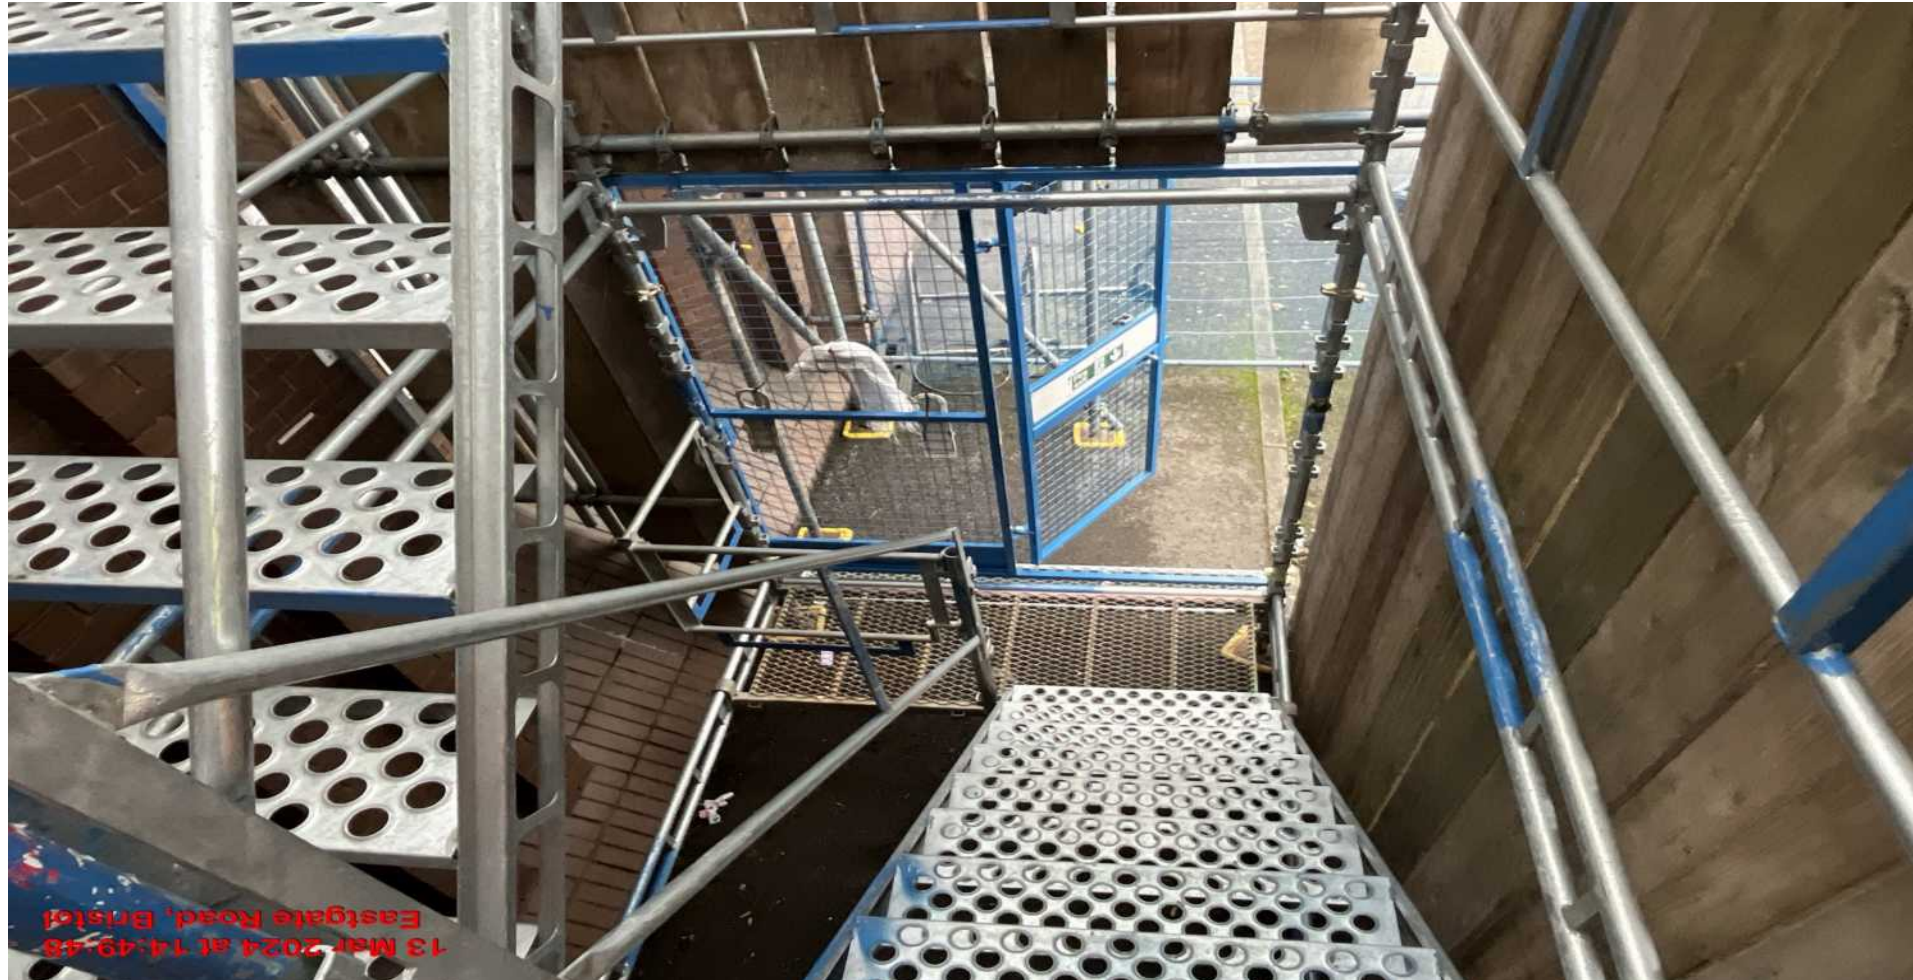
EAS 002

Haki Staircase near Site Cabins

Status of Scaffold: **Passed**

Notes: **Haki Staircase** was erected in order to meet requirements of TG20:21. Staircase is Tied into adjacent building.
Staircase was free of damage and defect.

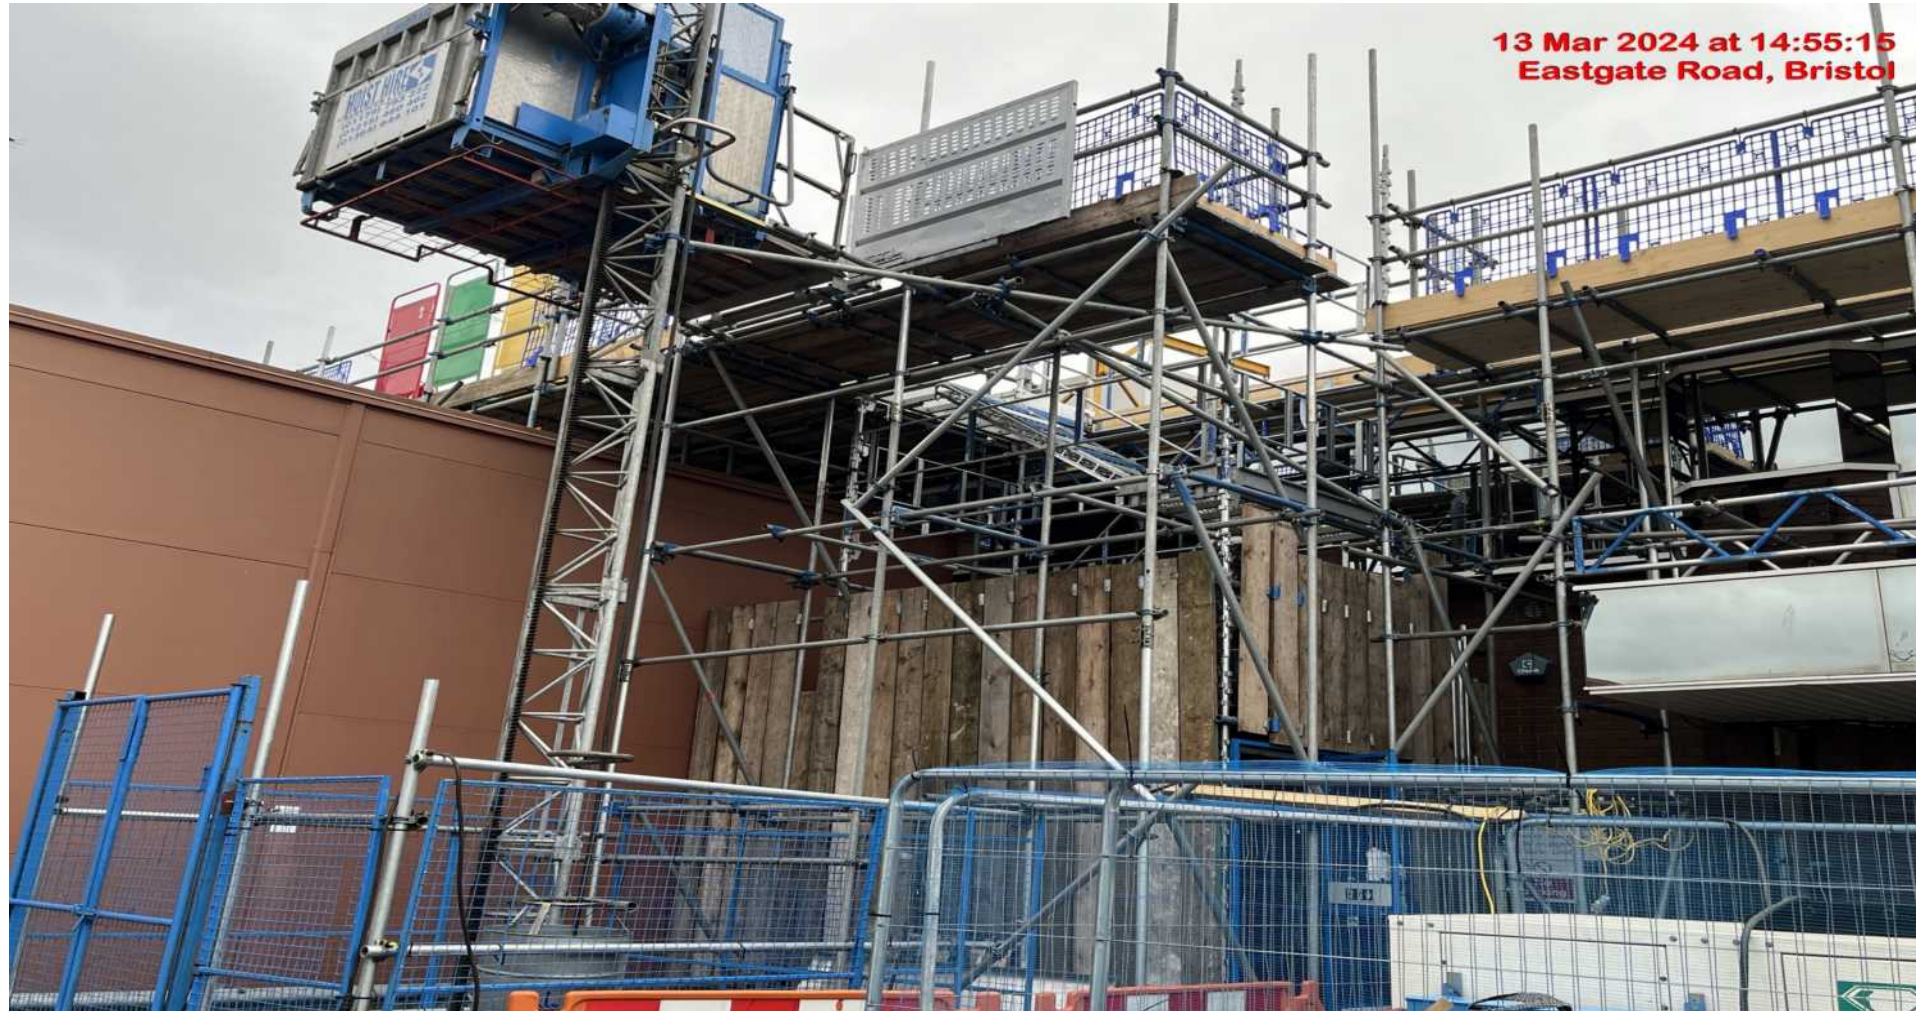
EAS 002

Haki Staircase near Site Cabins

Status of Scaffold: **Passed**

Notes: **Haki Staircase** was erected in order to meet requirements of TG20:21. Staircase is Tied into adjacent building.
Staircase was free of damage and defect.

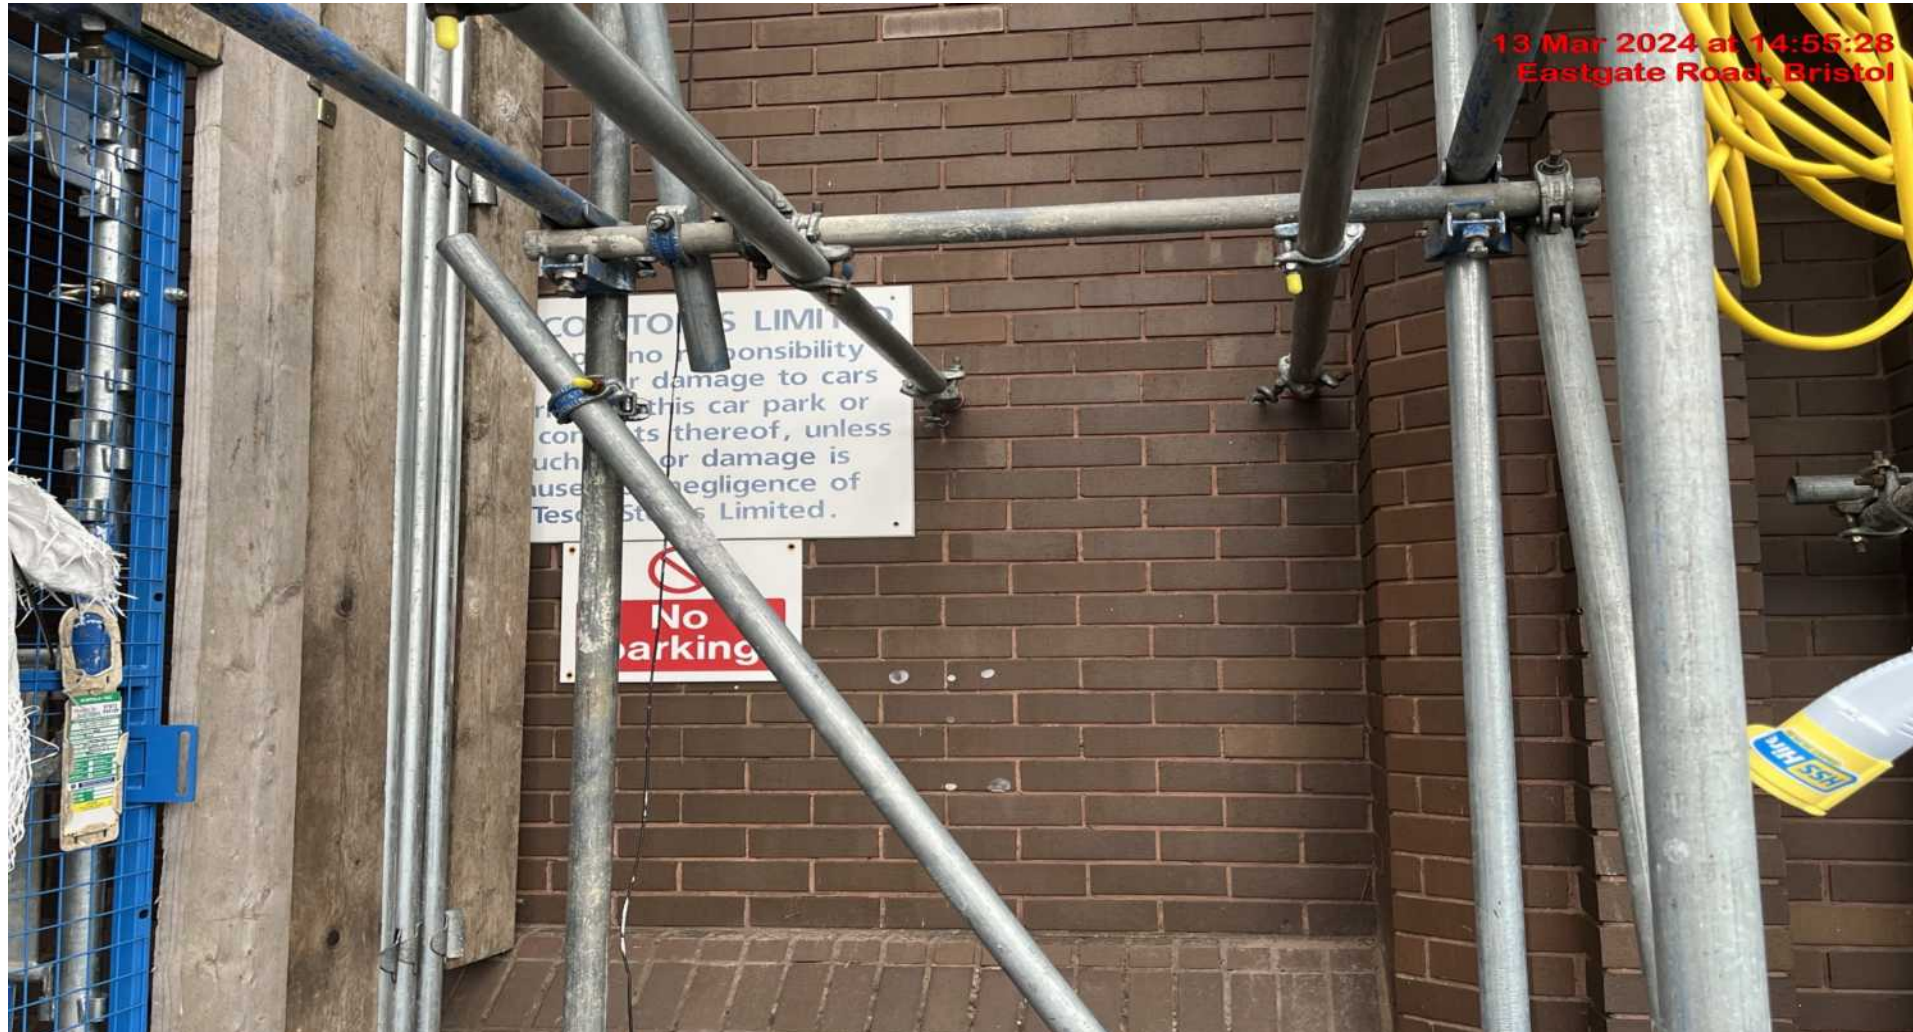
EAS 002

Haki Staircase near Site Cabins

Status of Scaffold: **Passed**

Notes: **Haki Staircase** was erected in order to meet requirements of TG20:21. Staircase is Tied into adjacent building.
Staircase was free of damage and defect.

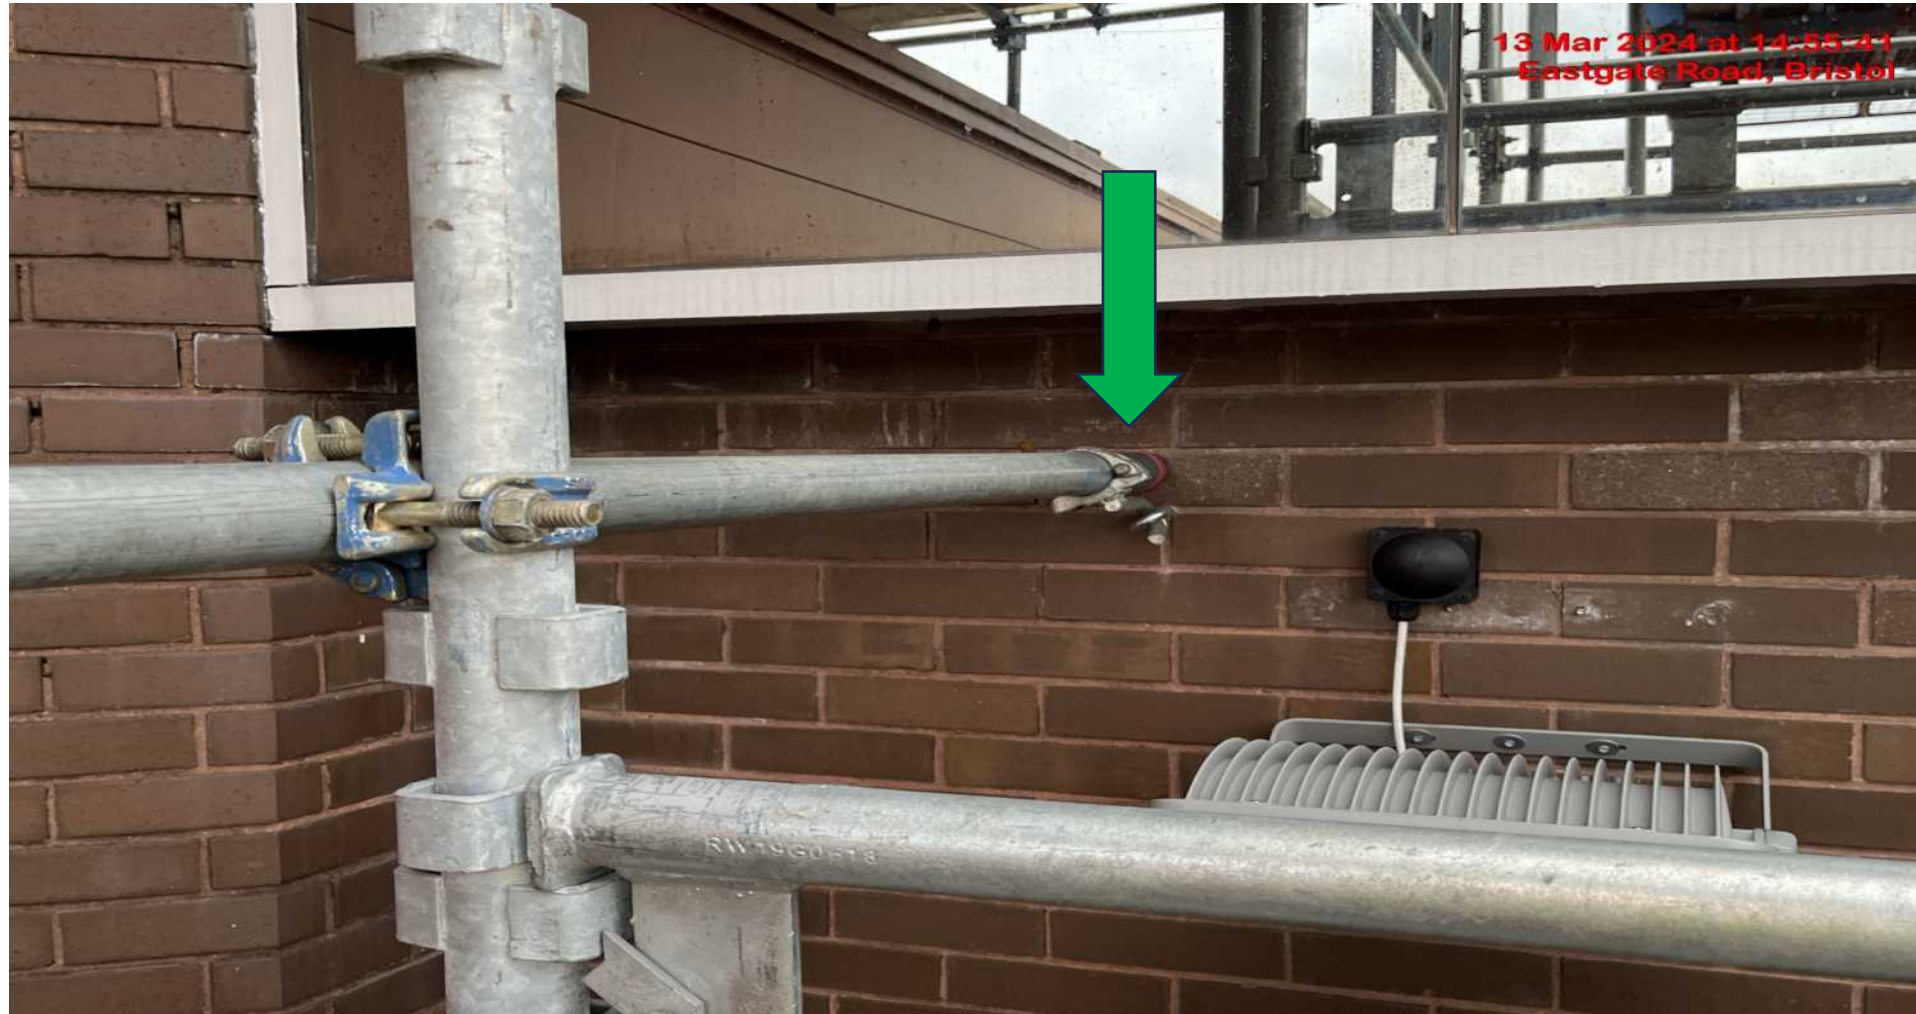
EAS 002

Haki Staircase near Site Cabins

Status of Scaffold: **Passed**

Notes: **Haki Staircase** was erected in order to meet requirements of TG20:21. Staircase is Tied into adjacent building.
Staircase was free of damage and defect.

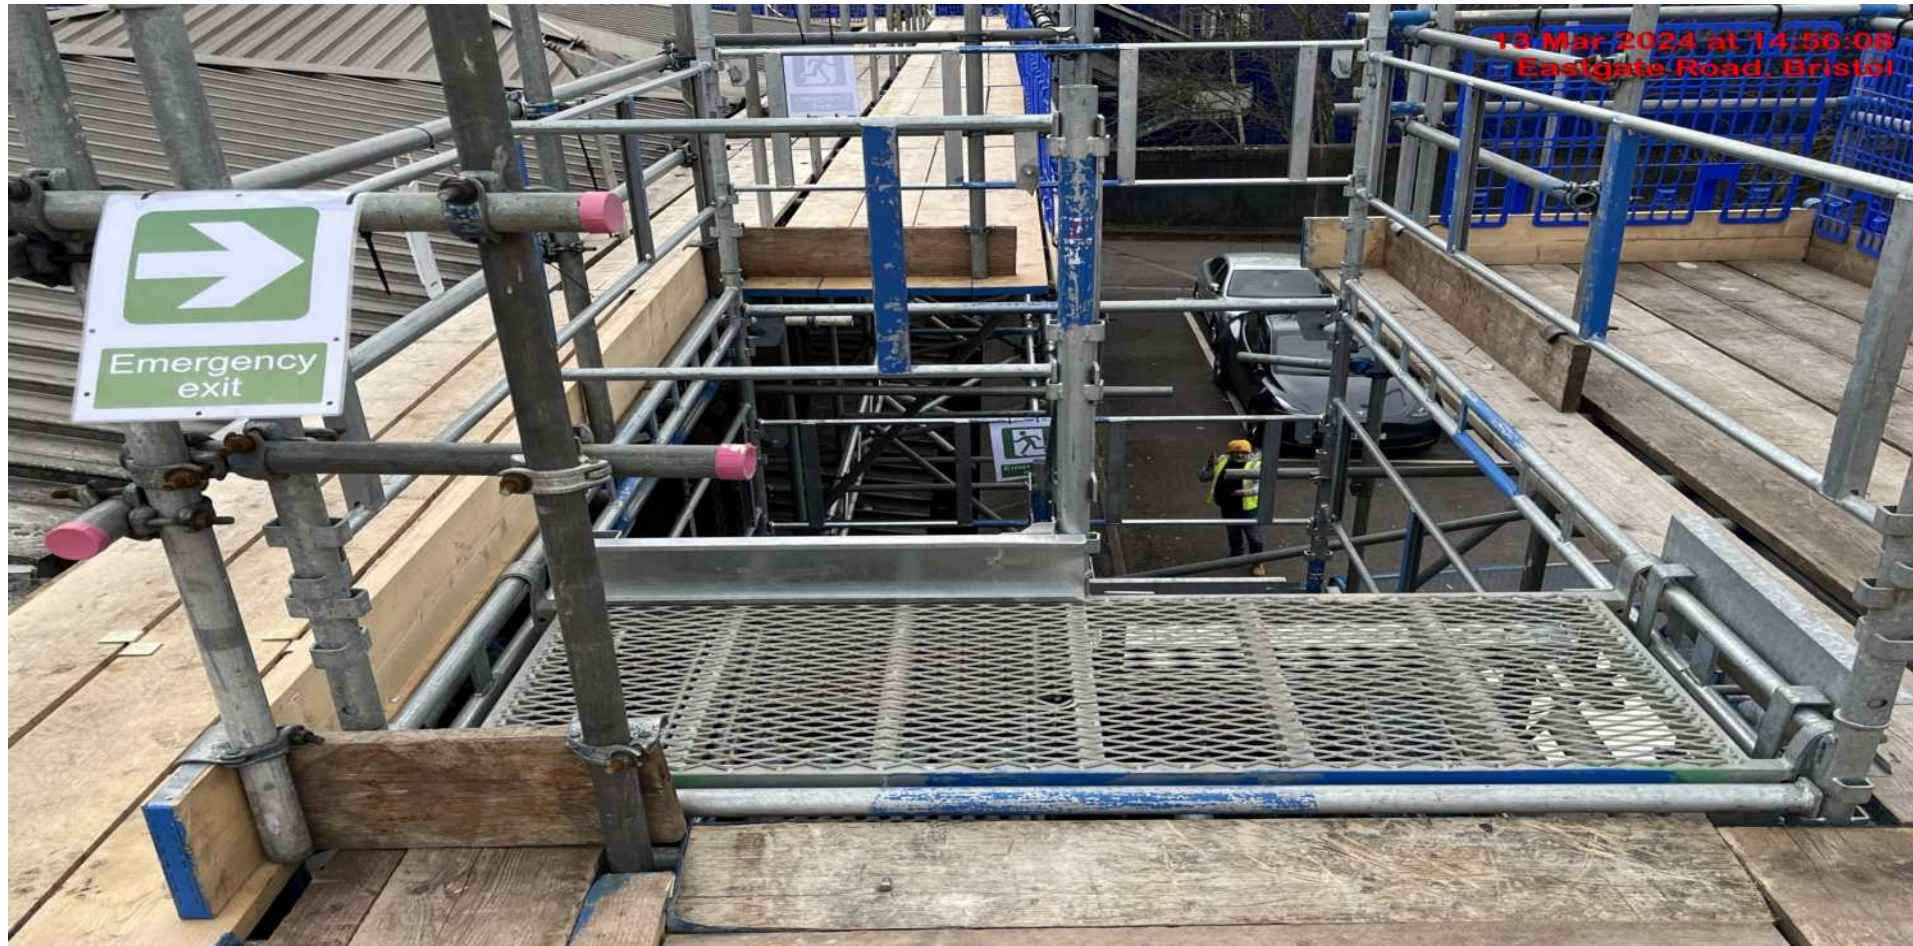
EAS 003

Independent Access Scaffold, Car Park & Delivery Bay Elevations

Notes: Scaffold has been Tied into the Building in order to prevent movement.

Sufficient Face Bracings and Ledger Bracings have been used on all Elevations of the Scaffold in order to meet requirements of TG20:21.

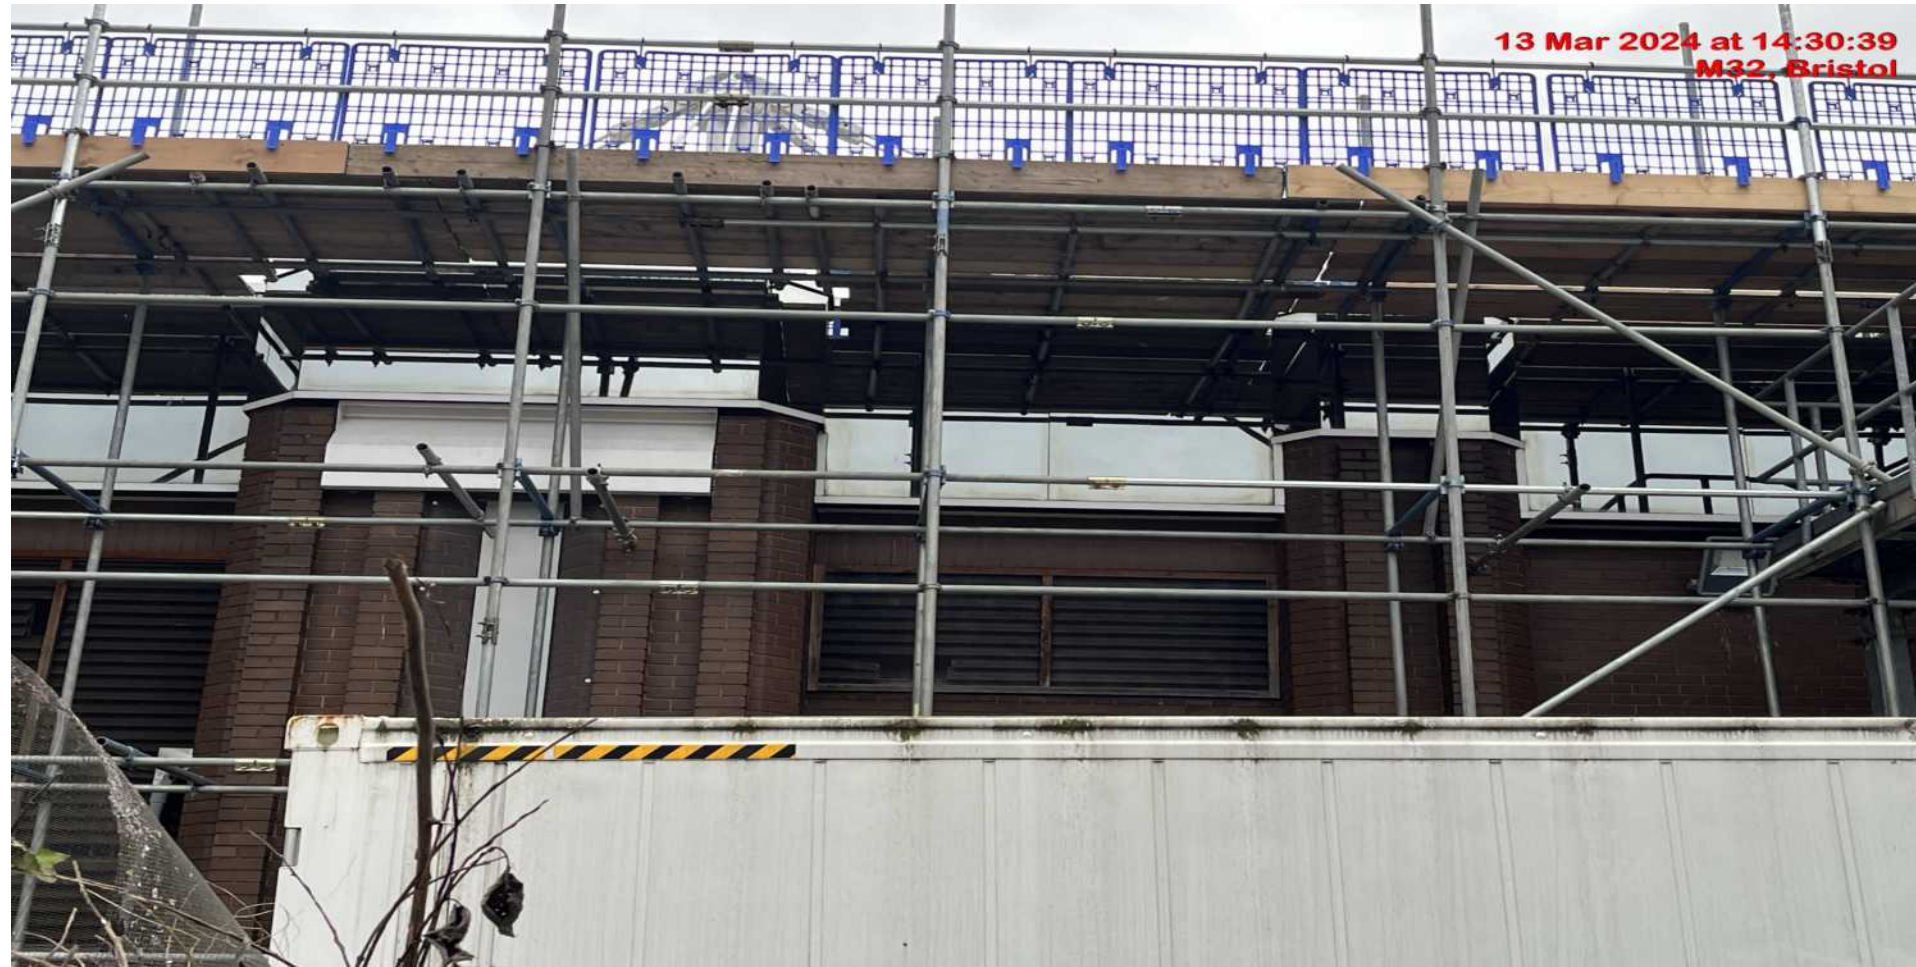
EAS 003

Independent Access Scaffold, Car Park & Delivery Bay Elevations

Notes: Scaffold has been Tied into the Building in order to prevent movement.

Sufficient Face Bracings and Ledger Bracings have been used on all Elevations of the Scaffold in order to meet requirements of TG20:21.

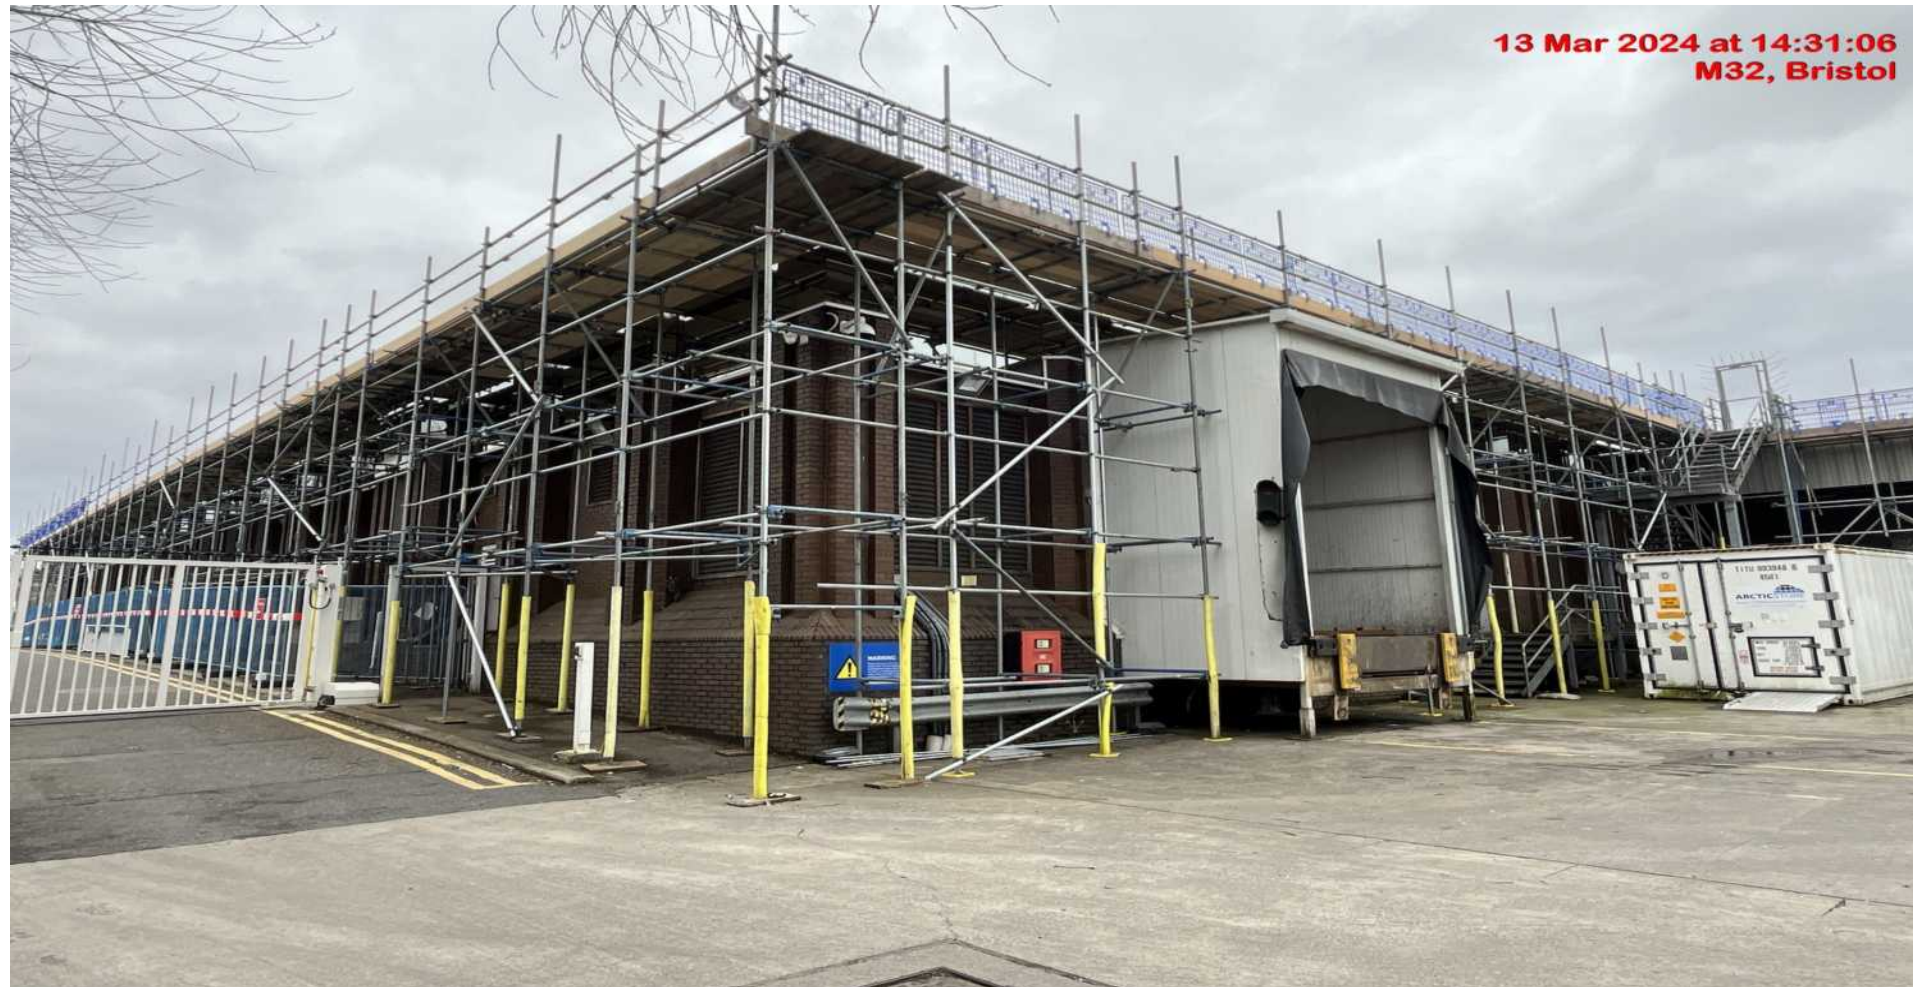
Notes: Scaffold has been Tied into the Building in order to prevent movement.

Sufficient Face Bracings and Ledger Bracings have been used on all Elevations of the Scaffold in order to meet requirements of TG20:21.

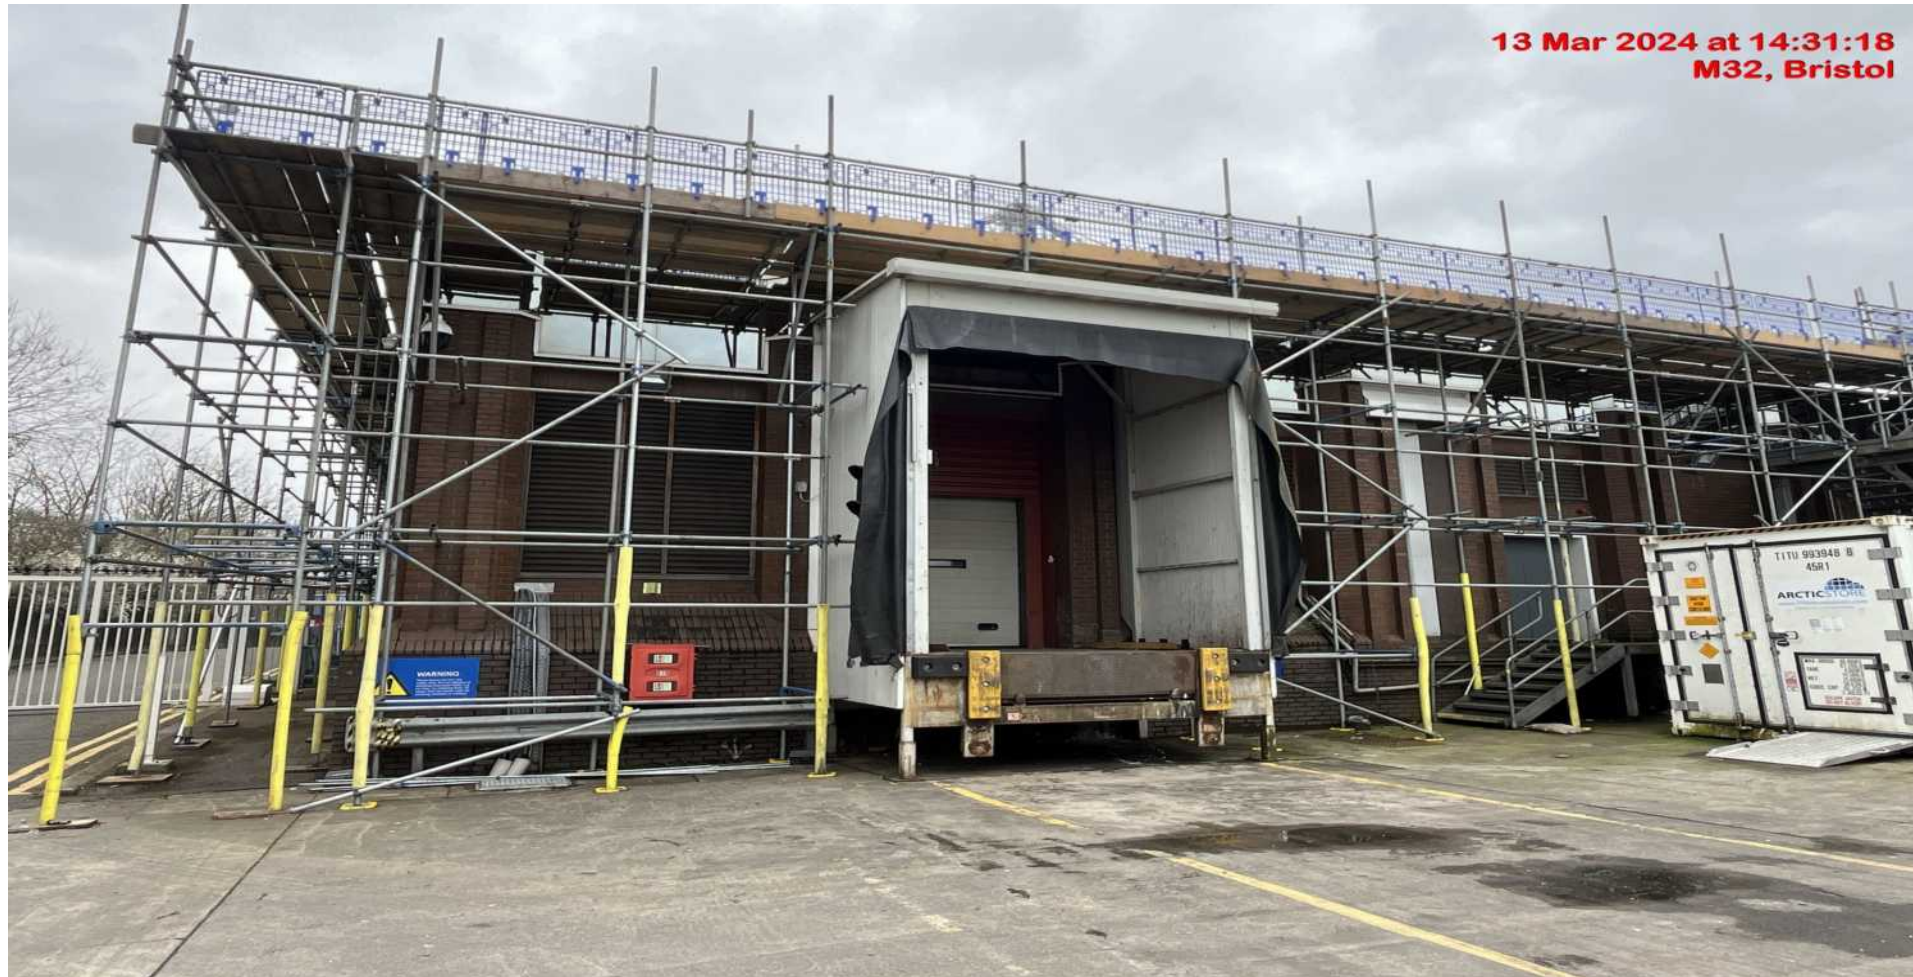
Notes: Scaffold has been Tied into the Building in order to prevent movement.

Sufficient Face Bracings and Ledger Bracings have been used on all Elevations of the Scaffold in order to meet requirements of TG20:21.

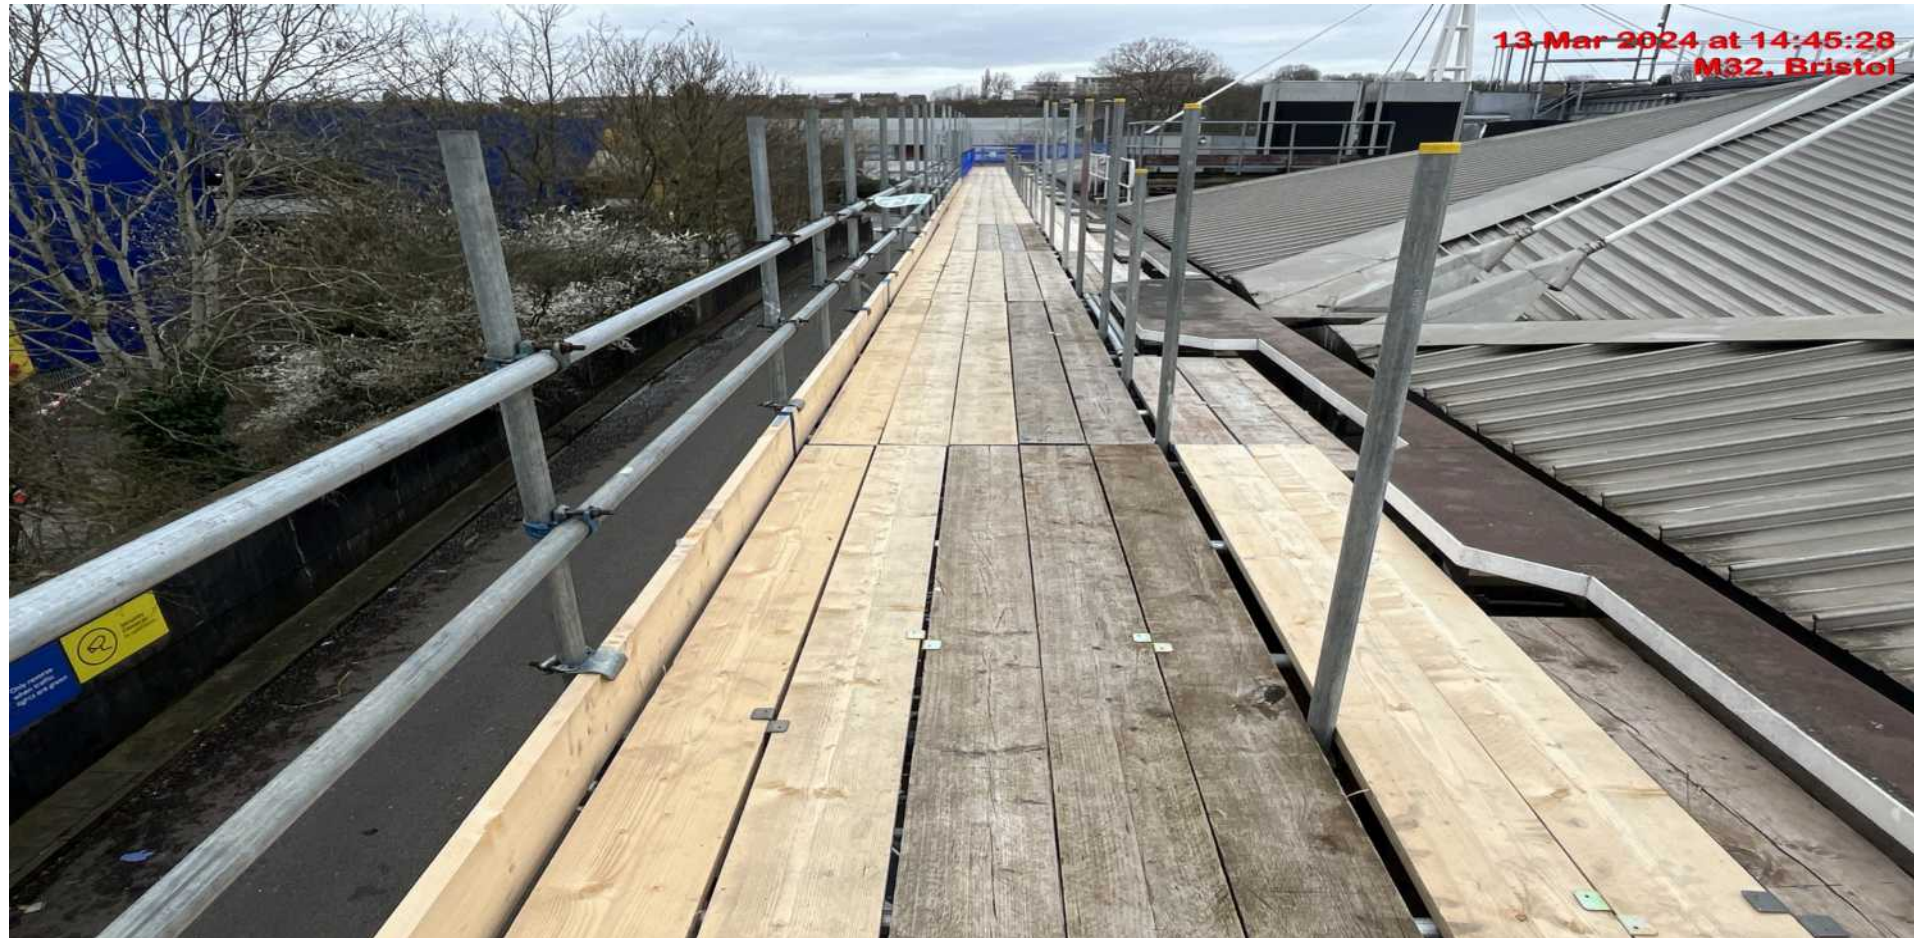
Notes: Scaffold has been Tied into the Building in order to prevent movement. Working Lift is free of debris and waste materials.

Some of the Scaffold Boards near to the Glass Windows of the Building and/or needed to be secured in more than 1 position.
