Cymru Scaffold Inspections

Tesco, Eastgate Rd, Eastville, Bristol BS5 6XU

Wednesday 13th March 2024

INSPECTION OF: Site Scaffolds & Scaffold Management on Site

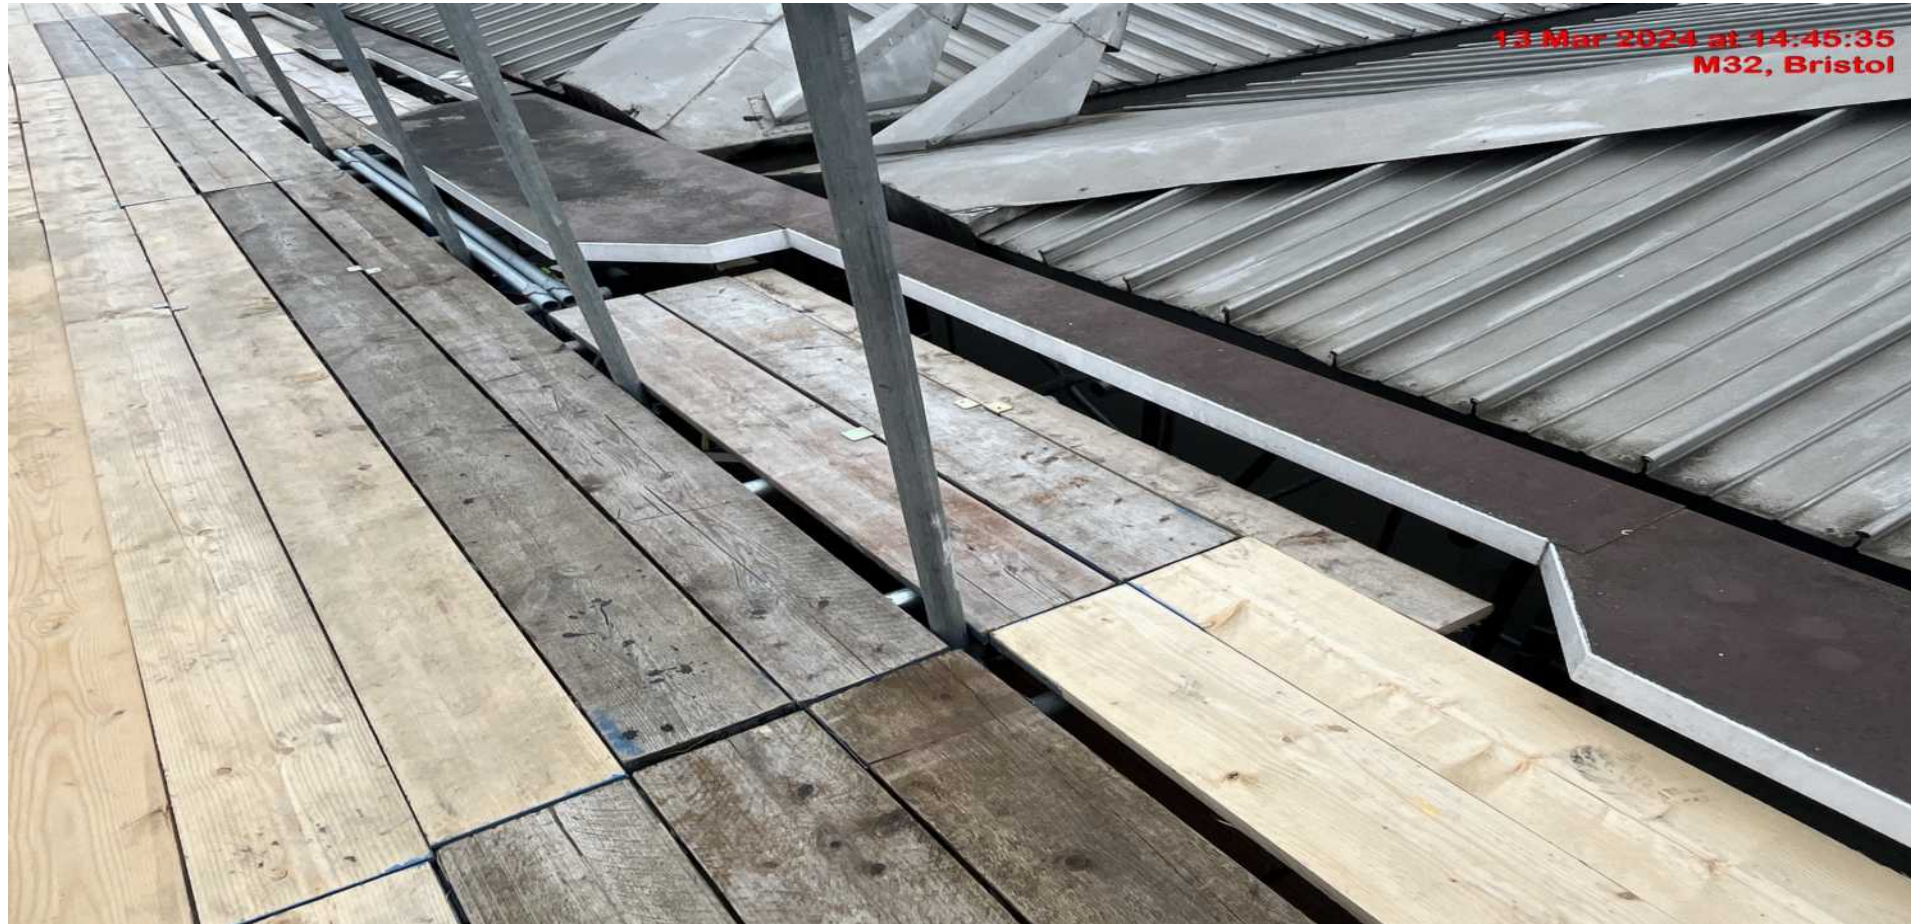
Notes: Scaffold has been Tied into the Building in order to prevent movement. Working Lift is free of debris and waste materials.

Some of the Scaffold Boards near to the Glass Windows of the Building and/or needed to be secured in more than 1 position.

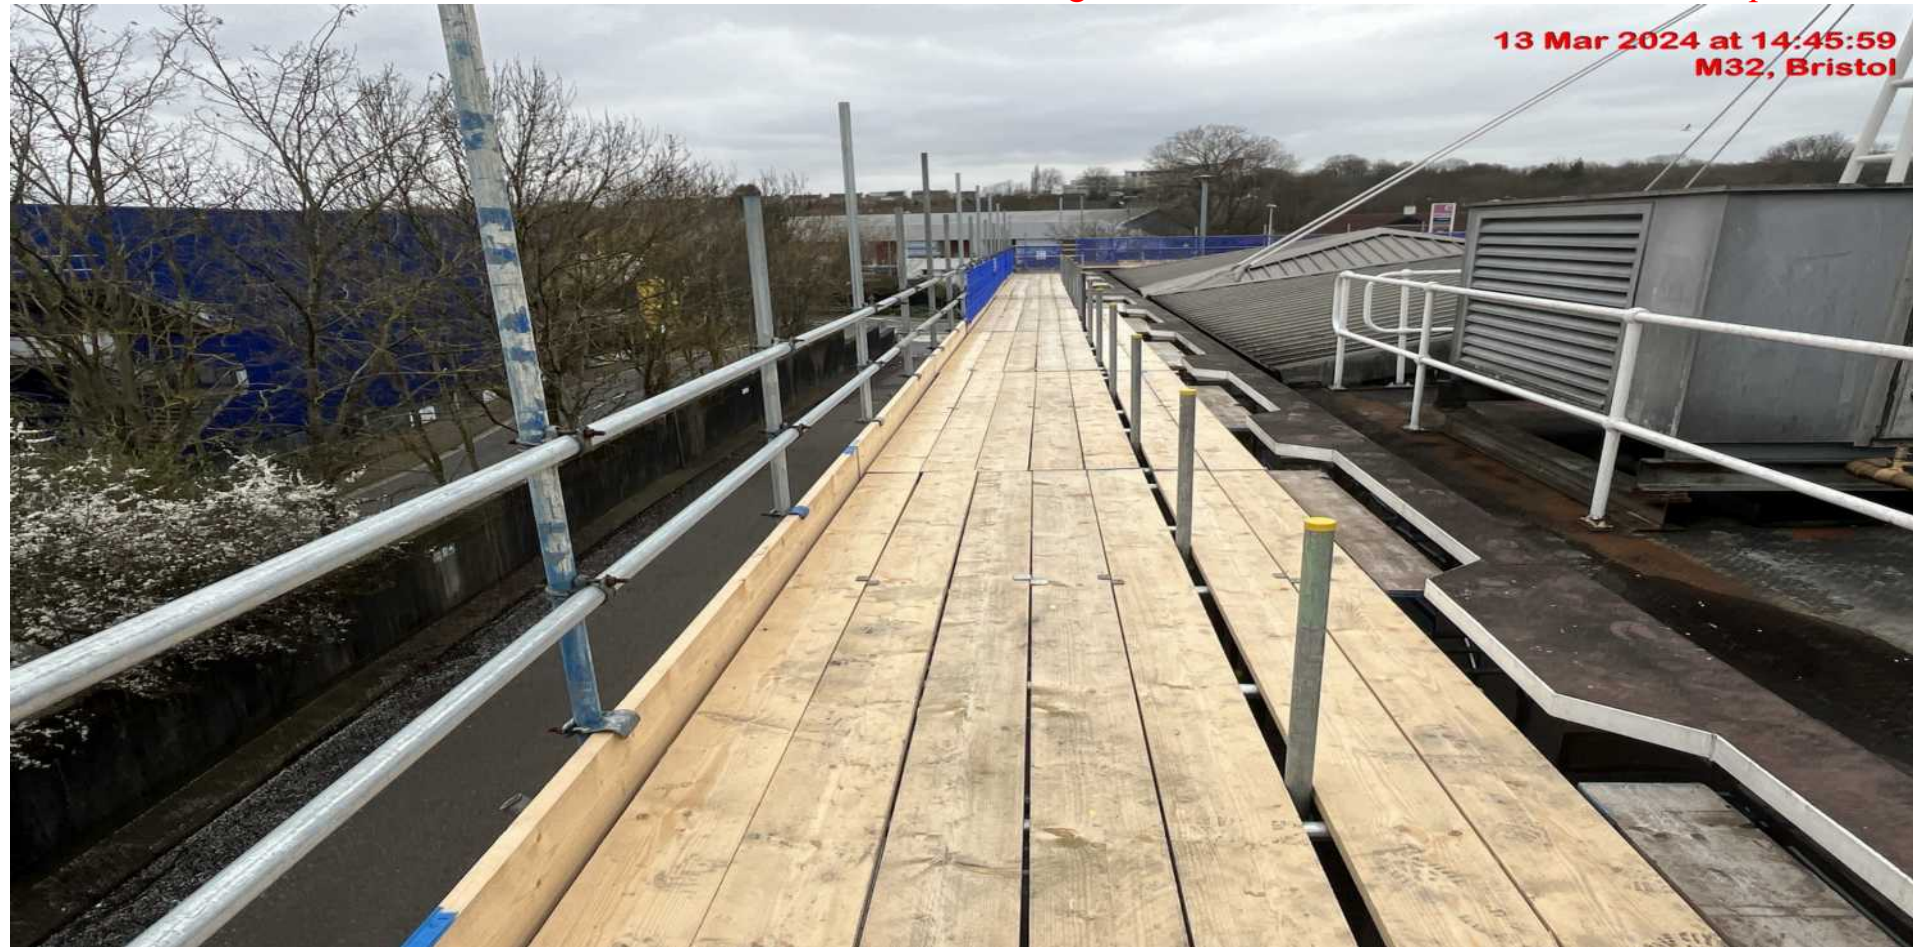
Notes: Scaffold has been Tied into the Building in order to prevent movement. Working Lift is free of debris and waste materials.

Some of the Scaffold Boards near to the Glass Windows of the Building and/or needed to be secured in more than 1 position.

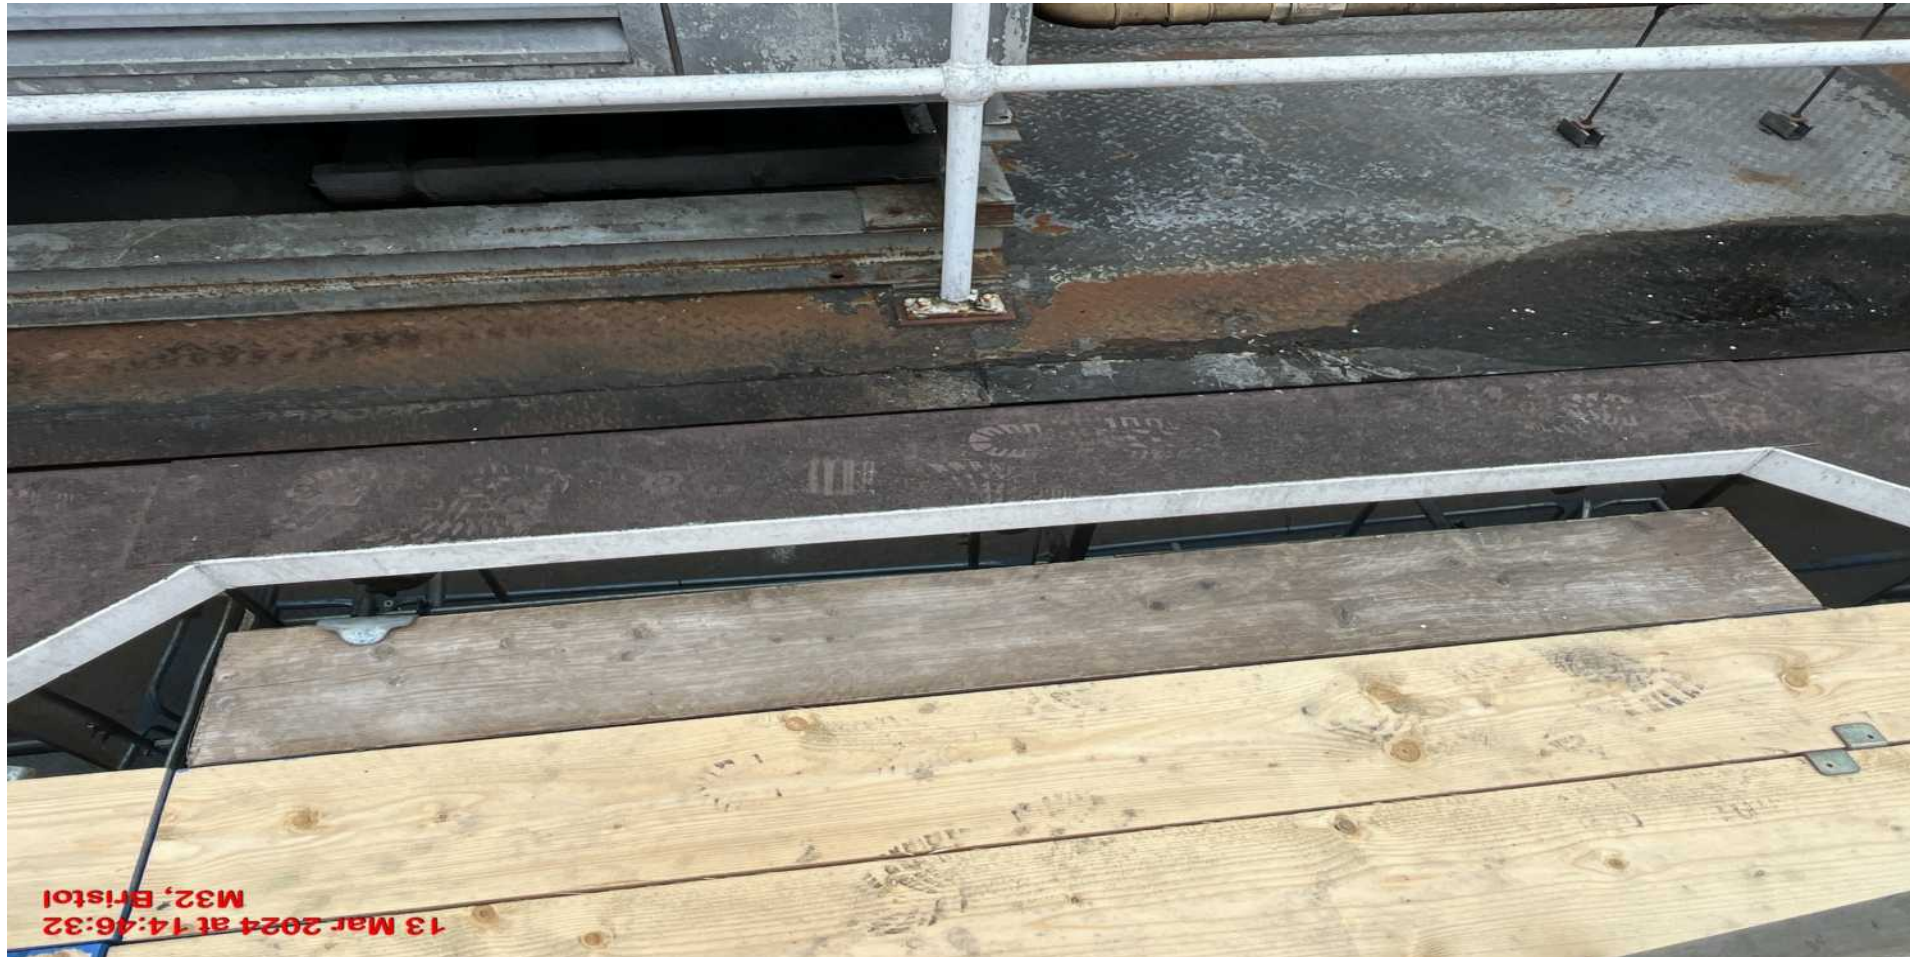
Notes: Scaffold has been Tied into the Building in order to prevent movement. Working Lift is free of debris and waste materials.

Some of the Scaffold Boards near to the Glass Windows of the Building and/or needed to be secured in more than 1 position.

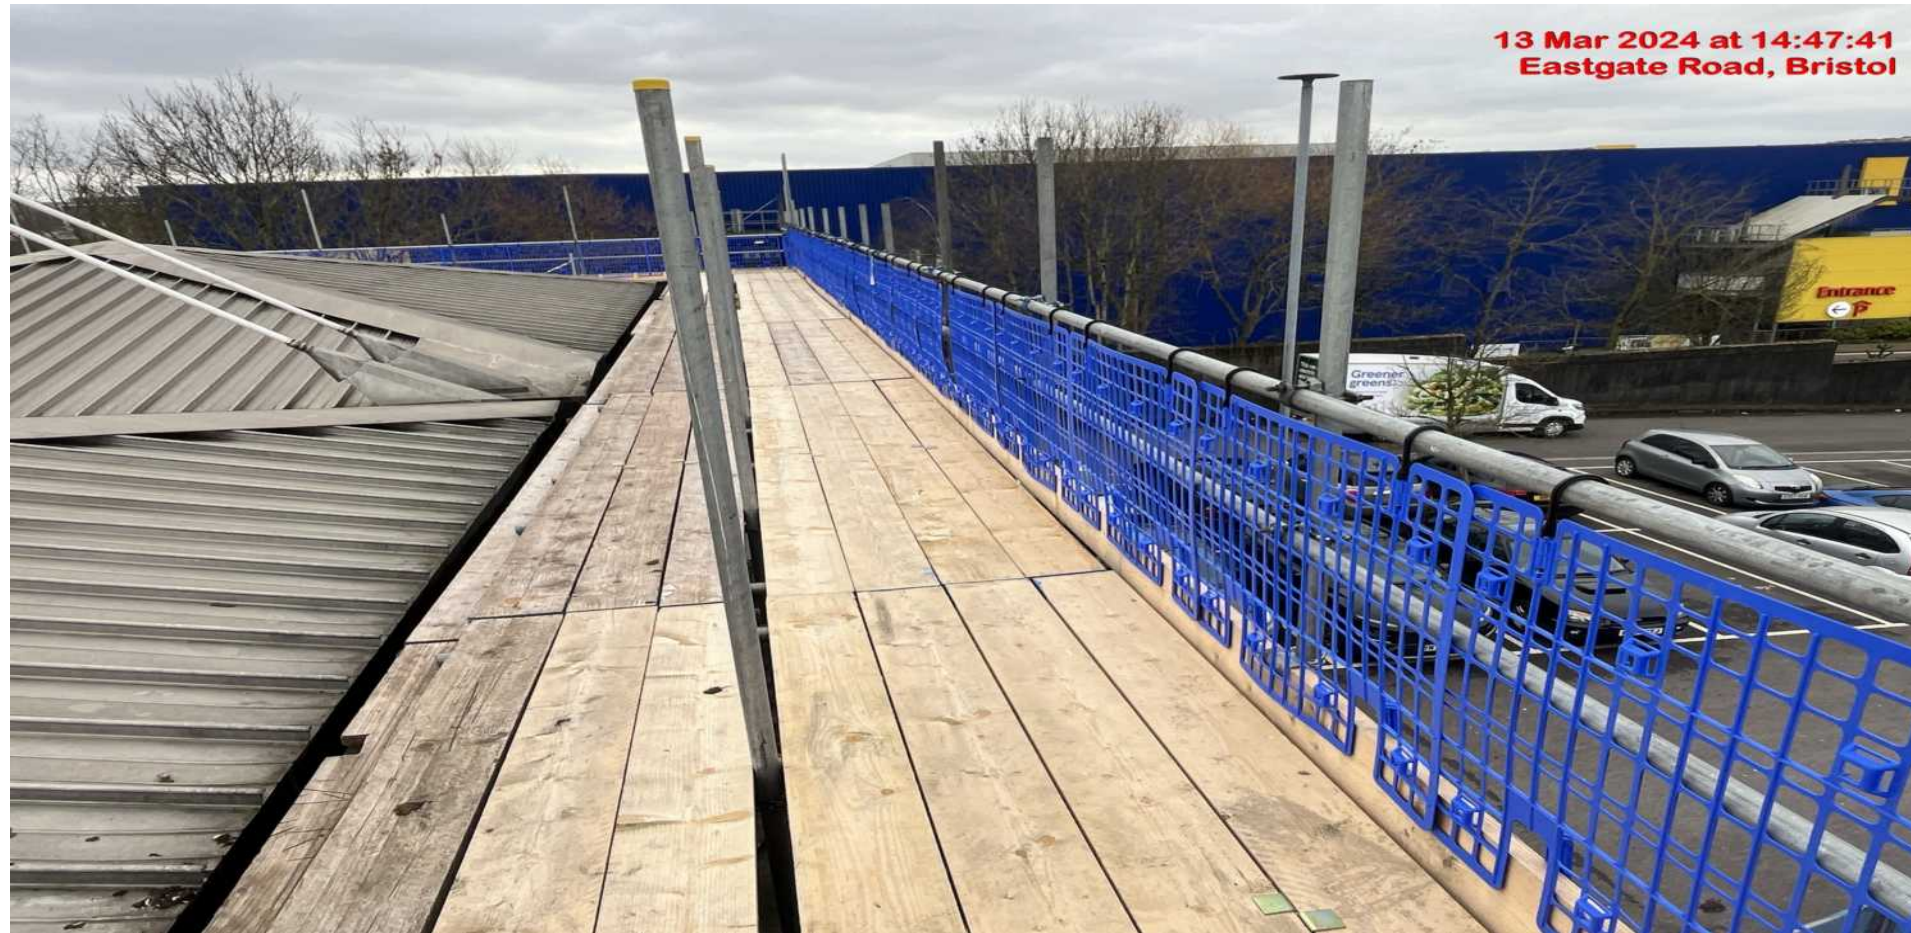
Notes: Scaffold has been Tied into the Building in order to prevent movement. Working Lift is free of debris and waste materials.

Some of the Scaffold Boards near to the Glass Windows of the Building and/or needed to be secured in more than 1 position.

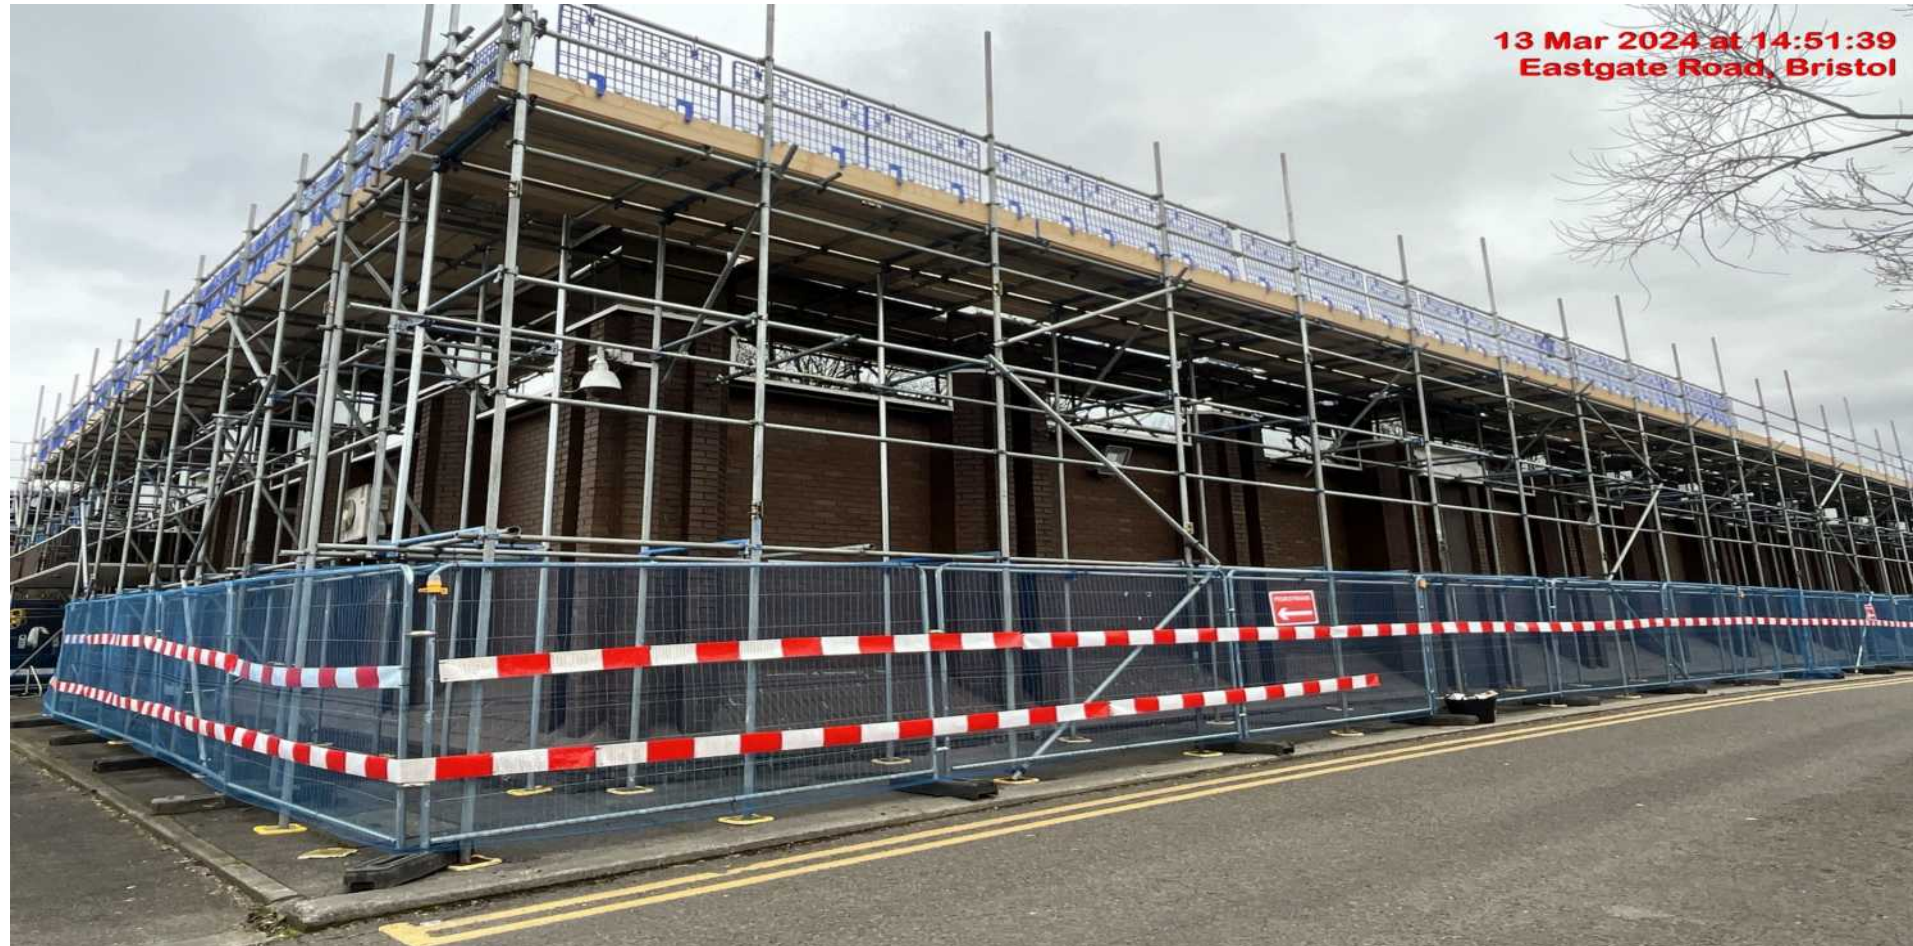
Notes: Scaffold has been Tied into the Building in order to prevent movement.

Sufficient Face Bracings and Ledger Bracings have been used on all Elevations of the Scaffold in order to meet requirements of TG20:21.

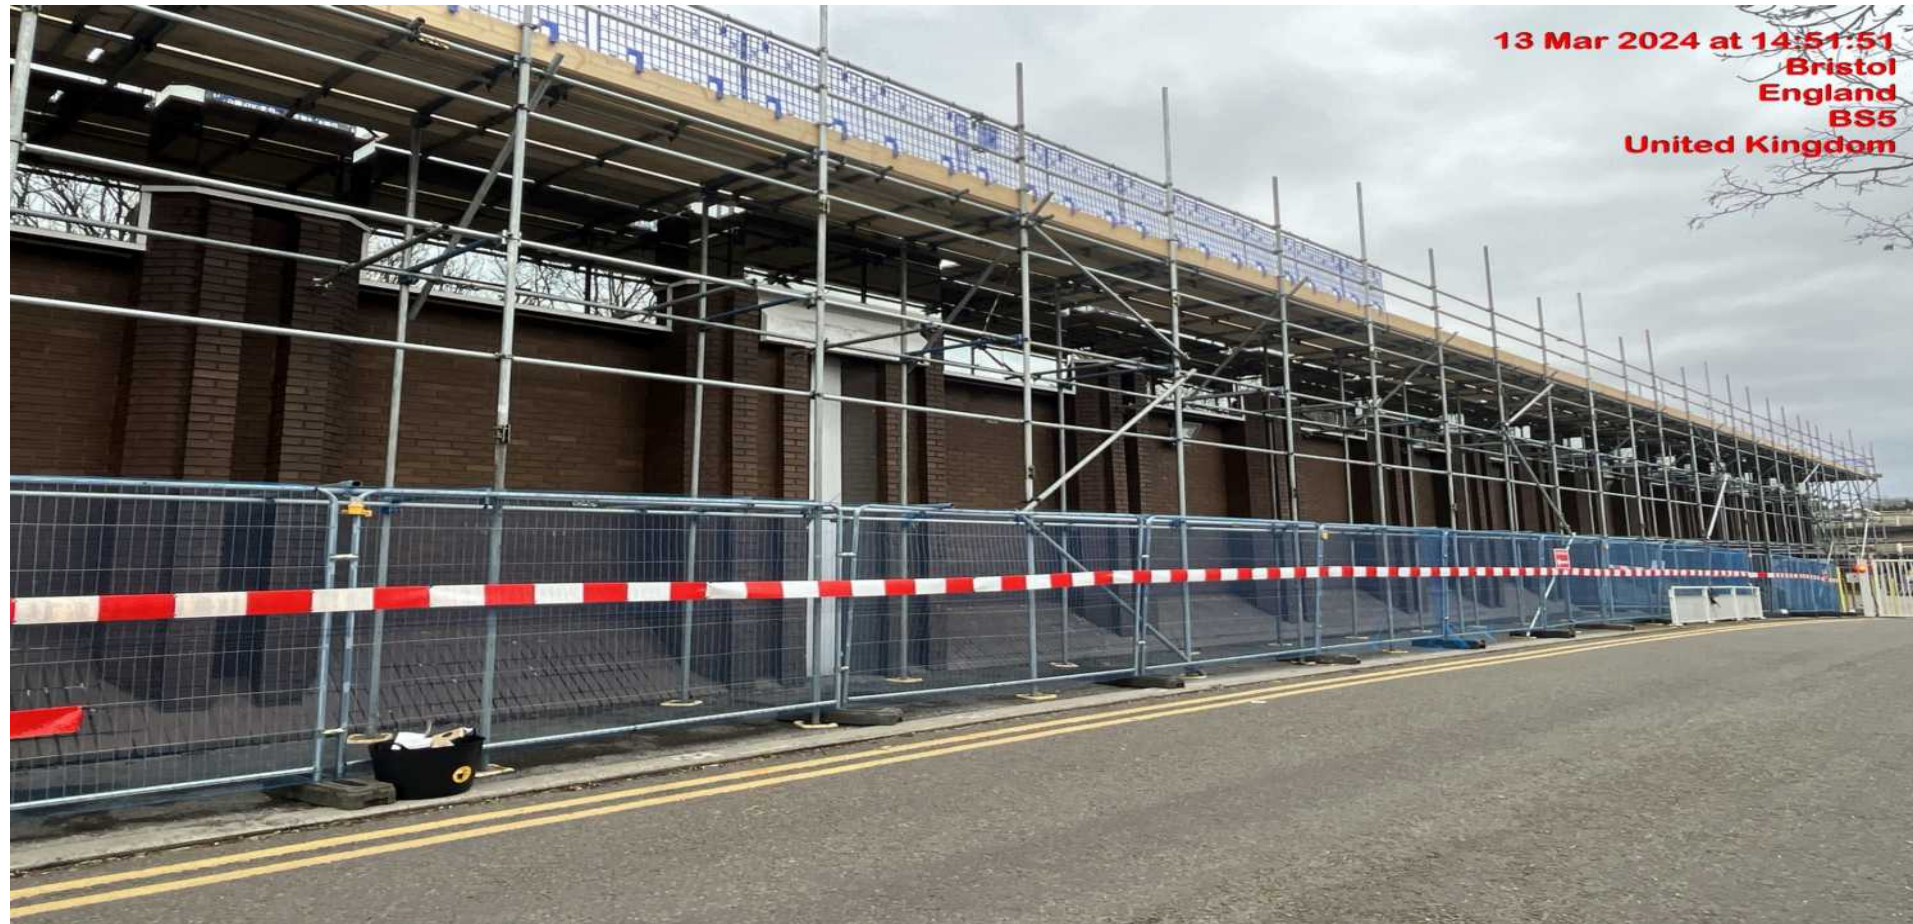
Sufficient Face Bracings and Ledger Bracings have been used on all Elevations of the Scaffold in order to meet requirements of TG20:21.

Scaffold Contractor has agreed to supply extra Brickguards for the Working Lifts.

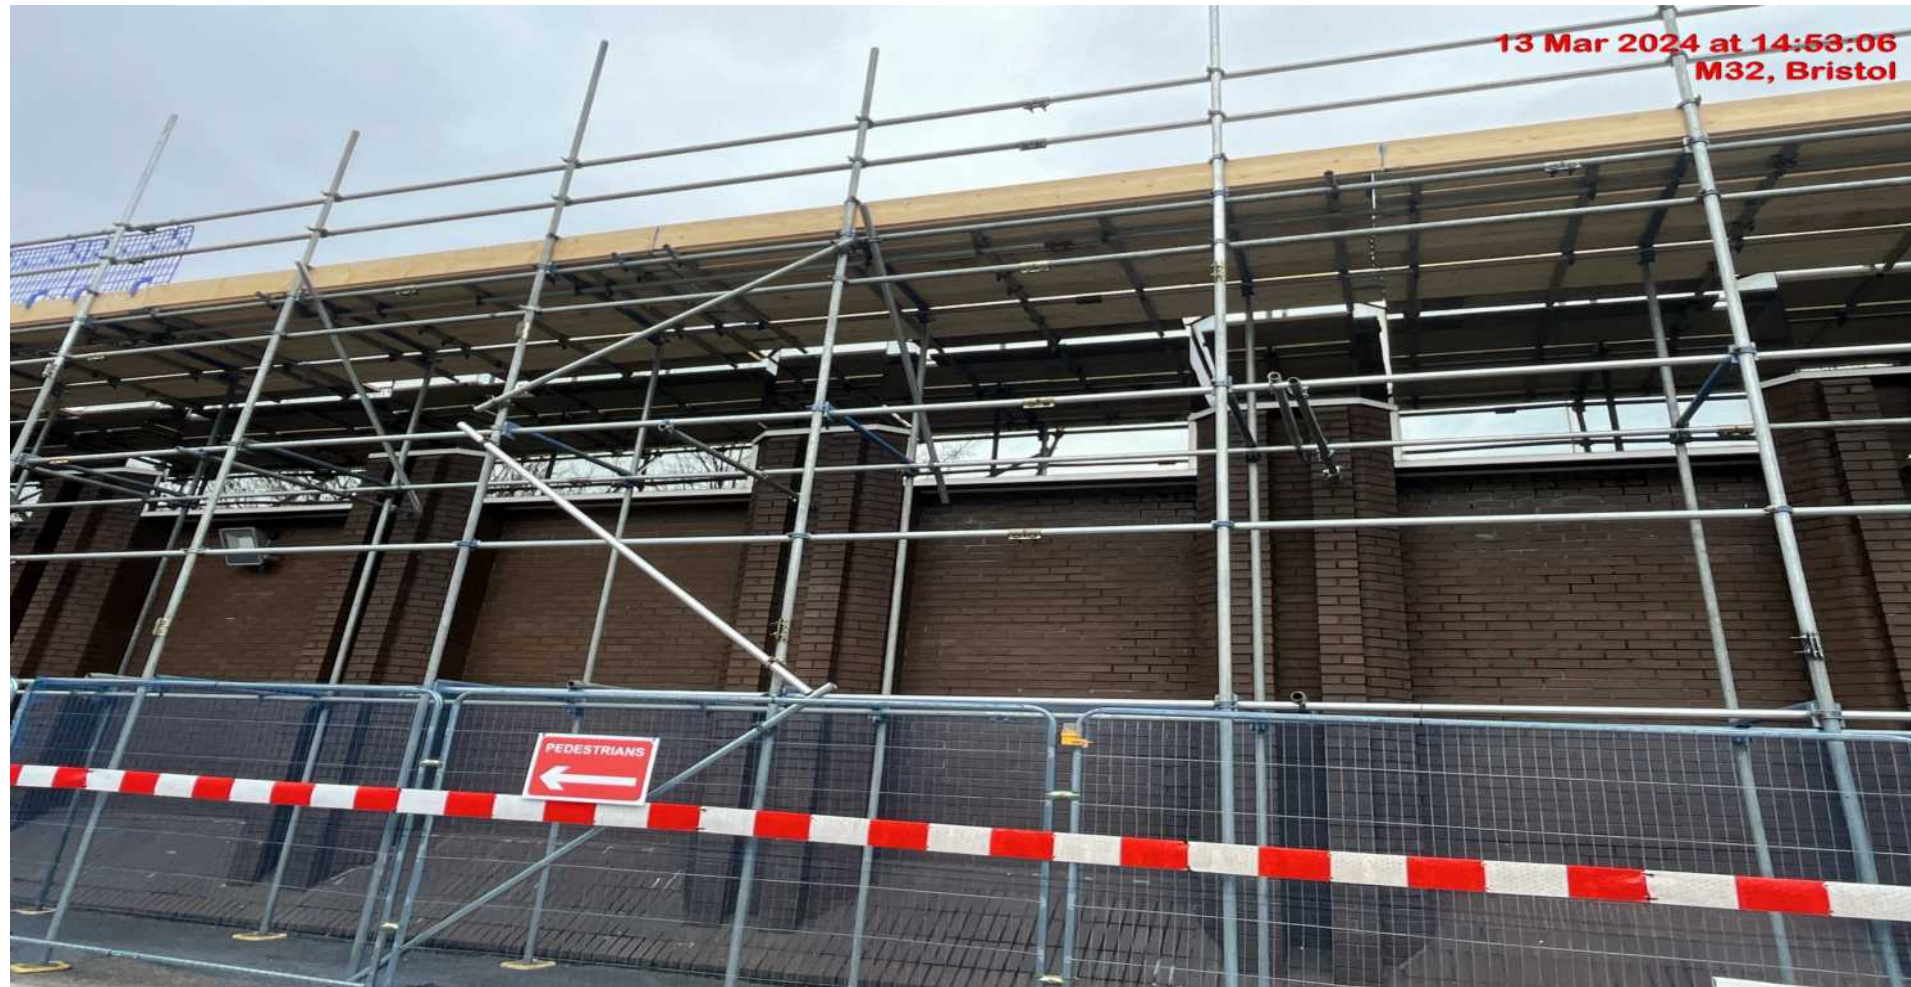
Notes: Scaffold has been Tied into the Building in order to prevent movement.

Sufficient Face Bracings and Ledger Bracings have been used on all Elevations of the Scaffold in order to meet requirements of TG20:21.

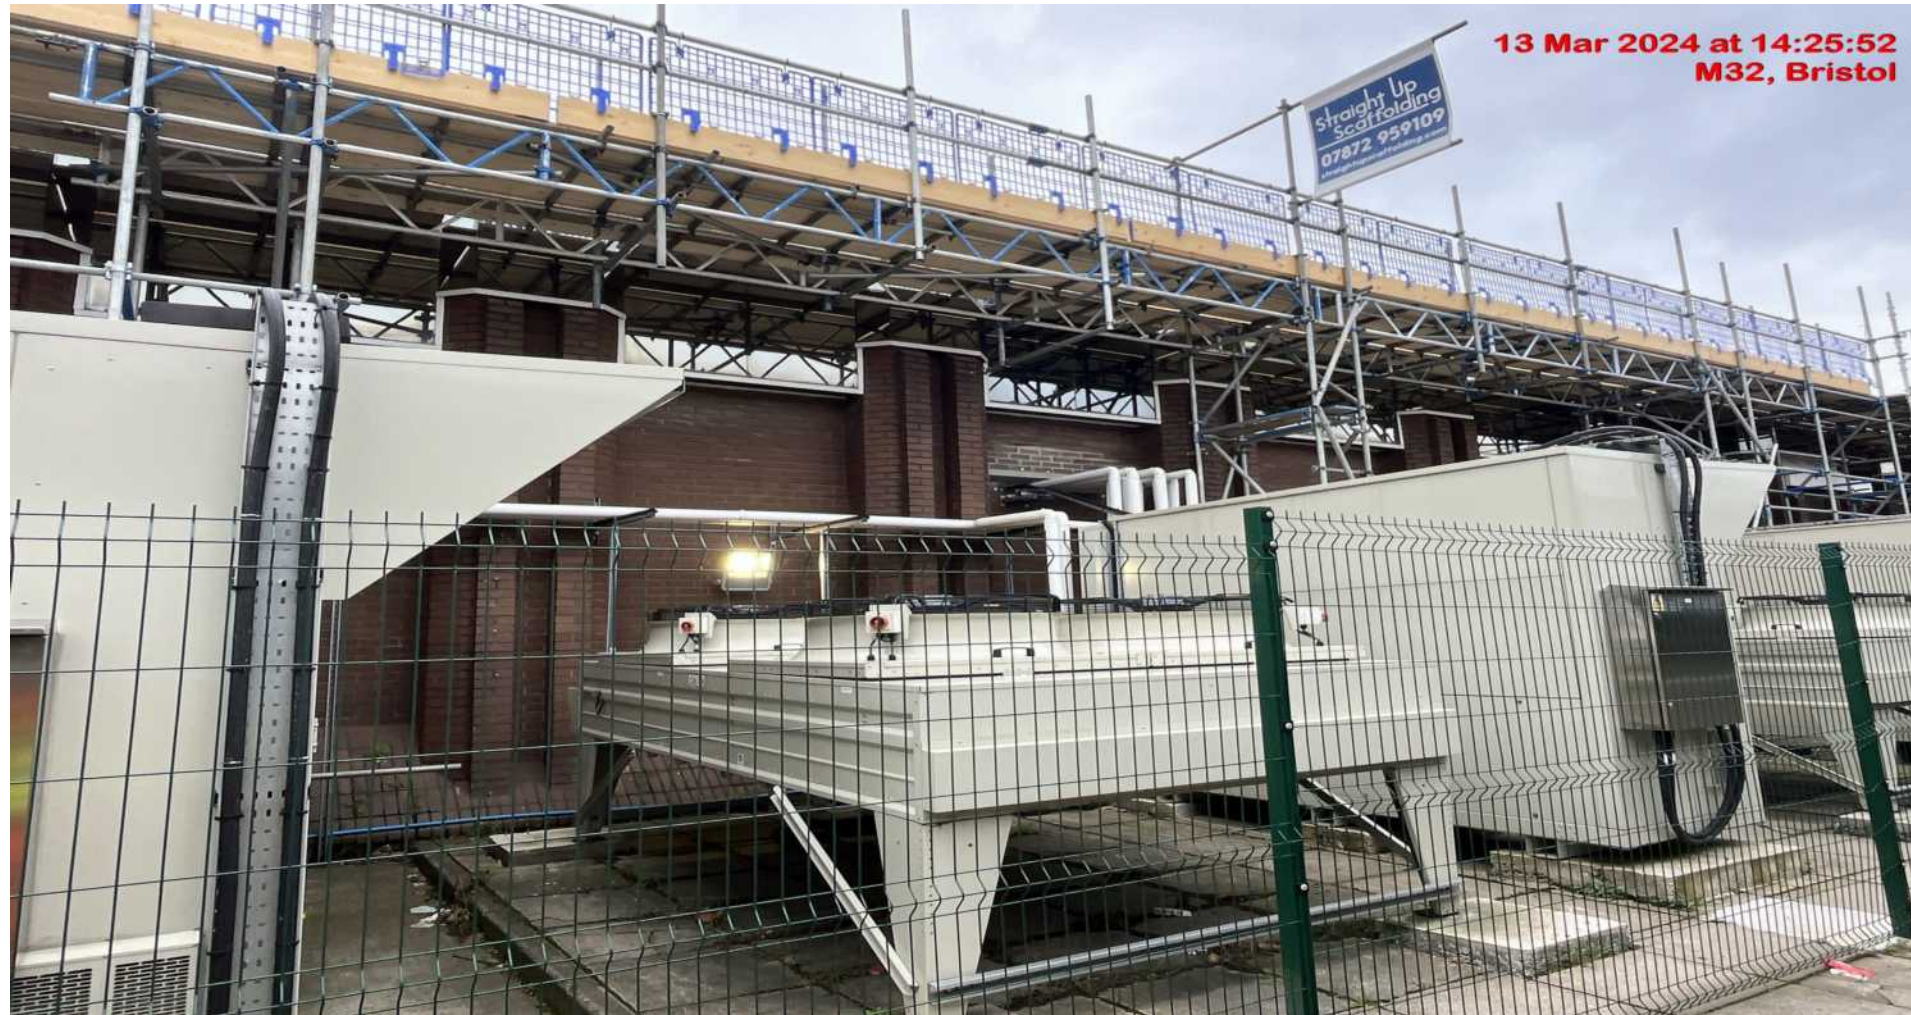
Notes: Scaffold was erected in order to meet requirements of TG20:21. **Handover Certificate is required for Scaffold.**

Sufficient Face Bracings and Ledger Bracings have been used on all Elevations of the Scaffold in order to meet requirements of TG20:21.

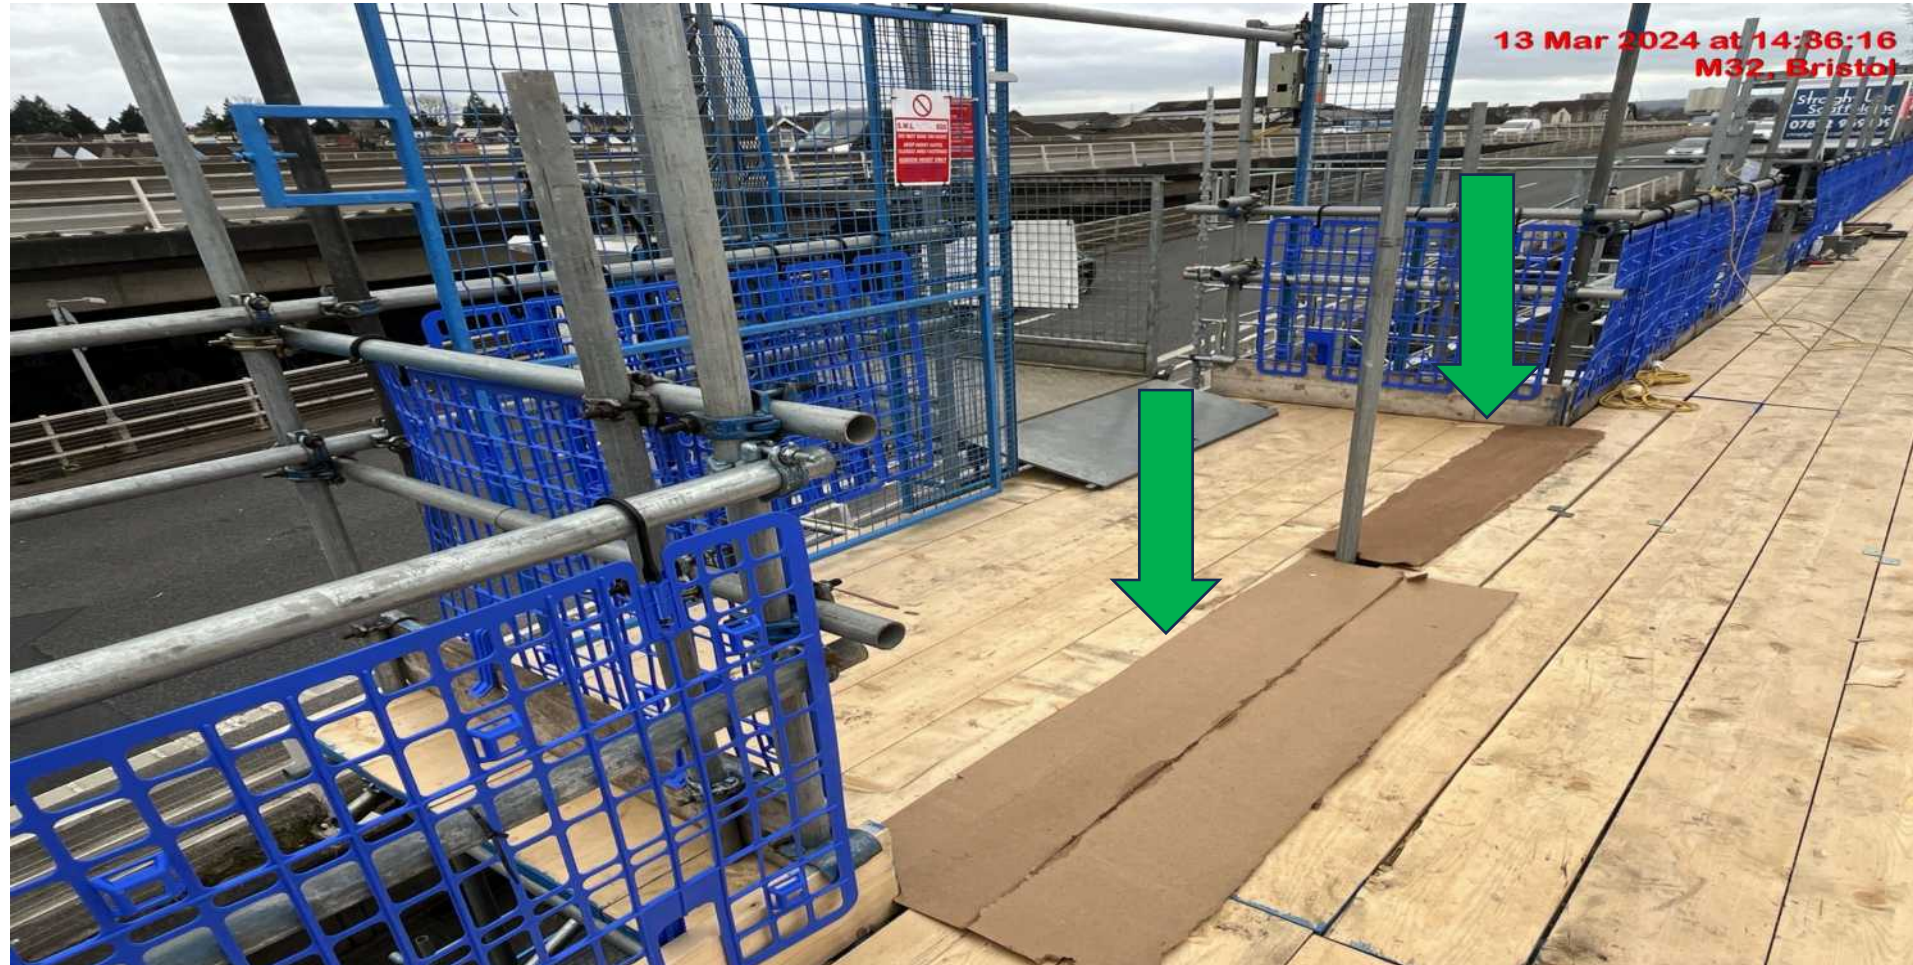
Sufficient Face Bracings and Ledger Bracings have been used on all Elevations of the Scaffold in order to meet requirements of TG20:21.

Toeboards have been added to the Working Lift.

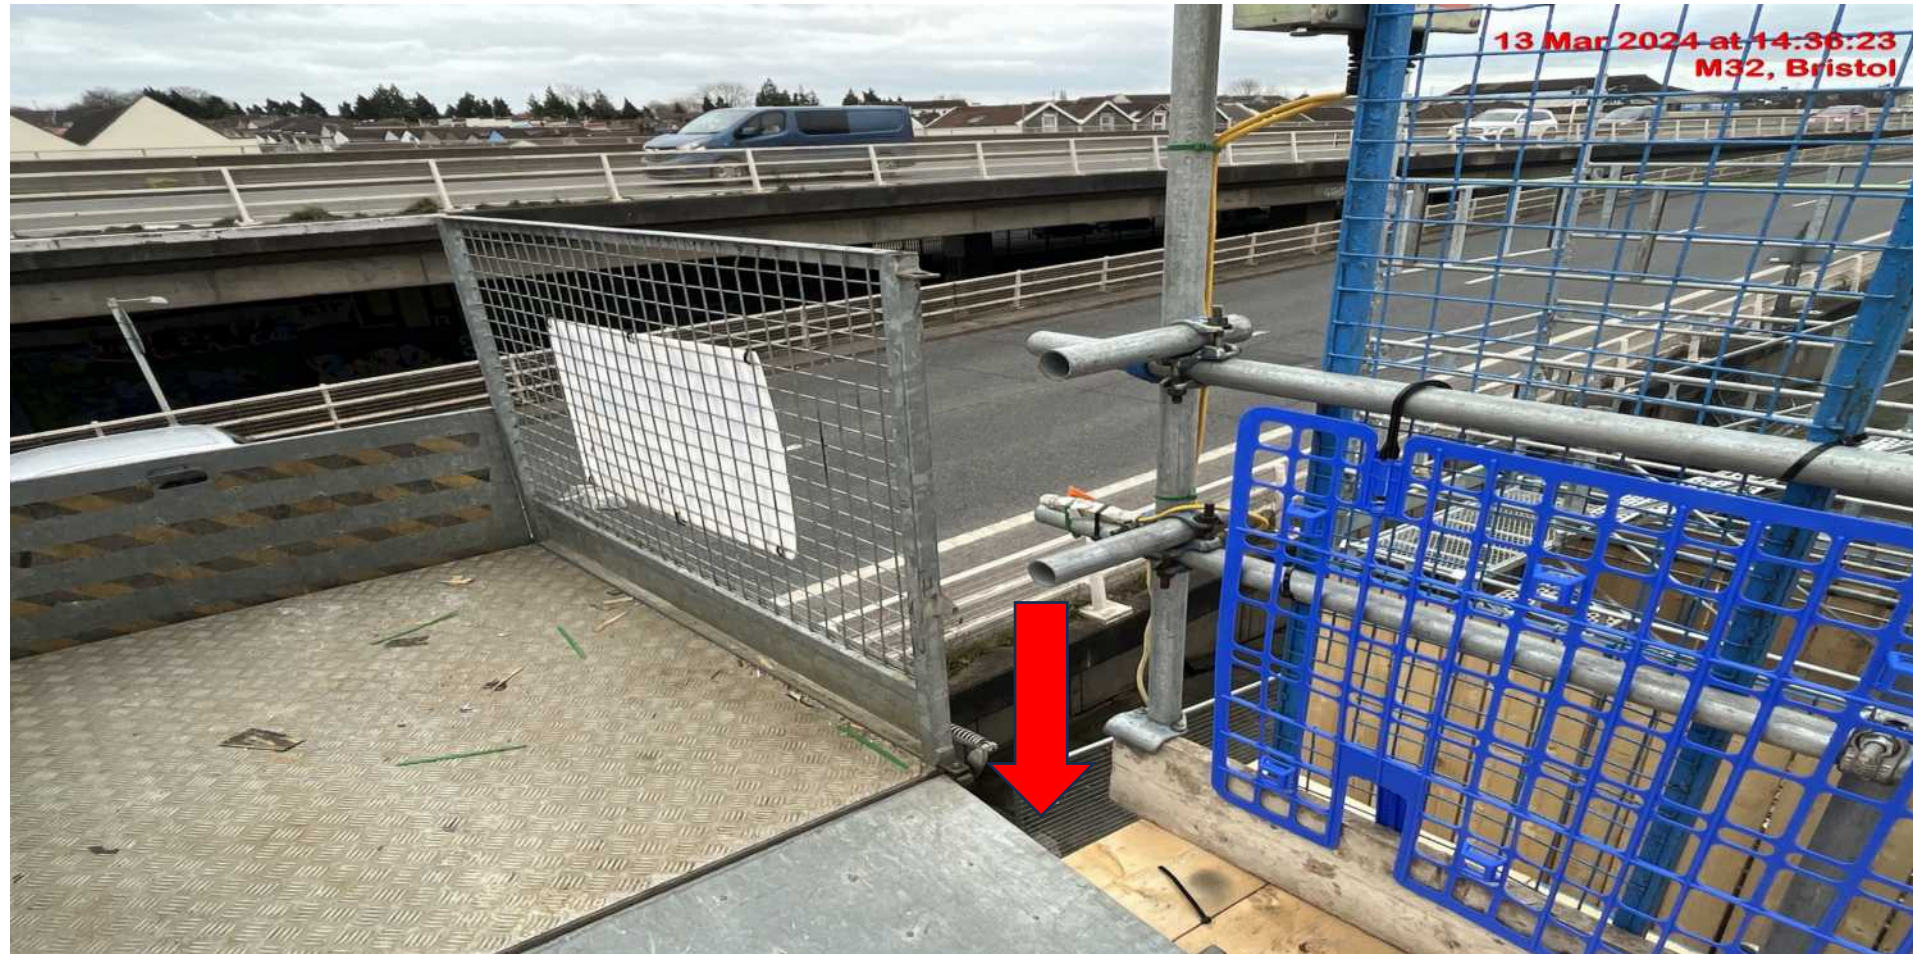
Sufficient Face Bracings and Ledger Bracings have been used on all Elevations of the Scaffold in order to meet requirements of TG20:21

Void needs to be eliminated on Working Lift.

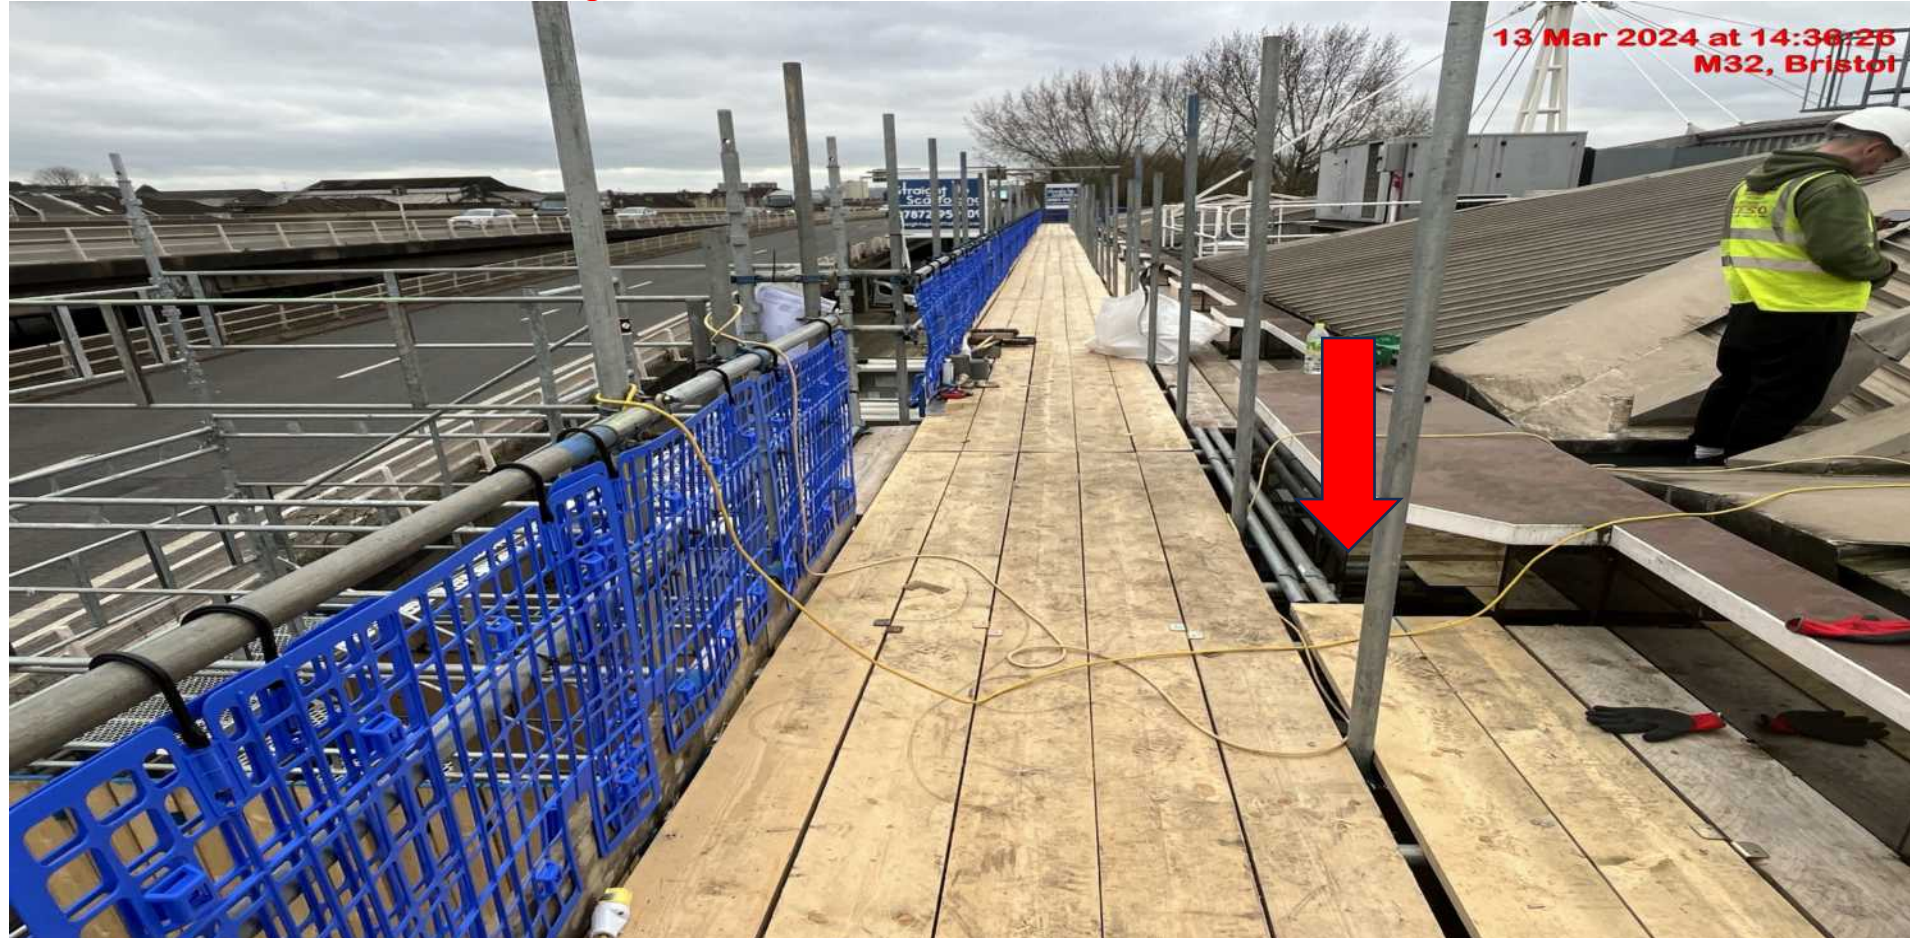
Sufficient Face Bracings and Ledger Bracings have been used on all Elevations of the Scaffold in order to meet requirements of TG20:21

Void needs to be eliminated on Working Lift.

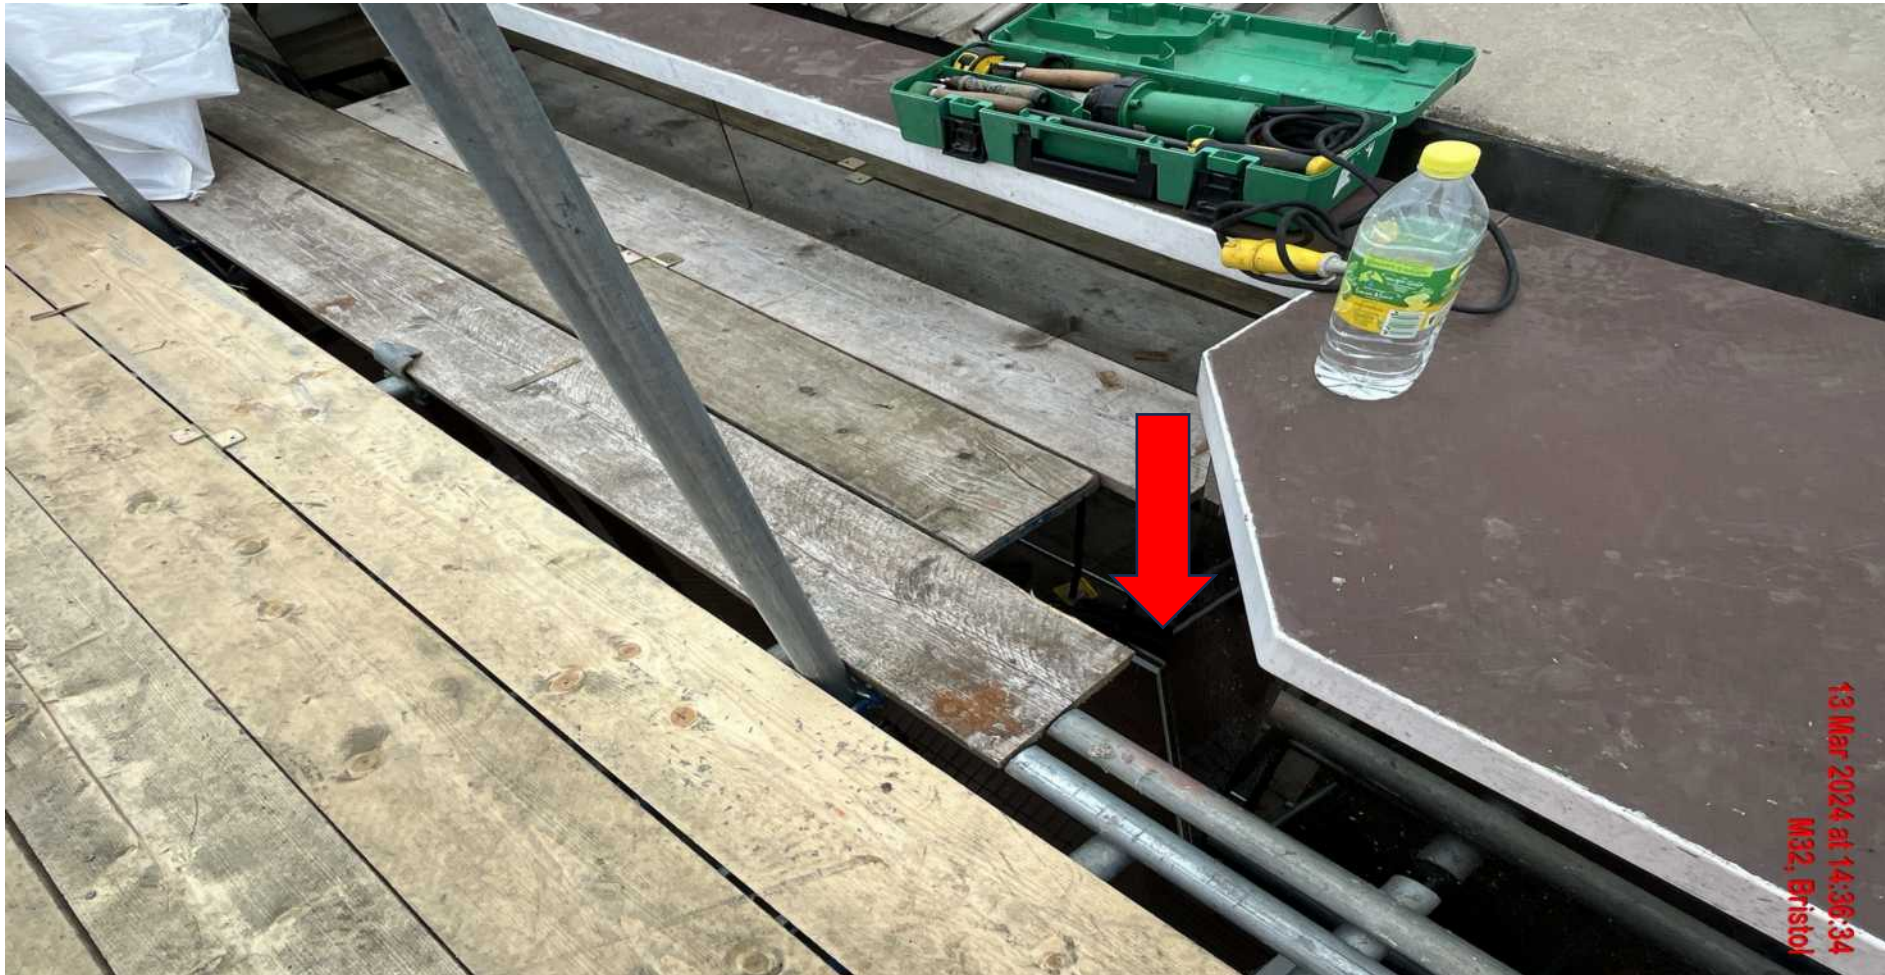
Sufficient Face Bracings and Ledger Bracings have been used on all Elevations of the Scaffold in order to meet requirements of TG20:21.

Void needs to be eliminated on Working Lift.
