Cymru Scaffold Inspections

Tesco, Eastgate Rd, Eastville, Bristol BS5 6XU

Wednesday 13th March 2024

INSPECTION OF: Site Scaffolds & Scaffold Management on Site

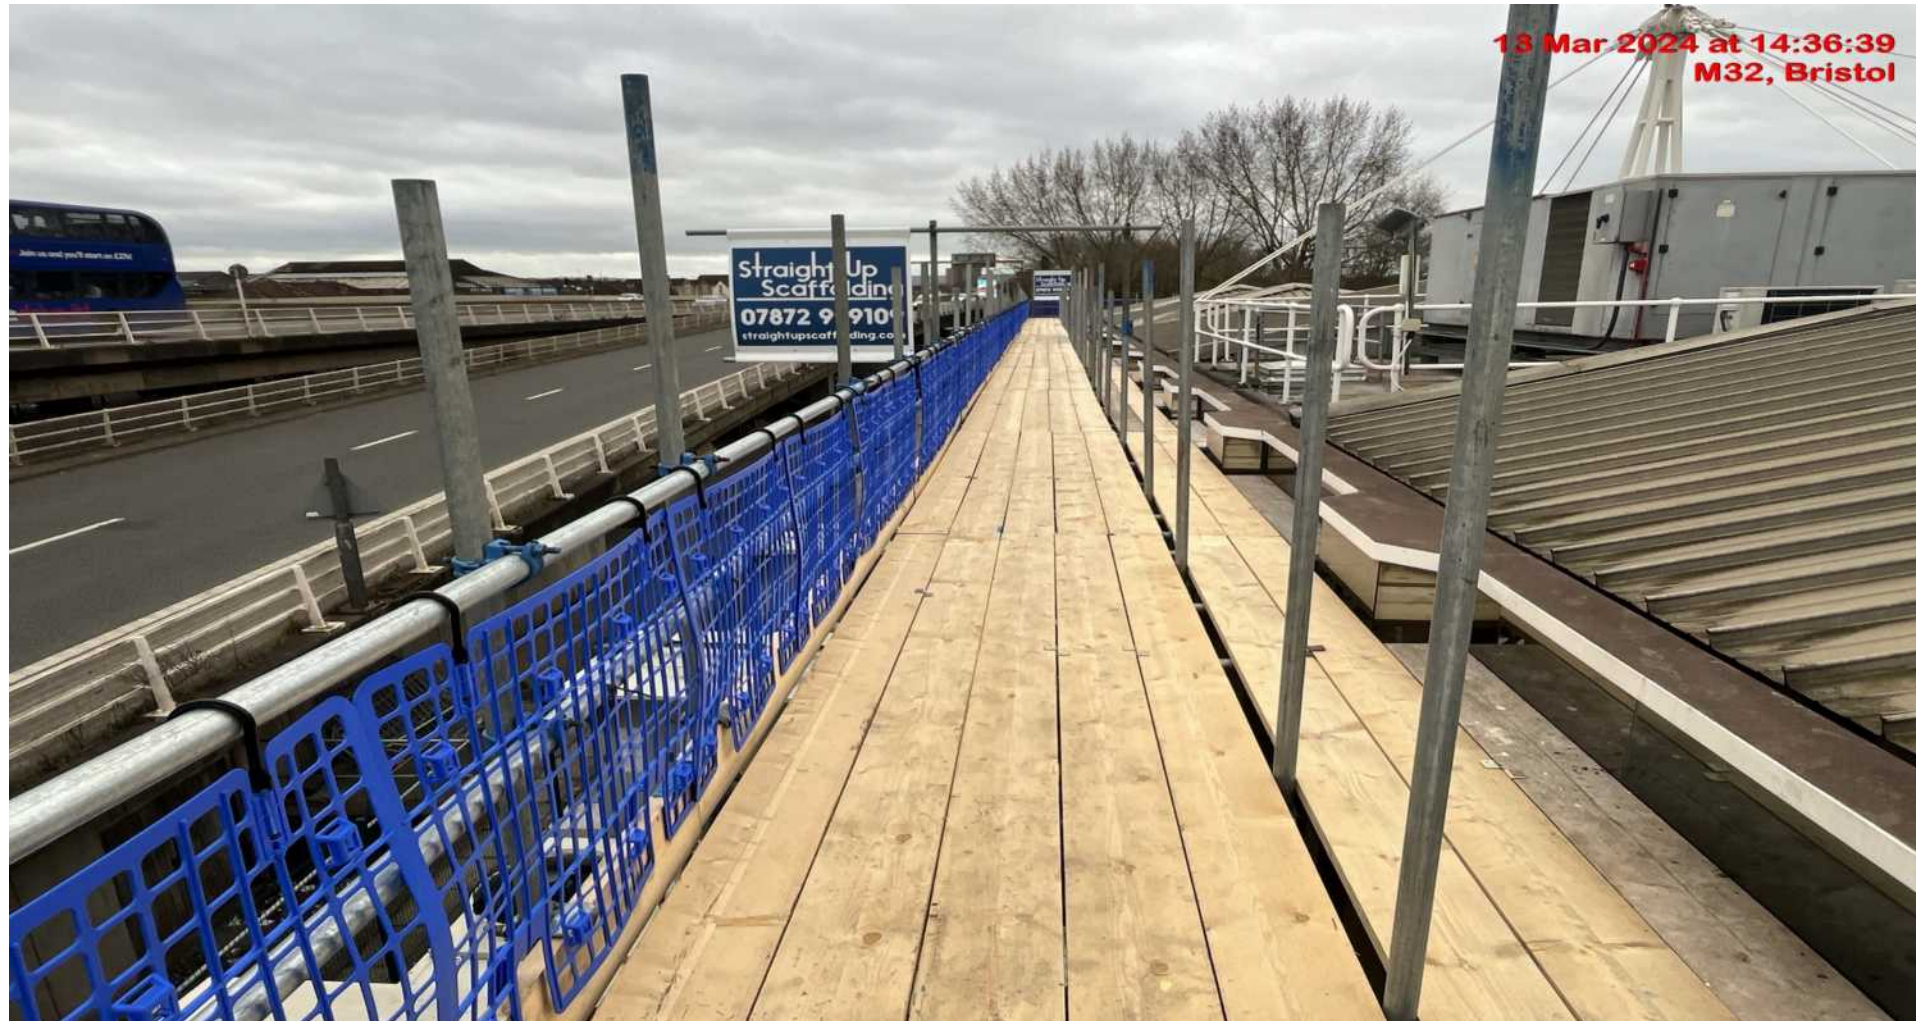
EAS 004

Notes: Scaffold was erected in order to meet requirements of TG20:21. Scaffold is Tied and Butted into Building.

Sufficient Face Bracings and Ledger Bracings have been used on all Elevations of the Scaffold in order to meet requirements of TG20:21.

Independent Access Scaffold, M32 Elevation

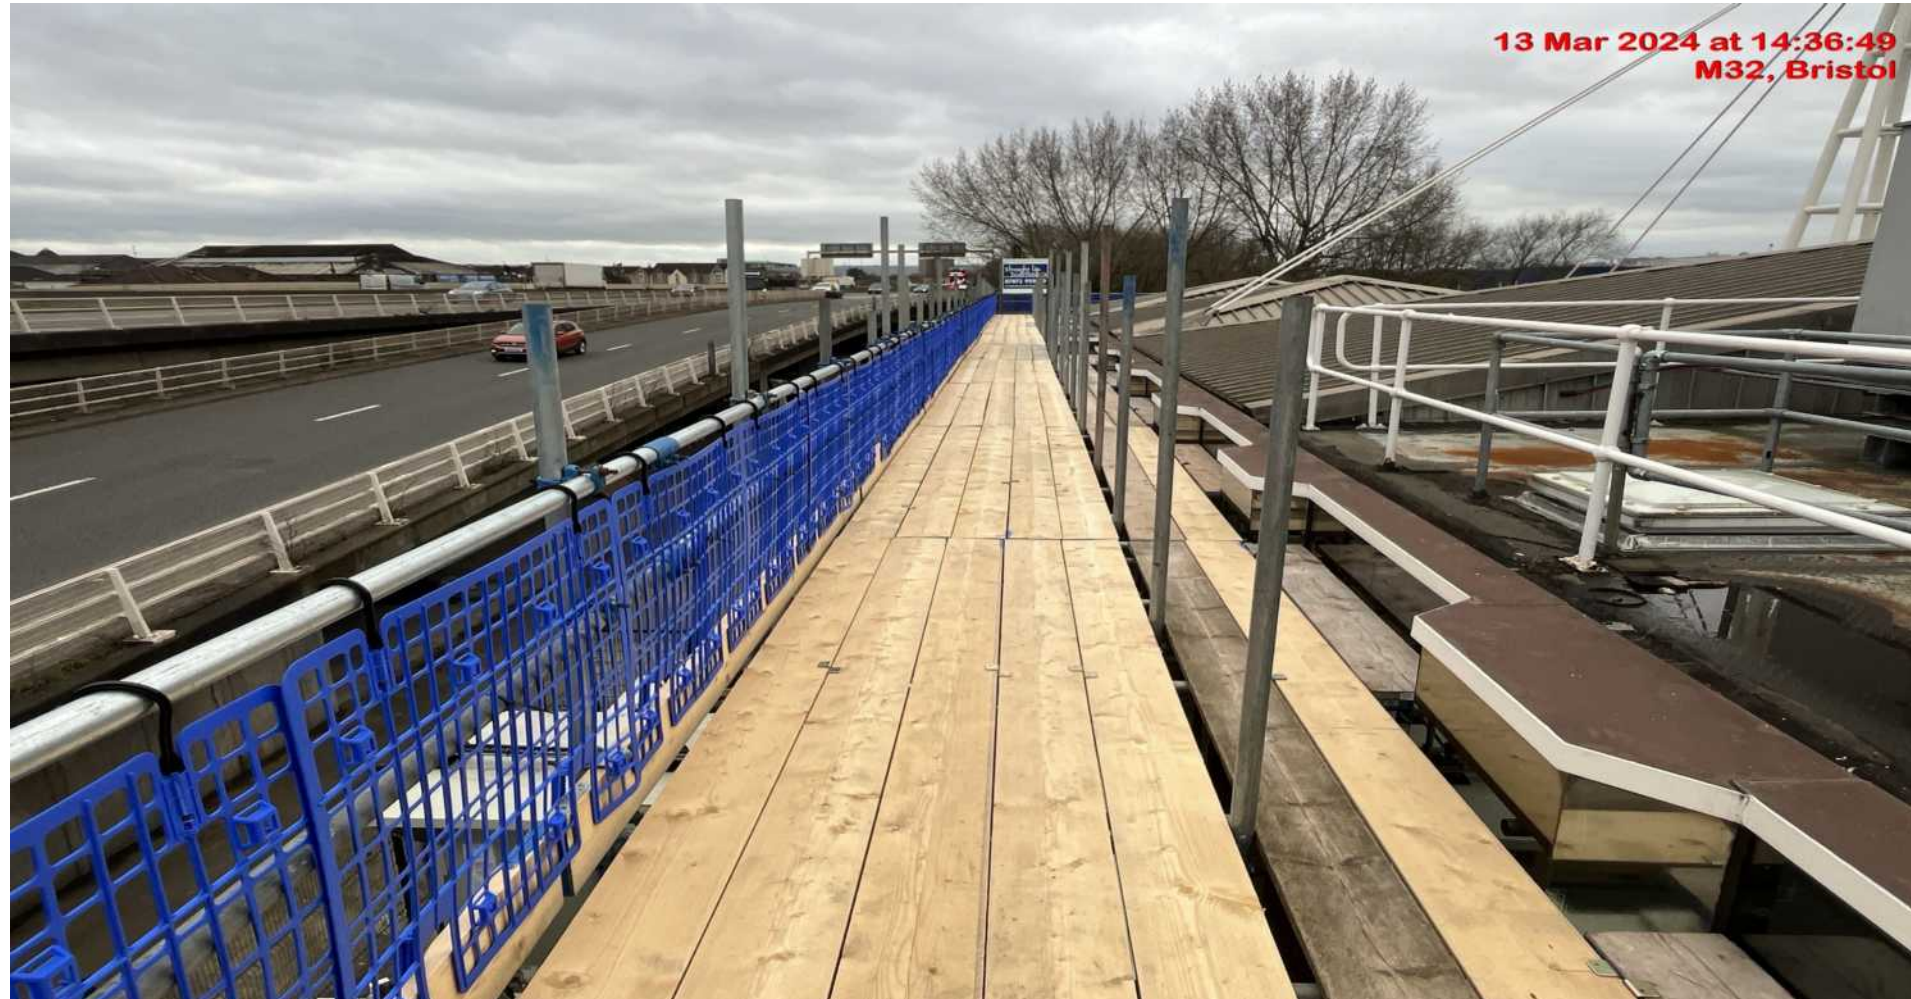
EAS 004

Notes: Scaffold was erected in order to meet requirements of TG20:21. Scaffold is Tied and Butted into Building.

Sufficient Face Bracings and Ledger Bracings have been used on all Elevations of the Scaffold in order to meet requirements of TG20:21.

Independent Access Scaffold, M32 Elevation

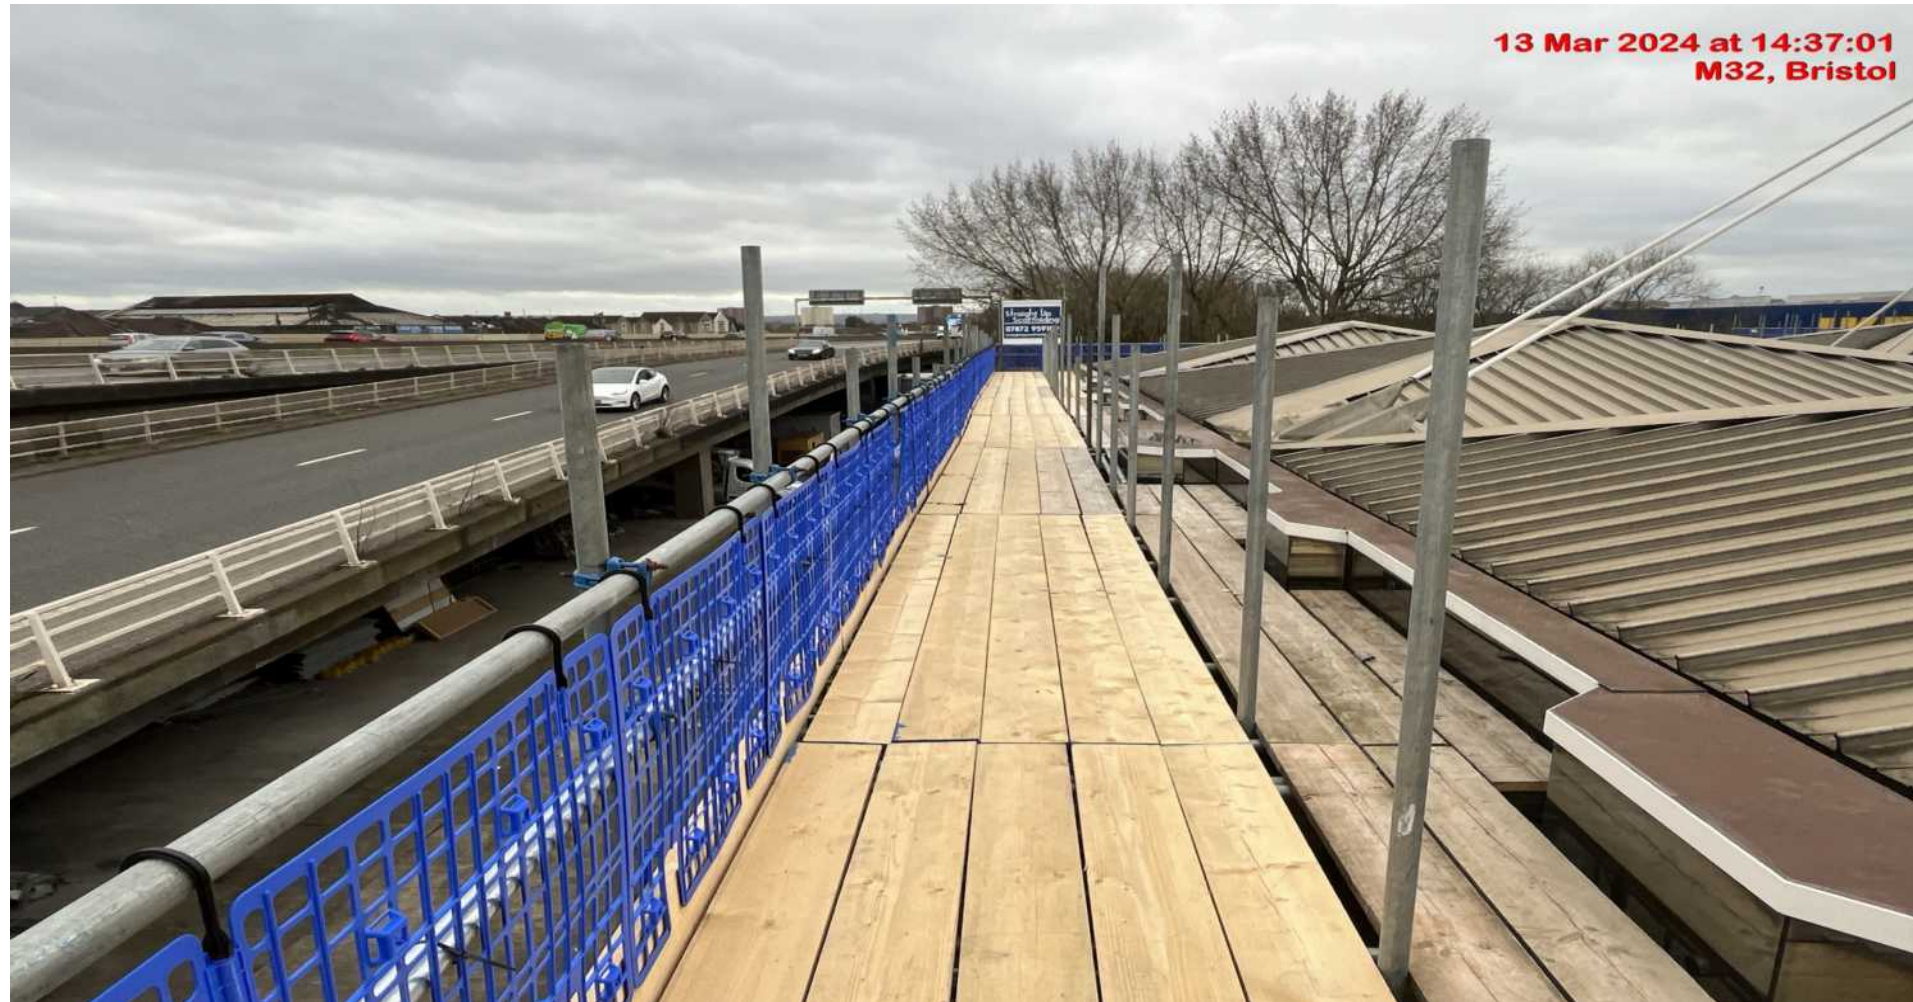
EAS 004

Notes: Scaffold was erected in order to meet requirements of TG20:21. Scaffold is Tied and Butted into Building.

Sufficient Face Bracings and Ledger Bracings have been used on all Elevations of the Scaffold in order to meet requirements of TG20:21.

Independent Access Scaffold, M32 Elevation

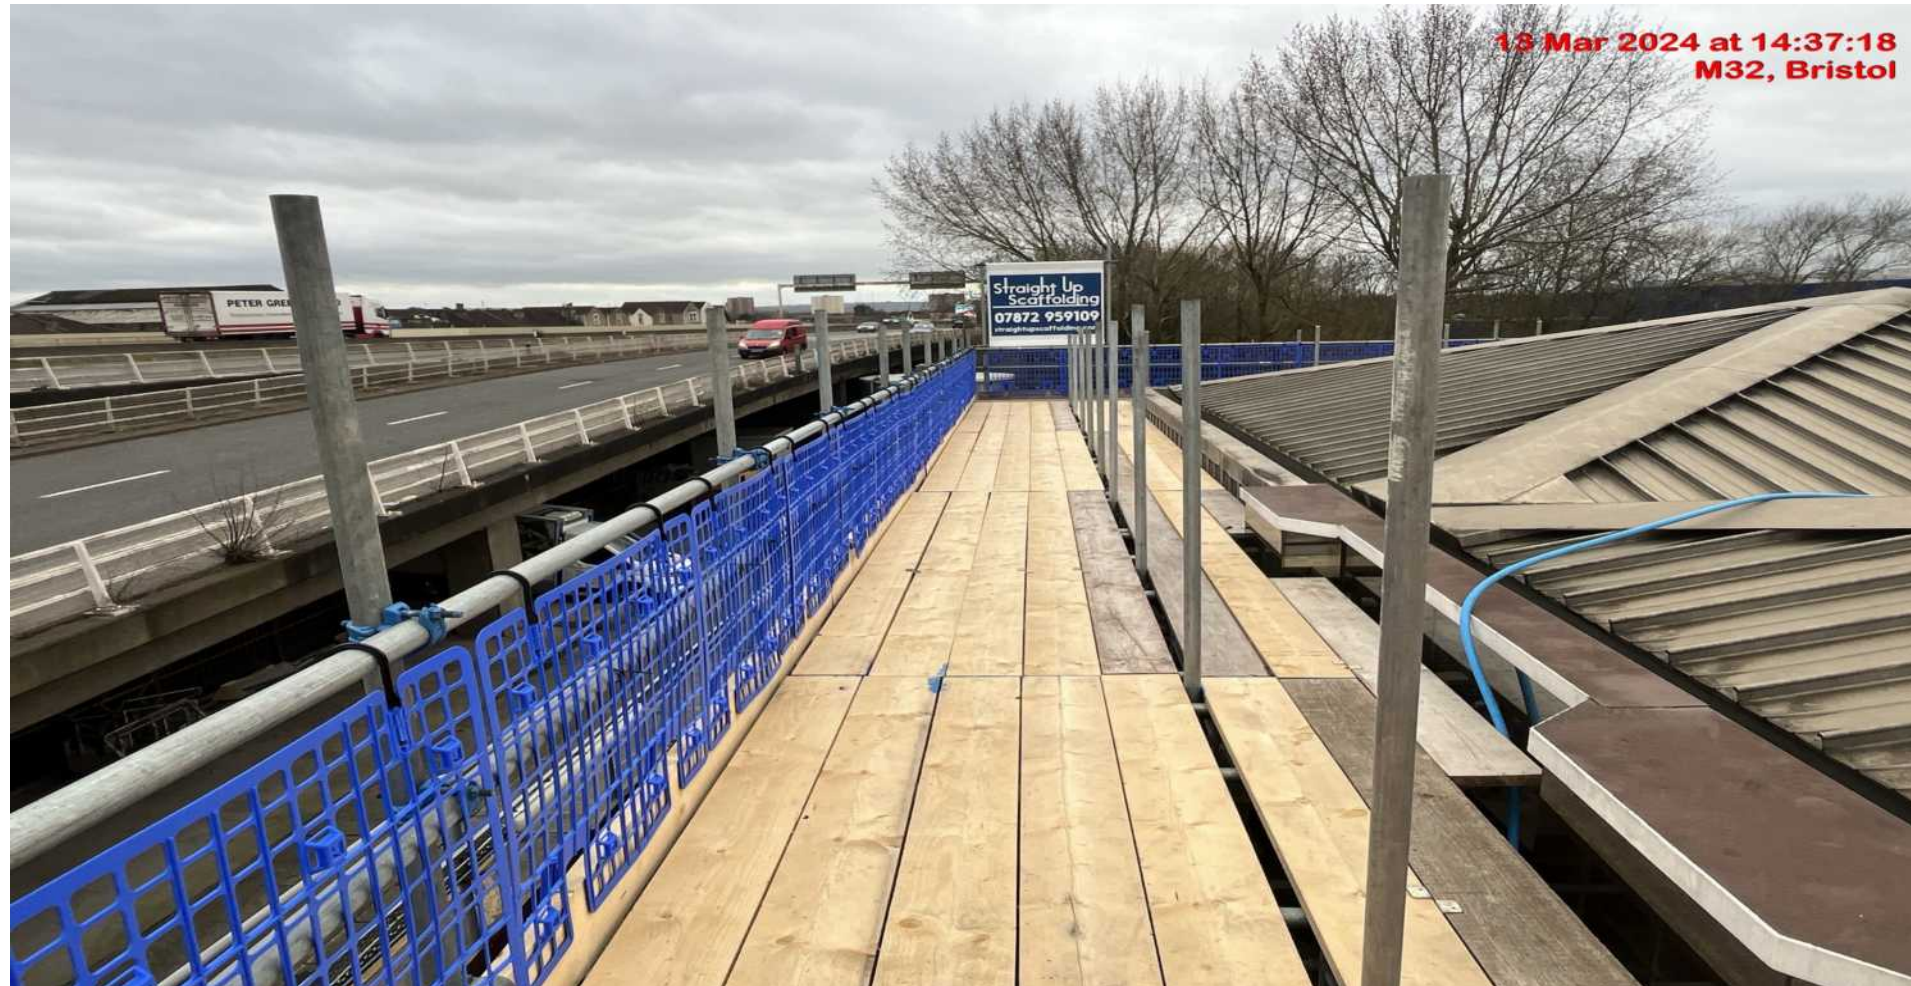
EAS 004

Notes: Scaffold was erected in order to meet requirements of TG20:21. Scaffold is Tied and Butted into Building.

Sufficient Face Bracings and Ledger Bracings have been used on all Elevations of the Scaffold in order to meet requirements of TG20:21.

Independent Access Scaffold, M32 Elevation

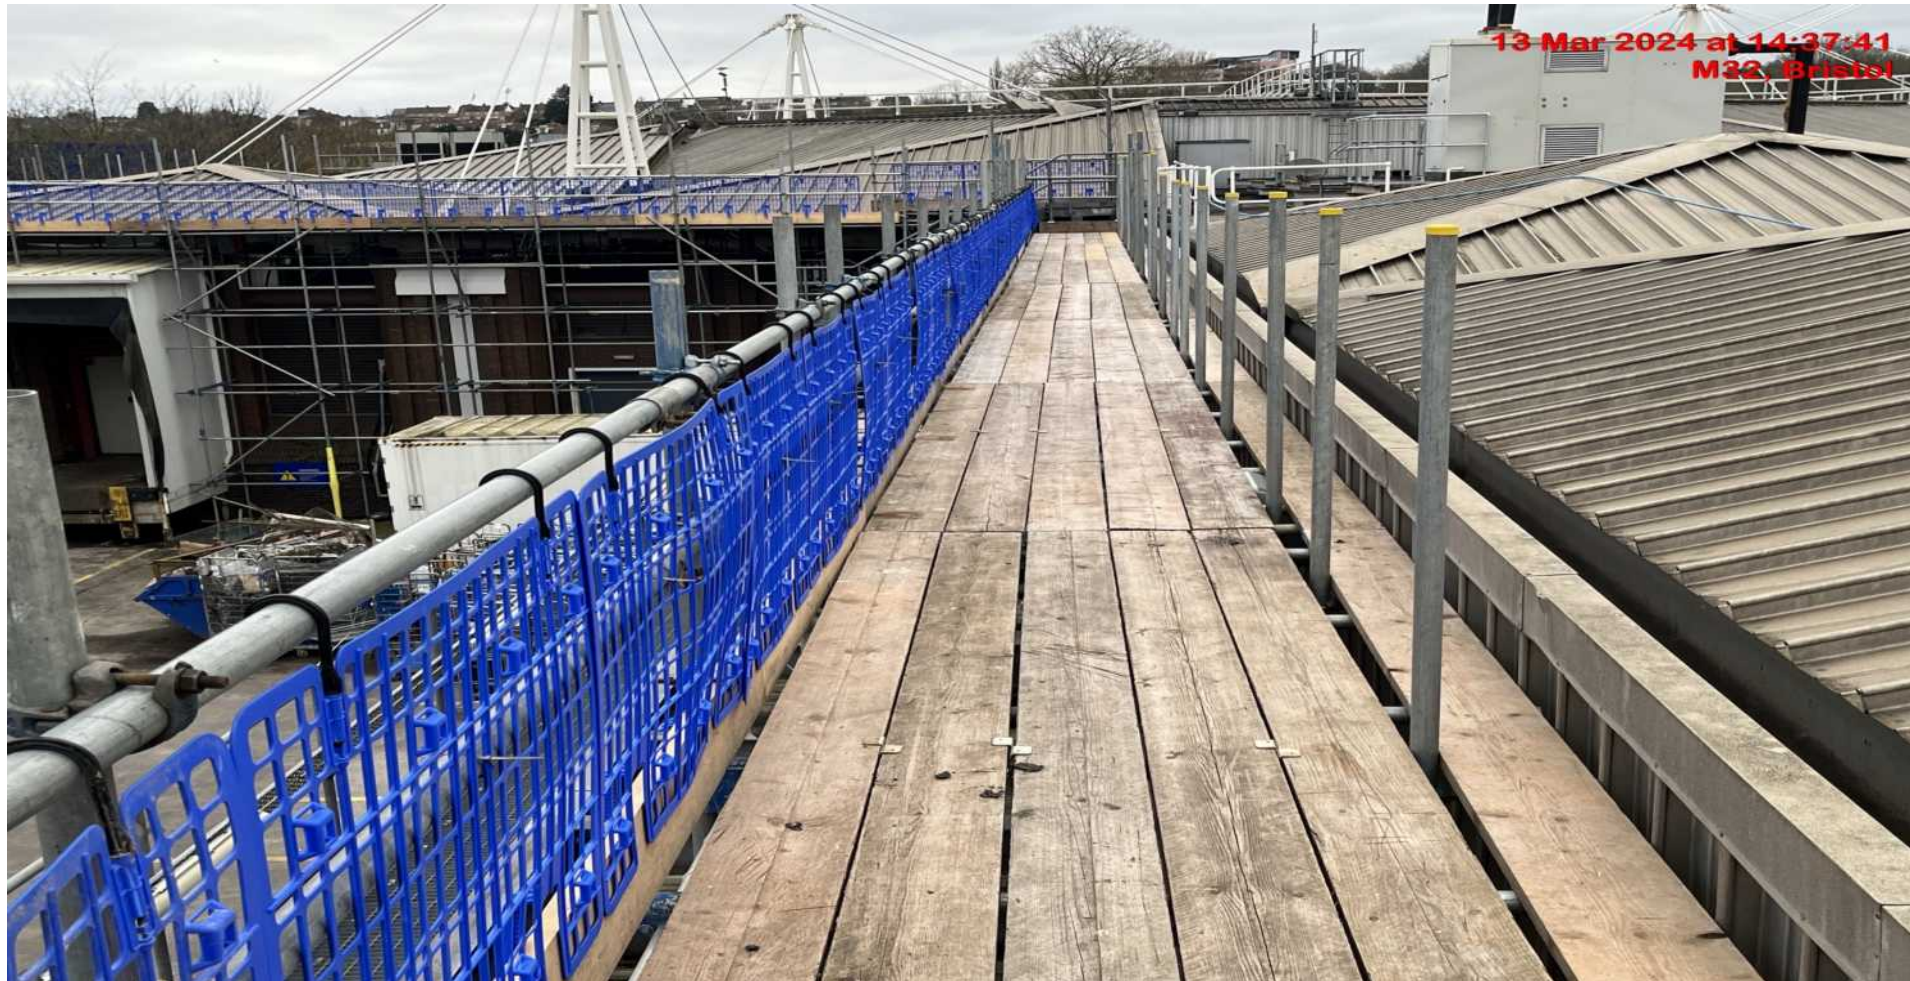
EAS 004

Notes: Scaffold was erected in order to meet requirements of TG20:21.

Sufficient Face Bracings and Ledger Bracings have been used on all Elevations of the Scaffold in order to meet requirements of TG20:21.

Independent Access Scaffold, M32 Elevation

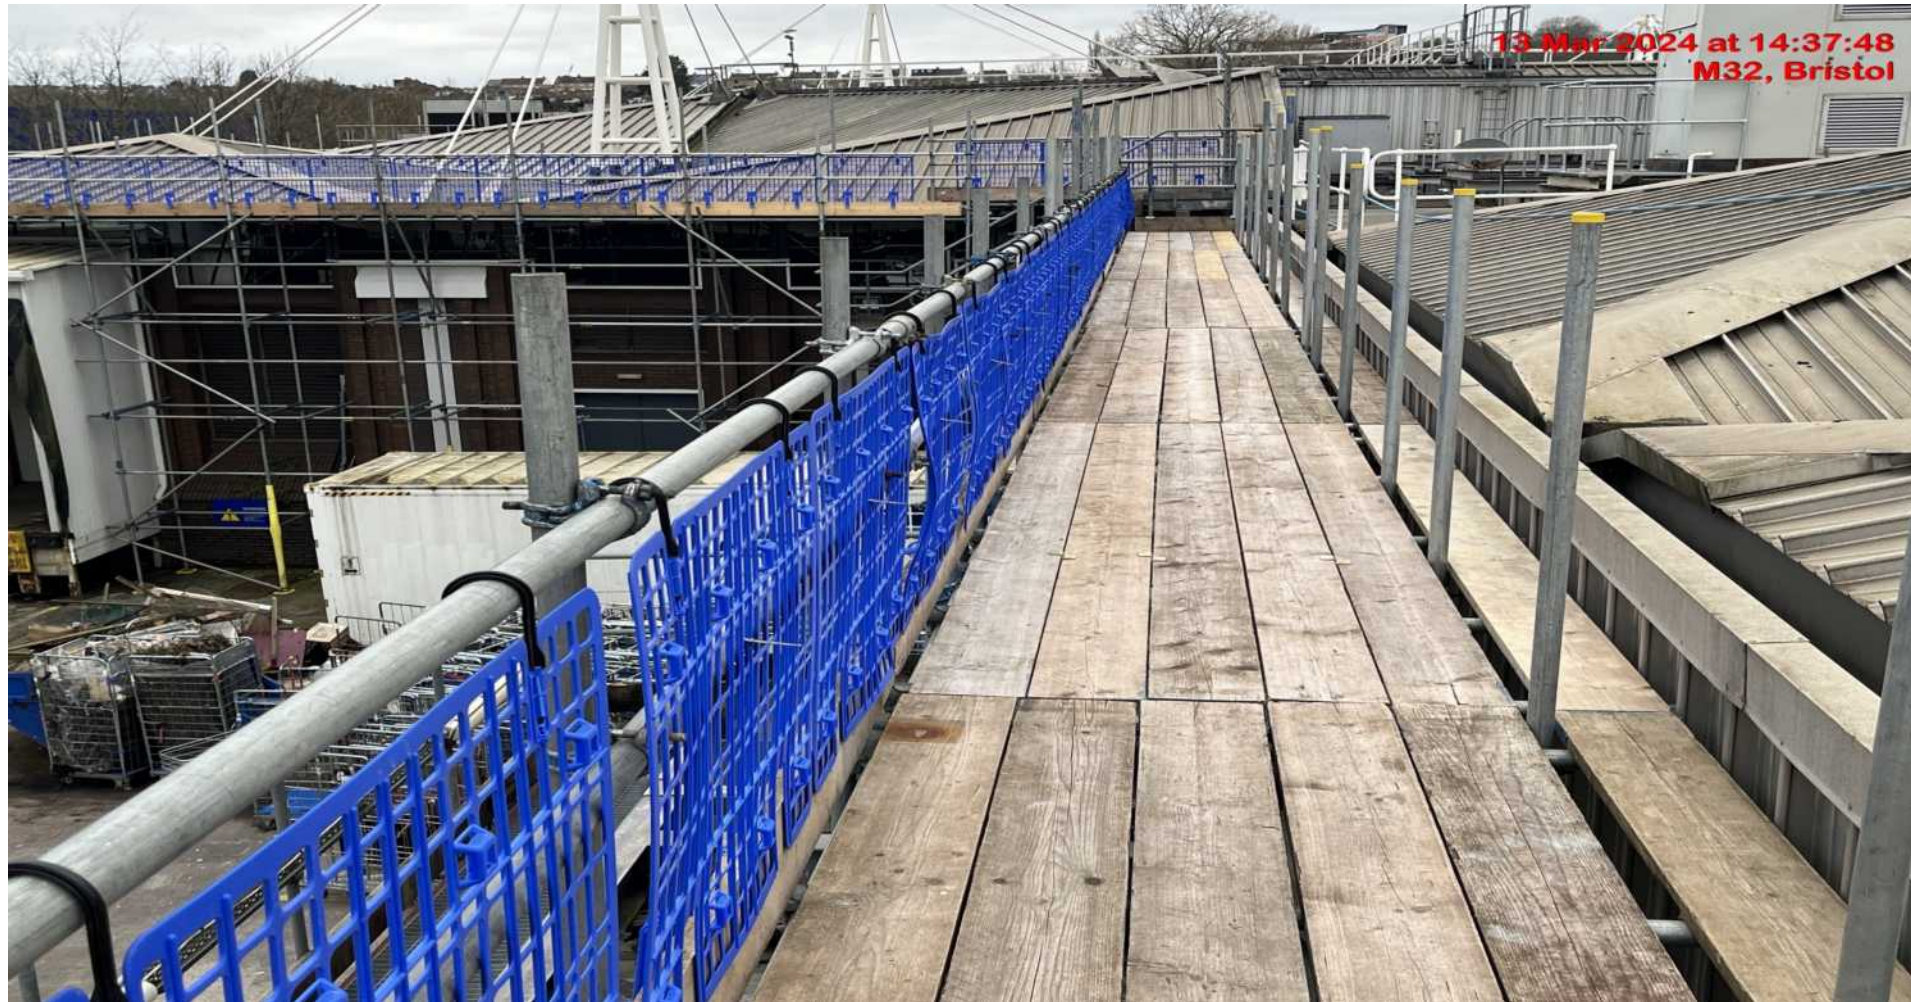
EAS 004

Notes: Scaffold was erected in order to meet requirements of TG20:21.

Sufficient Face Bracings and Ledger Bracings have been used on all Elevations of the Scaffold in order to meet requirements of TG20:21

Independent Access Scaffold, M32 Elevation

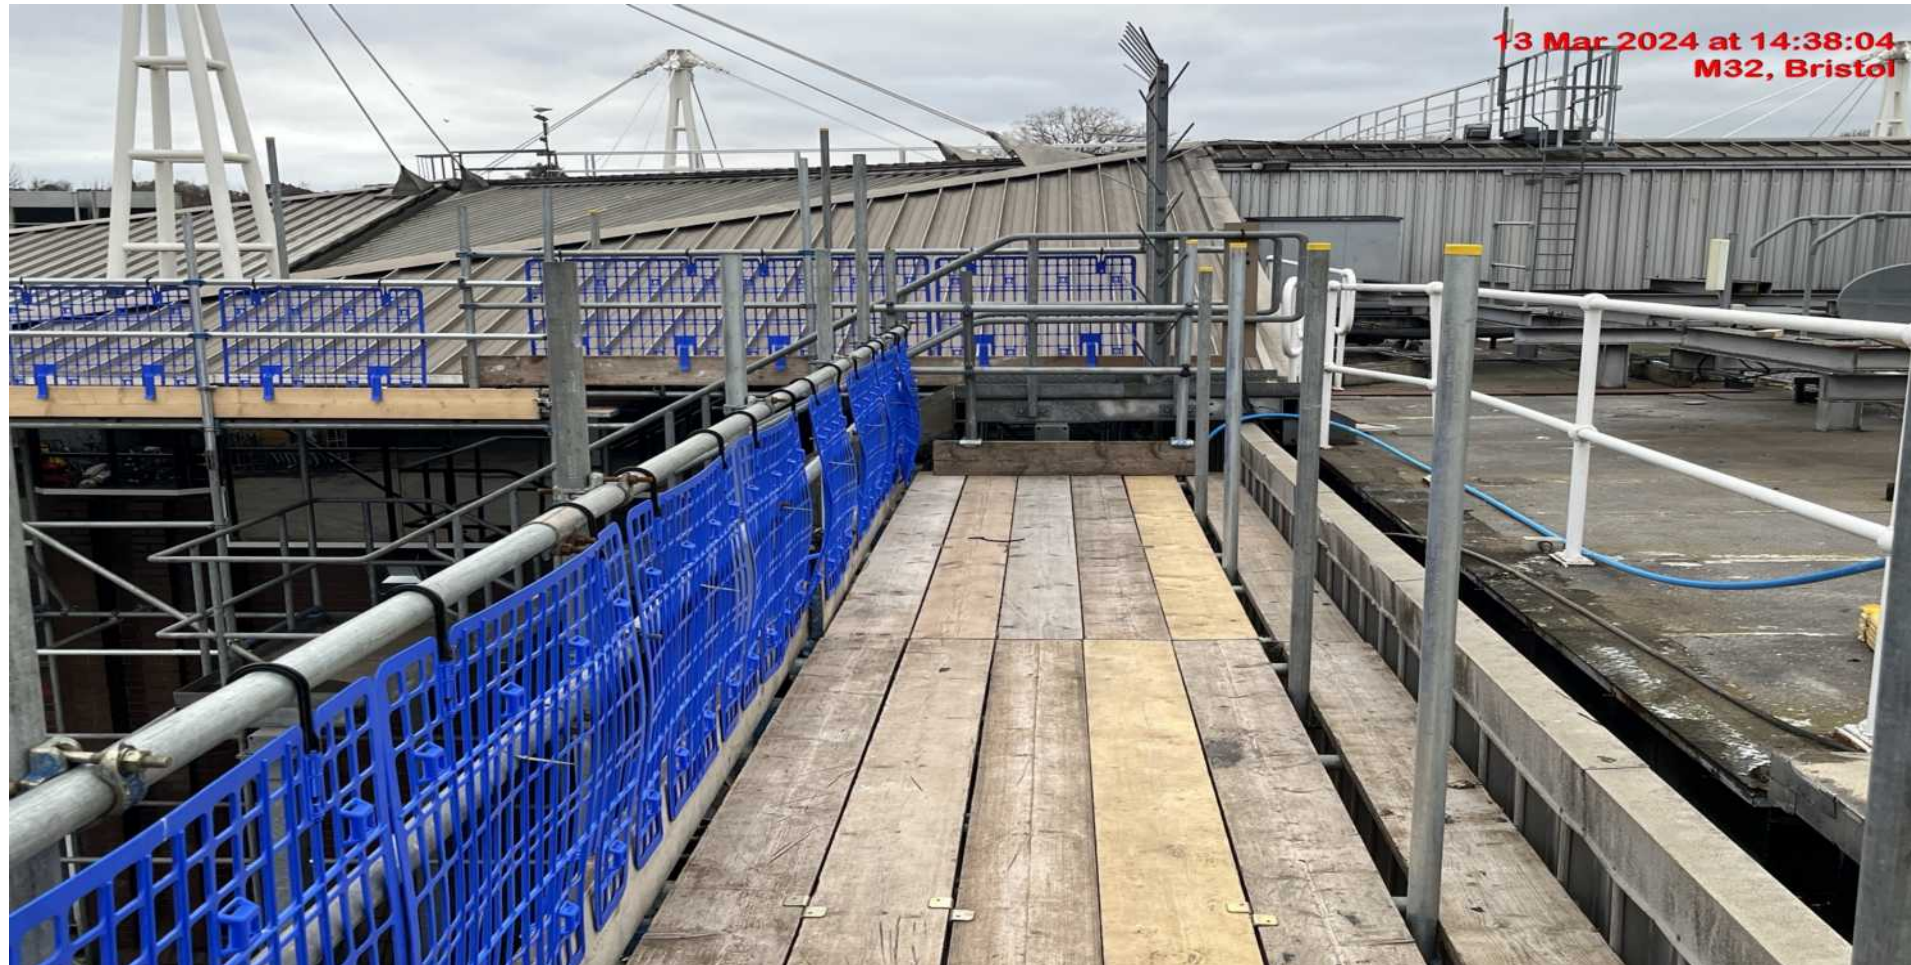
EAS 005

Notes: Scaffold was erected in order to meet requirements of TG20:21.

Sufficient Face Bracings, Ledger Bracings and Brickguards have been used on all Elevations of the Scaffold in order to meet requirements of TG20:21.

Haki Staircase at M32 Elevation of Building.

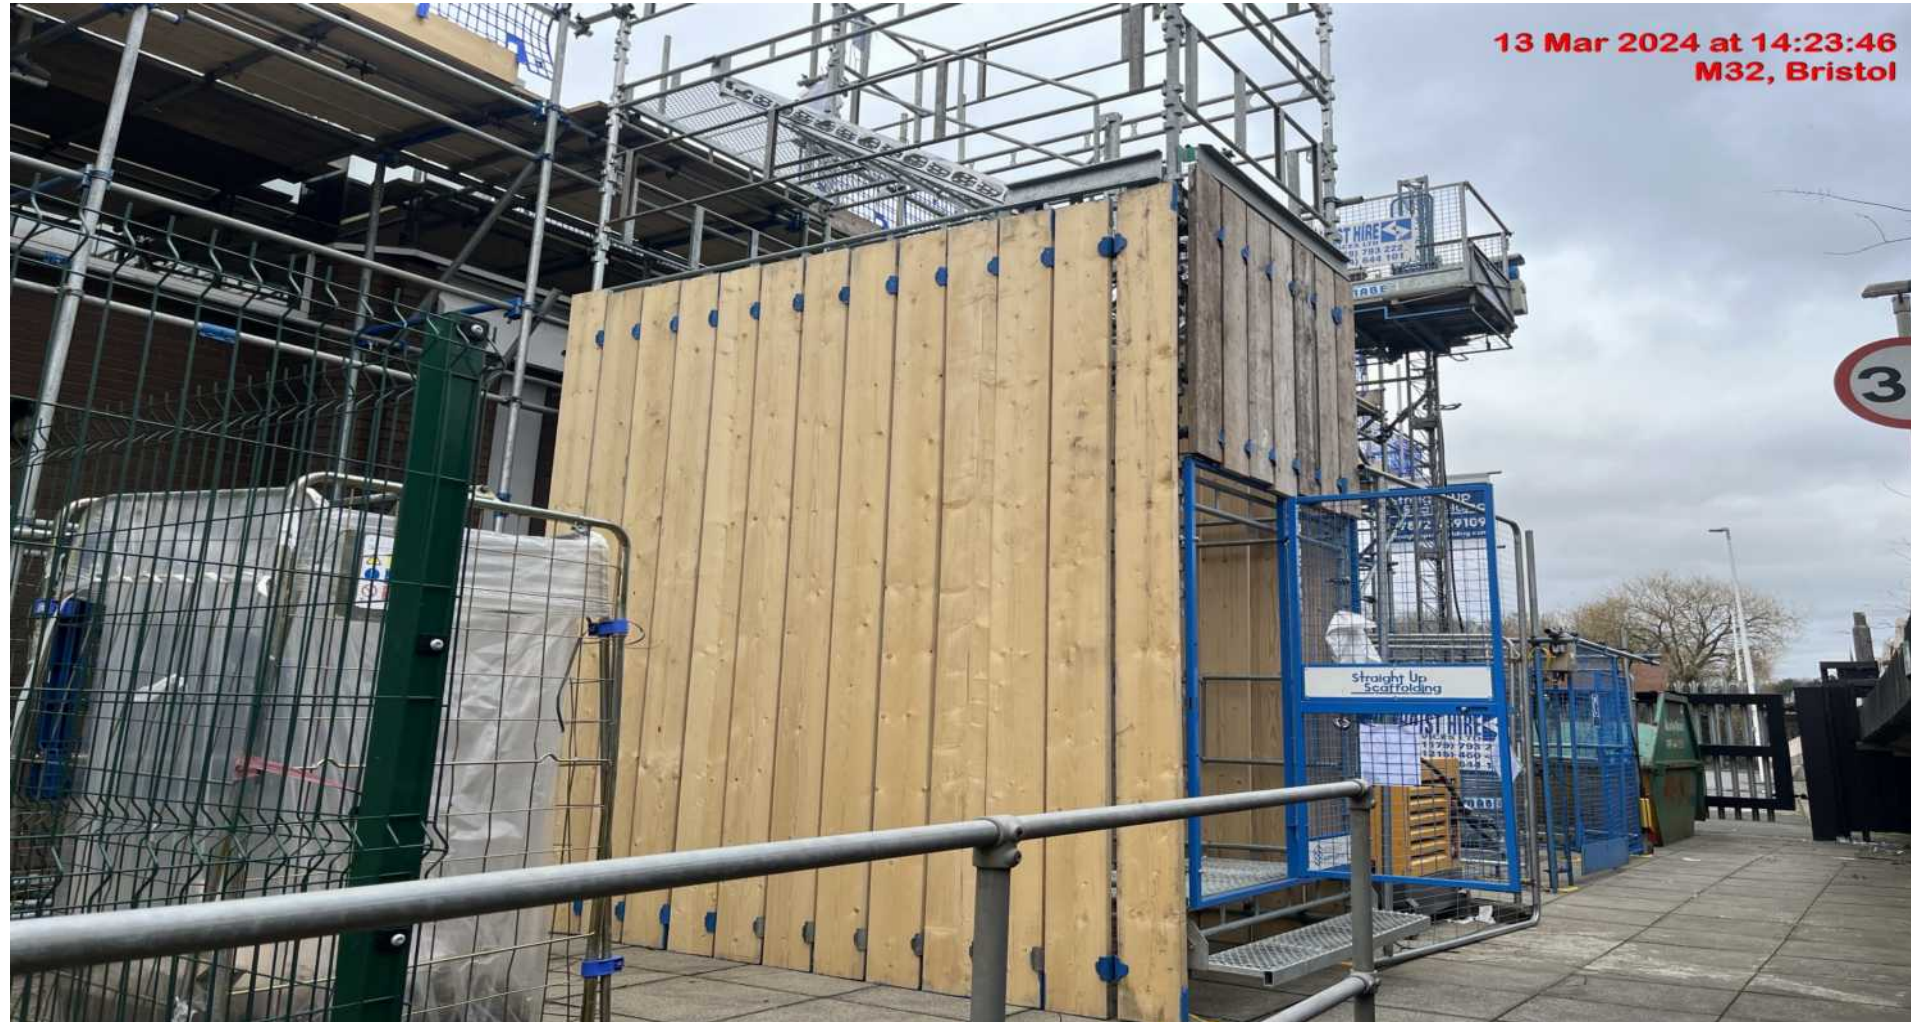
EAS 005

Status of Scaffold: Passed with observations

Notes: Handover Certificate needs to be in place for the Haki Staircase, Haki Staircase is free of Defect and Damage.

Haki Staircase at M32 Elevation of Building.

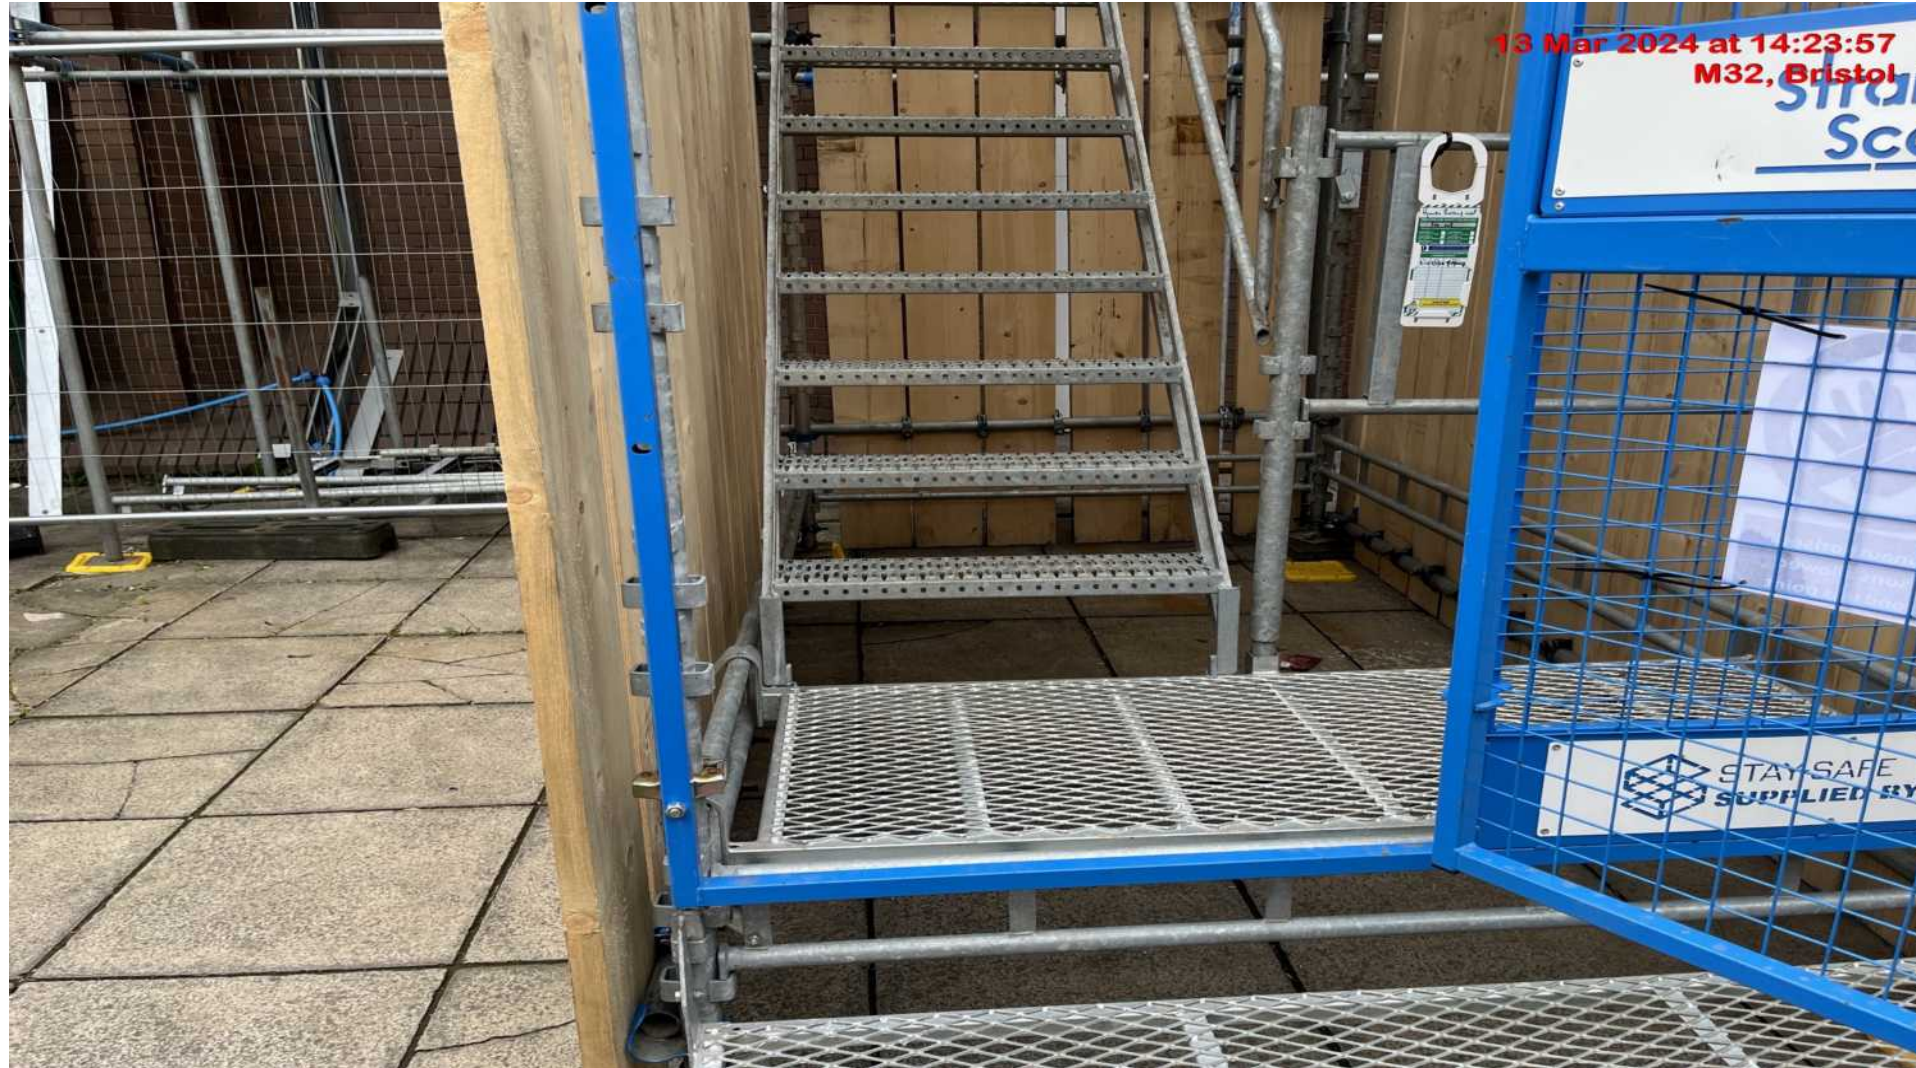
EAS 005

Status of Scaffold: Passed with observations

Notes: Handover Certificate needs to be in place for the Haki Staircase, Haki Staircase is free of Defect and Damage.

Haki Staircase at M32 Elevation of Building.

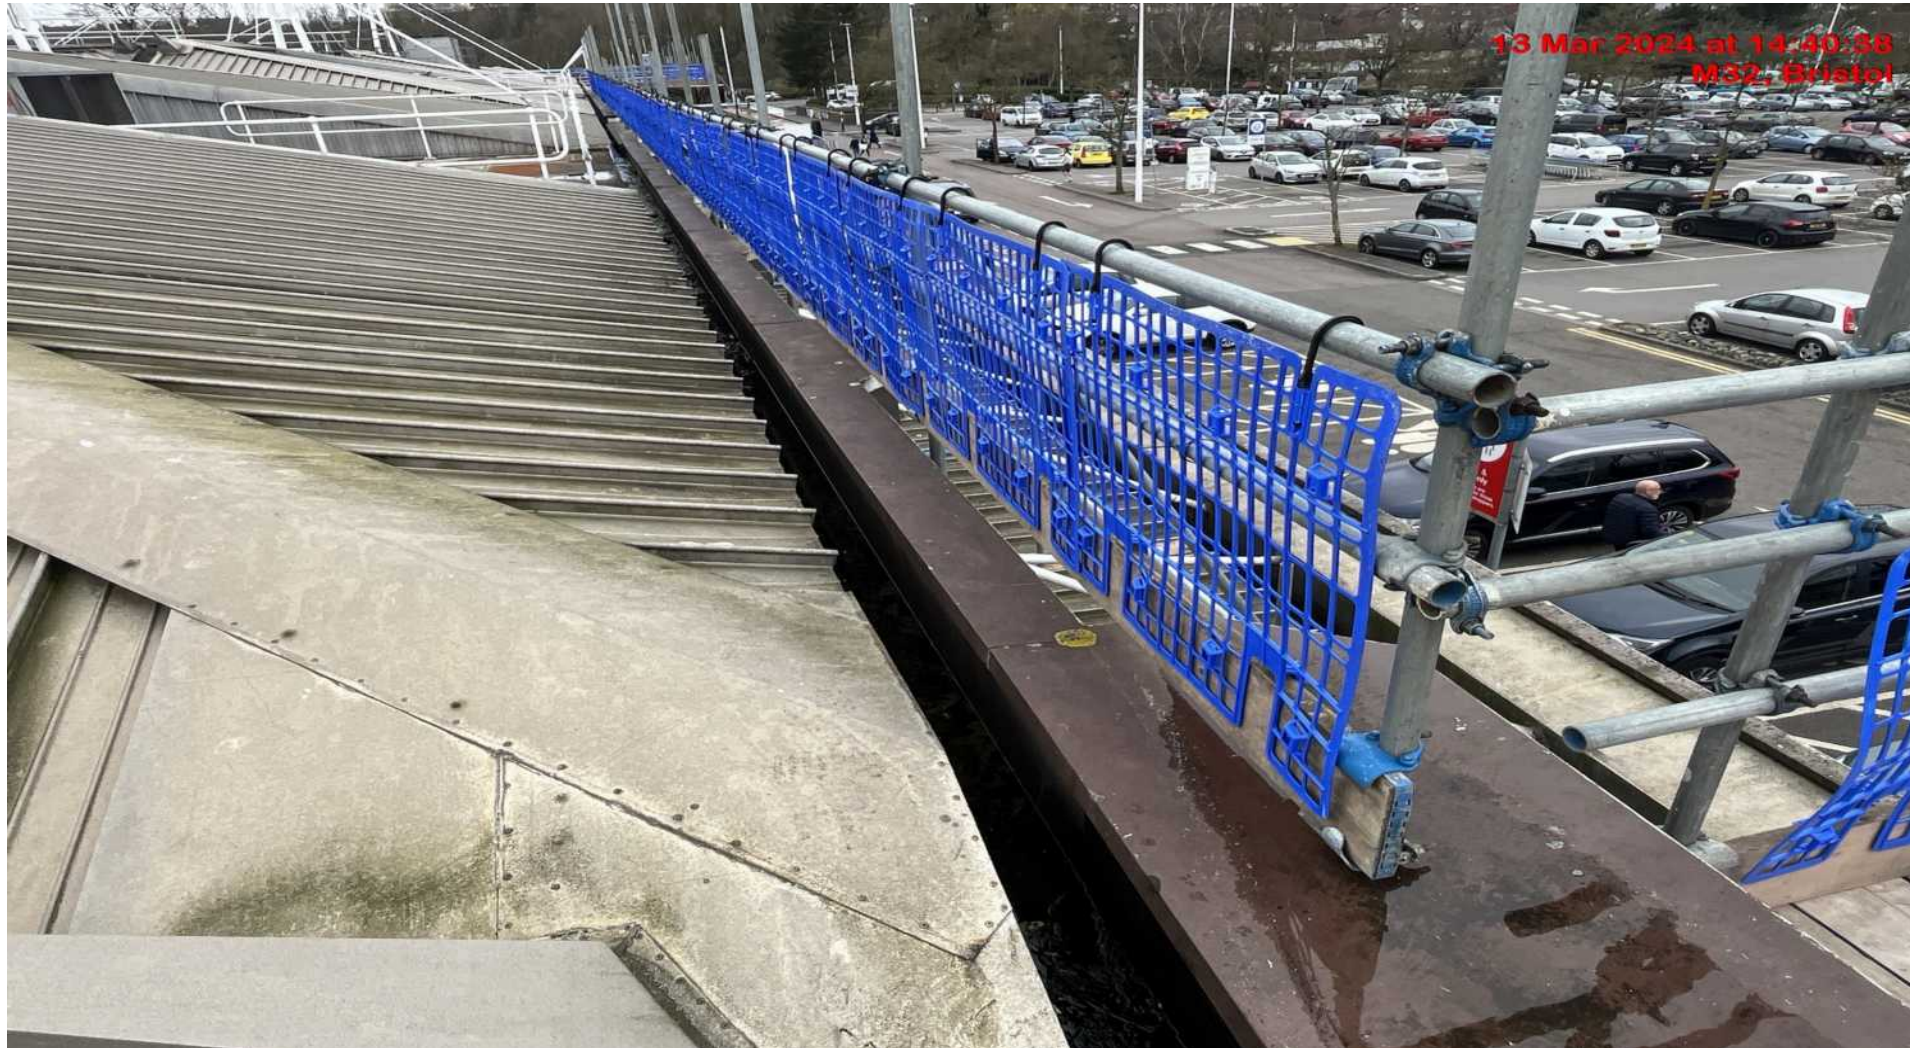
EAS 006

Notes: **No Handover Certificate in place for Edge Protection Handrails at time of the Scaffold Inspections.**

Edge Protection Handrails erected to meet requirements of TG20:21 and with sufficient Brickguards to prevent objects falling below.

Edge Protection Handrails above Store Entrance.

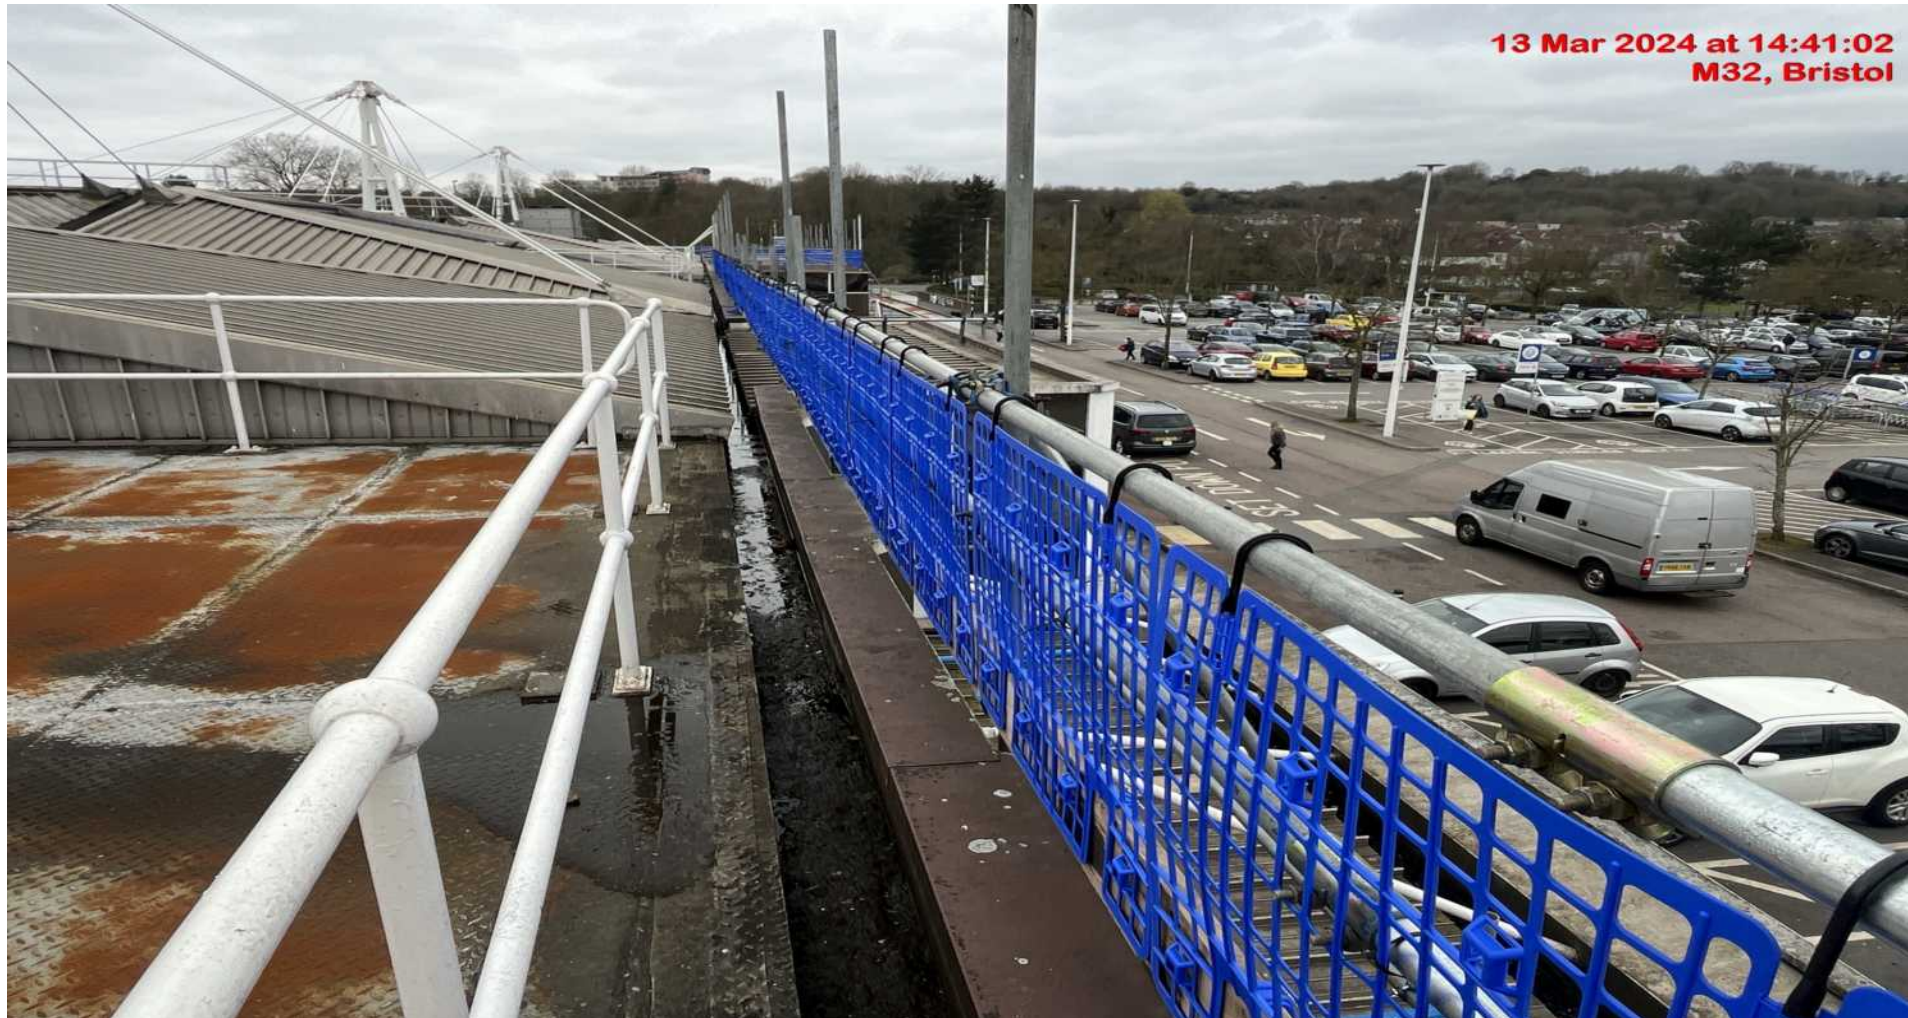
EAS 006

Notes: **No Handover Certificate in place for Edge Protection Handrails at time of the Scaffold Inspections.**

Edge Protection Handrails erected to meet requirements of TG20:21 and with sufficient Brickguards to prevent objects falling below.

Edge Protection Handrails above Store Entrance.
