Cymru Scaffold Inspections

Tesco, Eastgate Rd, Eastville, Bristol BS5 6XU

Wednesday 13th March 2024

INSPECTION OF: Site Scaffolds & Scaffold Management on Site

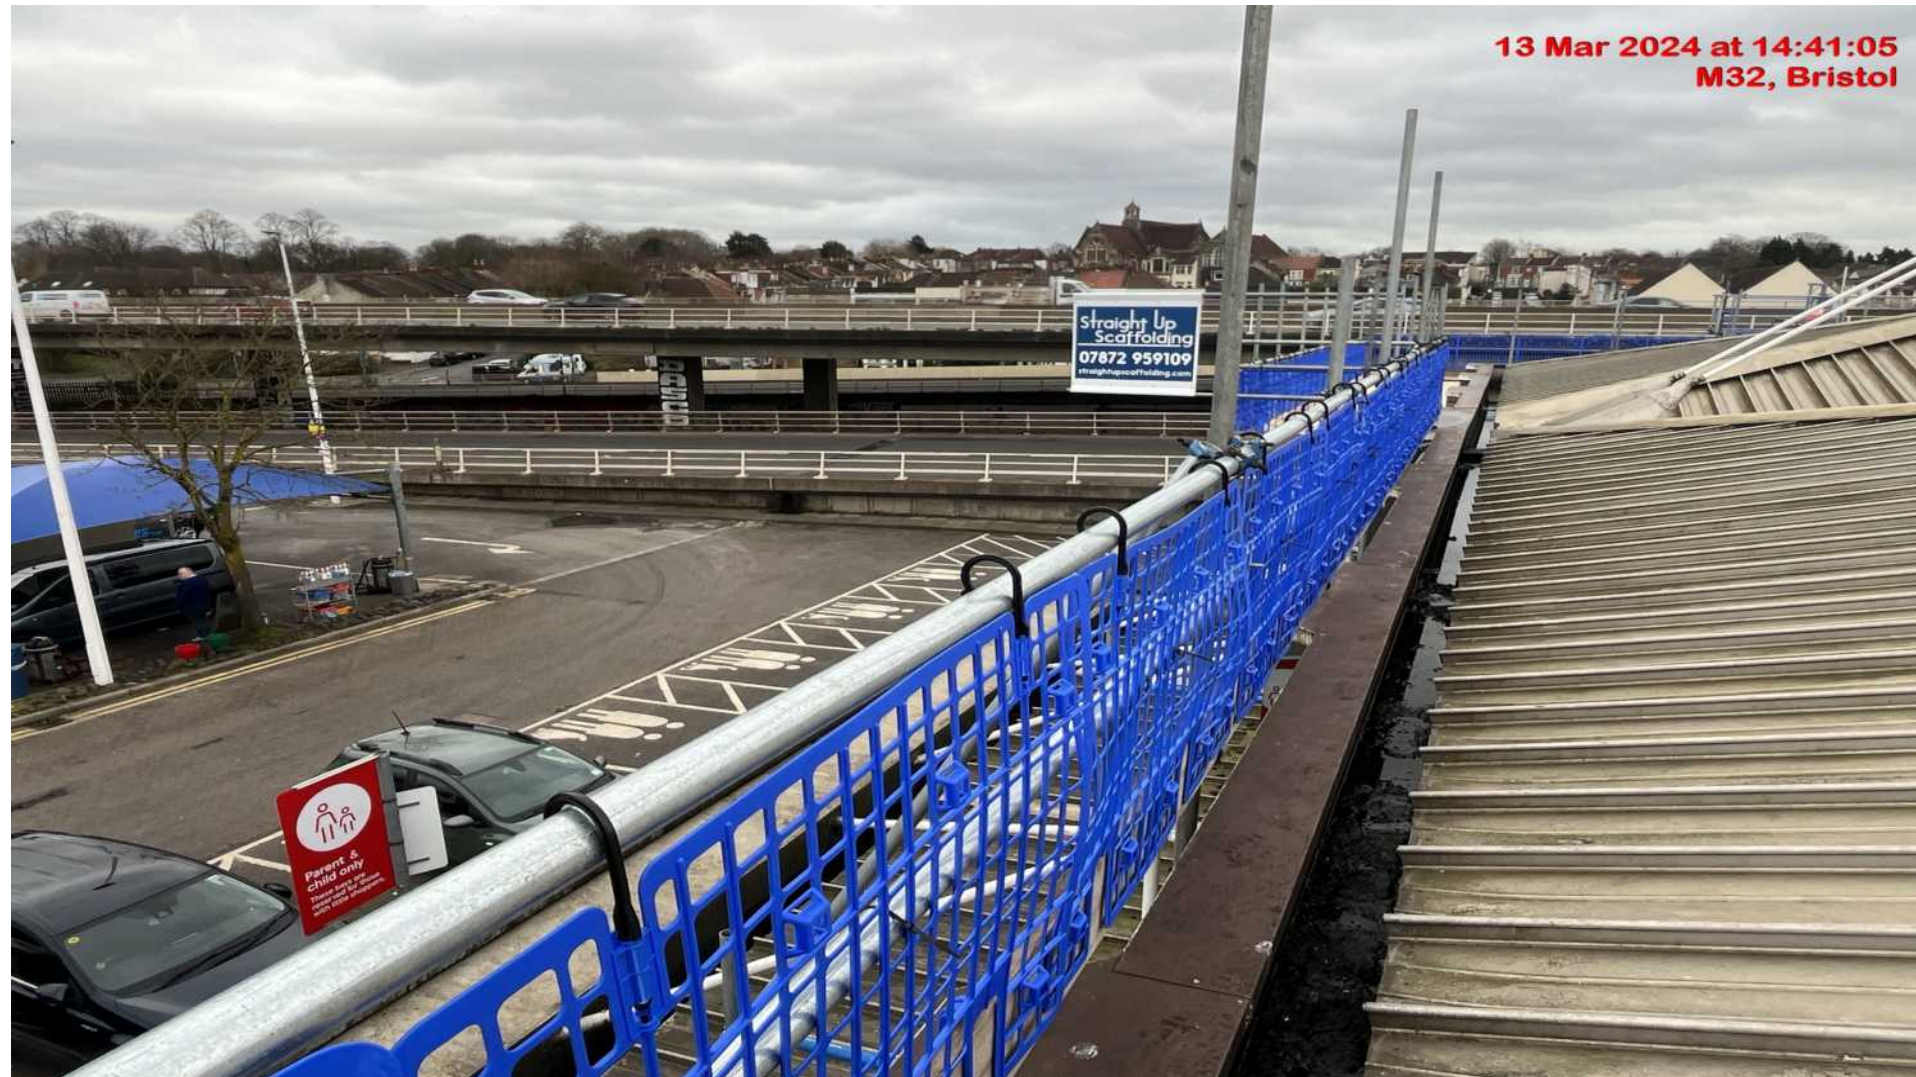
EAS 006

Notes: **No Handover Certificate in place for Edge Protection Handrails at time of the Scaffold Inspections.**

Edge Protection Handrails erected to meet requirements of TG20:21 and with sufficient Brickguards to prevent objects falling below.

Edge Protection Handrails above Store Entrance.

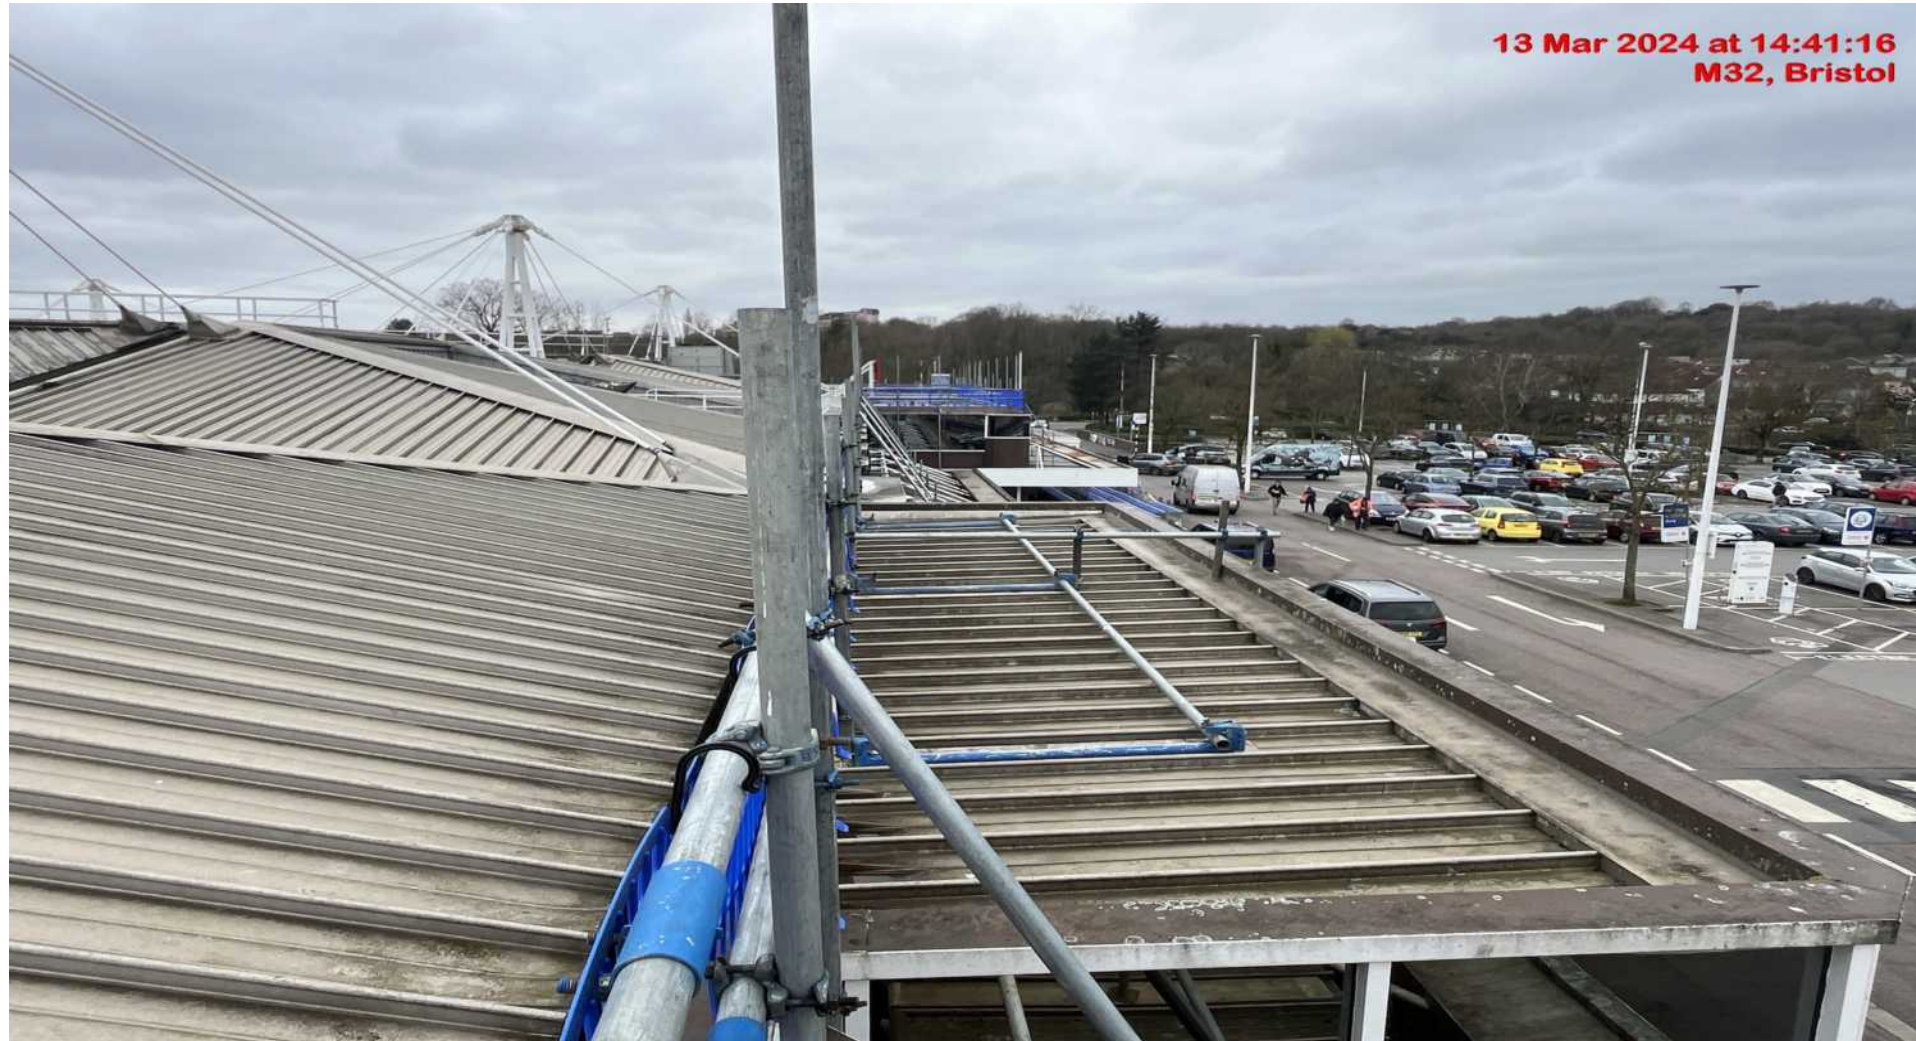
EAS 006

Notes: No Handover Certificate in place for Edge Protection Handrails at time of the Scaffold Inspections.

Edge Protection Handrails erected to meet requirements of TG20:21 and with sufficient Brickguards to prevent objects falling below.

Edge Protection Handrails above Store Entrance.

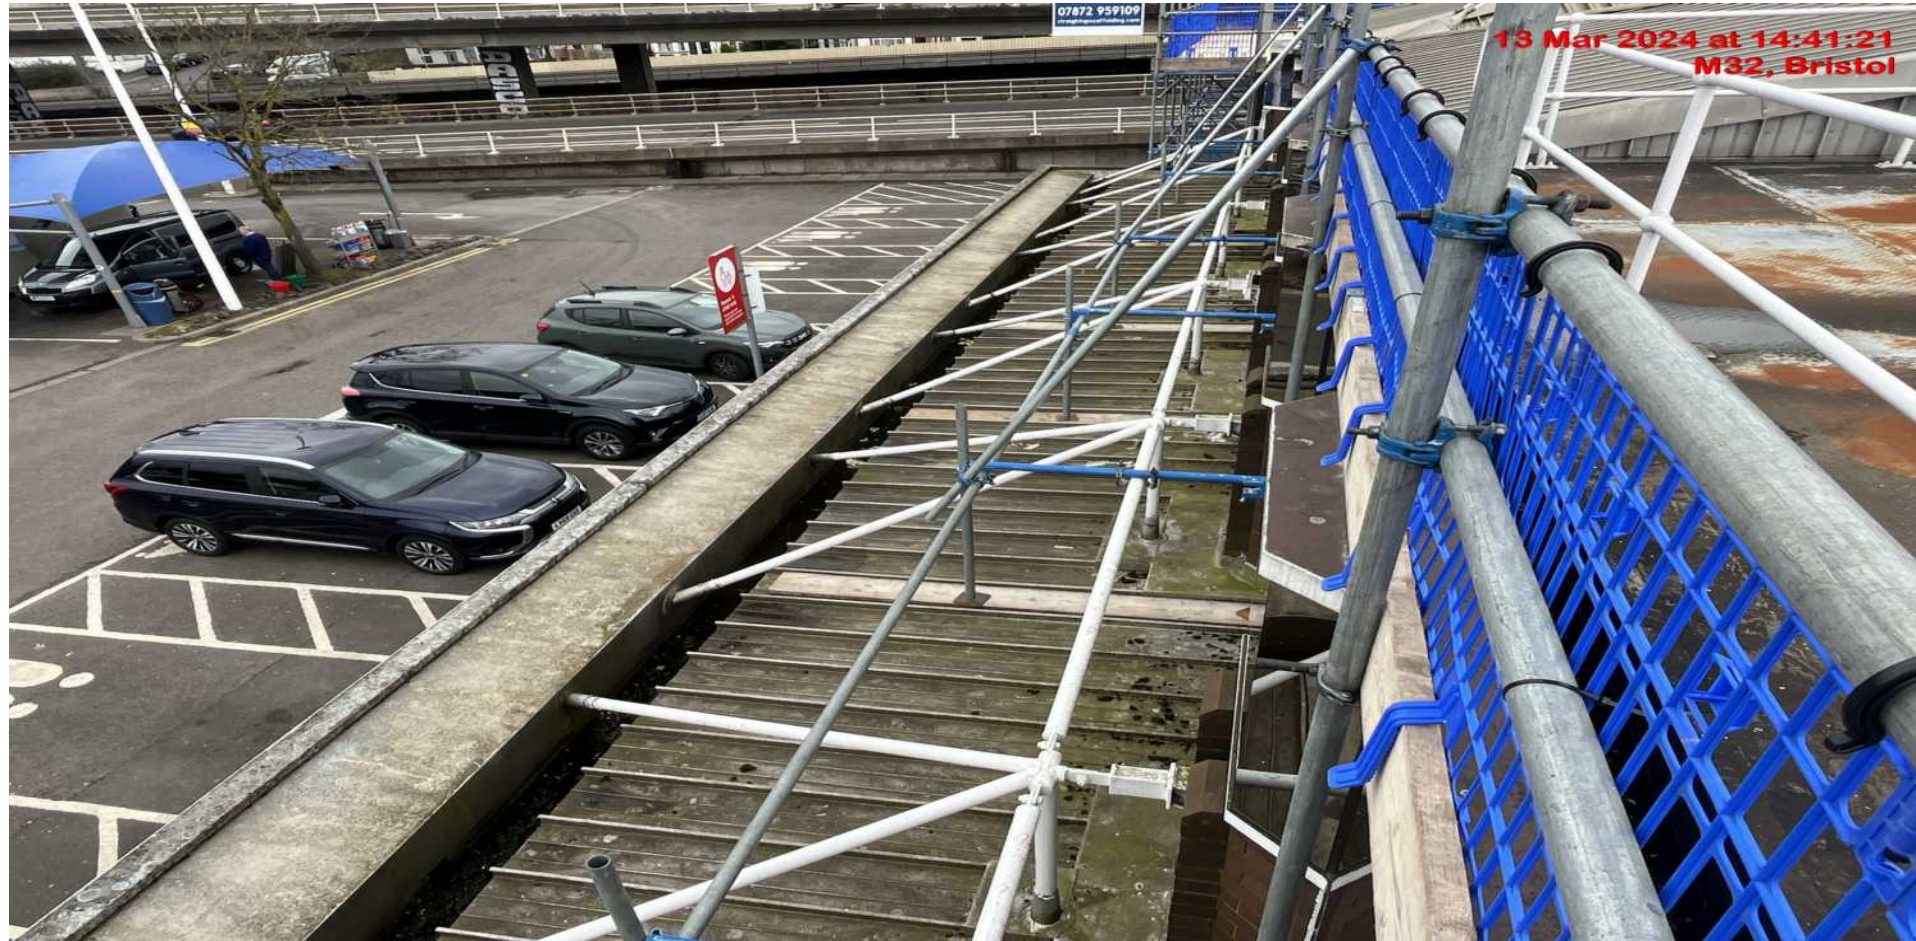
EAS 006

Notes: **No Handover Certificate in place for Edge Protection Handrails at time of the Scaffold Inspections.**

Edge Protection Handrails erected to meet requirements of TG20:21 and with sufficient Brickguards to prevent objects falling below.

Edge Protection Handrails above Store Entrance.

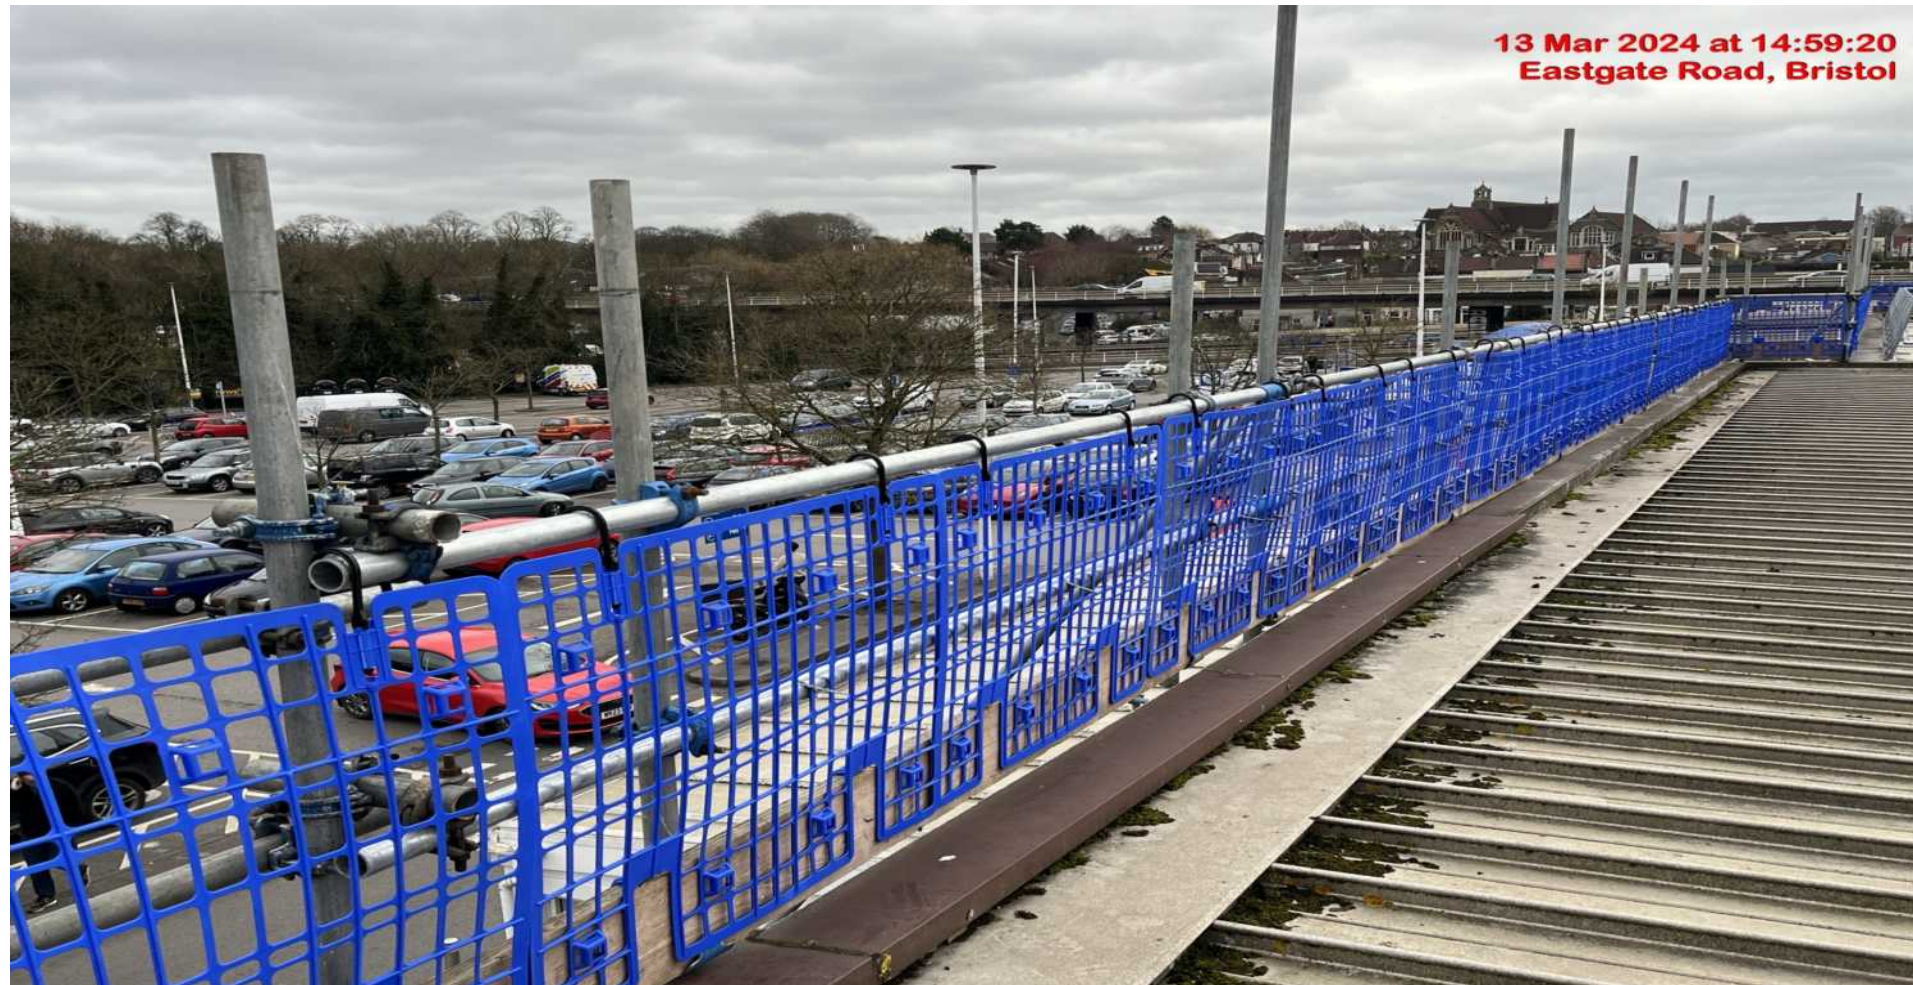
EAS 006

Notes: **No Handover Certificate in place for Edge Protection Handrails at time of the Scaffold Inspections.**

Edge Protection Handrails erected to meet requirements of TG20:21 and with sufficient Brickguards to prevent objects falling below.

Edge Protection Handrails above Store Entrance.

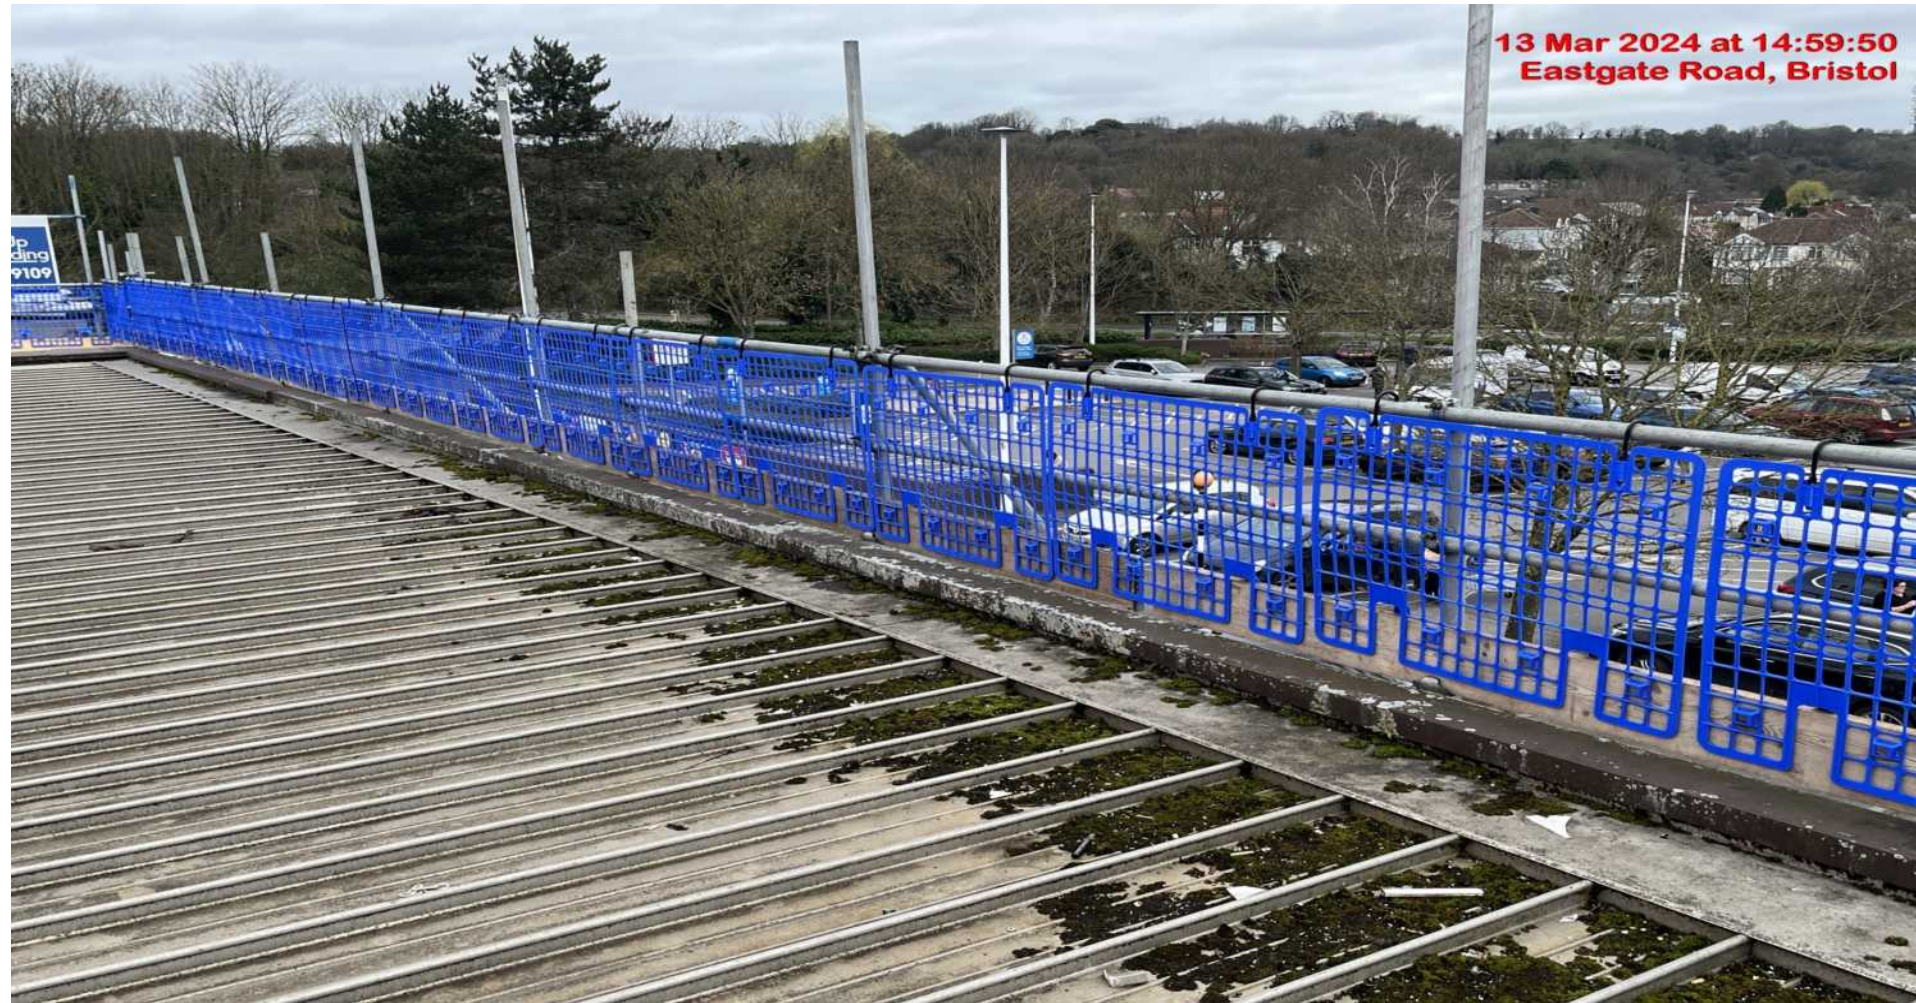
EAS 006

Notes: **No Handover Certificate in place for Edge Protection Handrails at time of the Scaffold Inspections.**

Edge Protection Handrails erected to meet requirements of TG20:21 and with sufficient Brickguards to prevent objects falling below.

Edge Protection Handrails above Store Entrance.

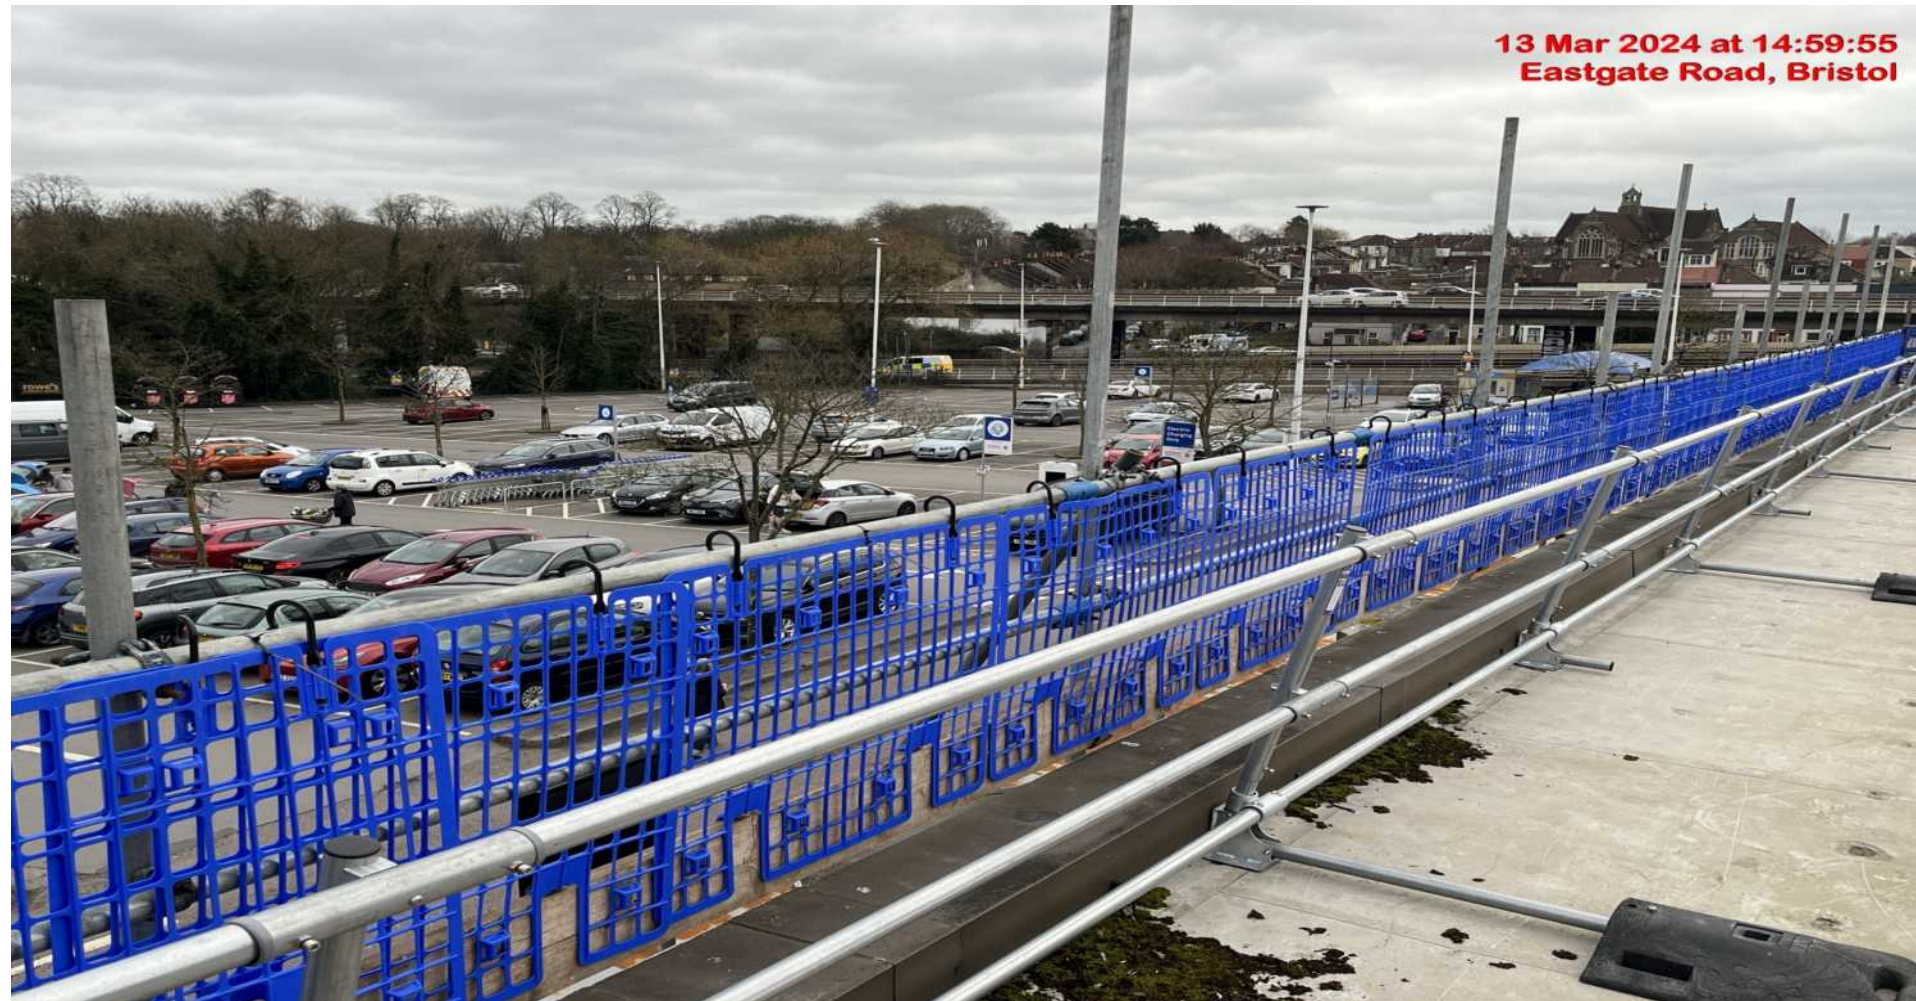
EAS 006

Notes: **No Handover Certificate in place for Edge Protection Handrails at time of the Scaffold Inspections.**

Edge Protection Handrails erected to meet requirements of TG20:21 and with sufficient Brickguards to prevent objects falling below.

Edge Protection Handrails above Store Entrance.

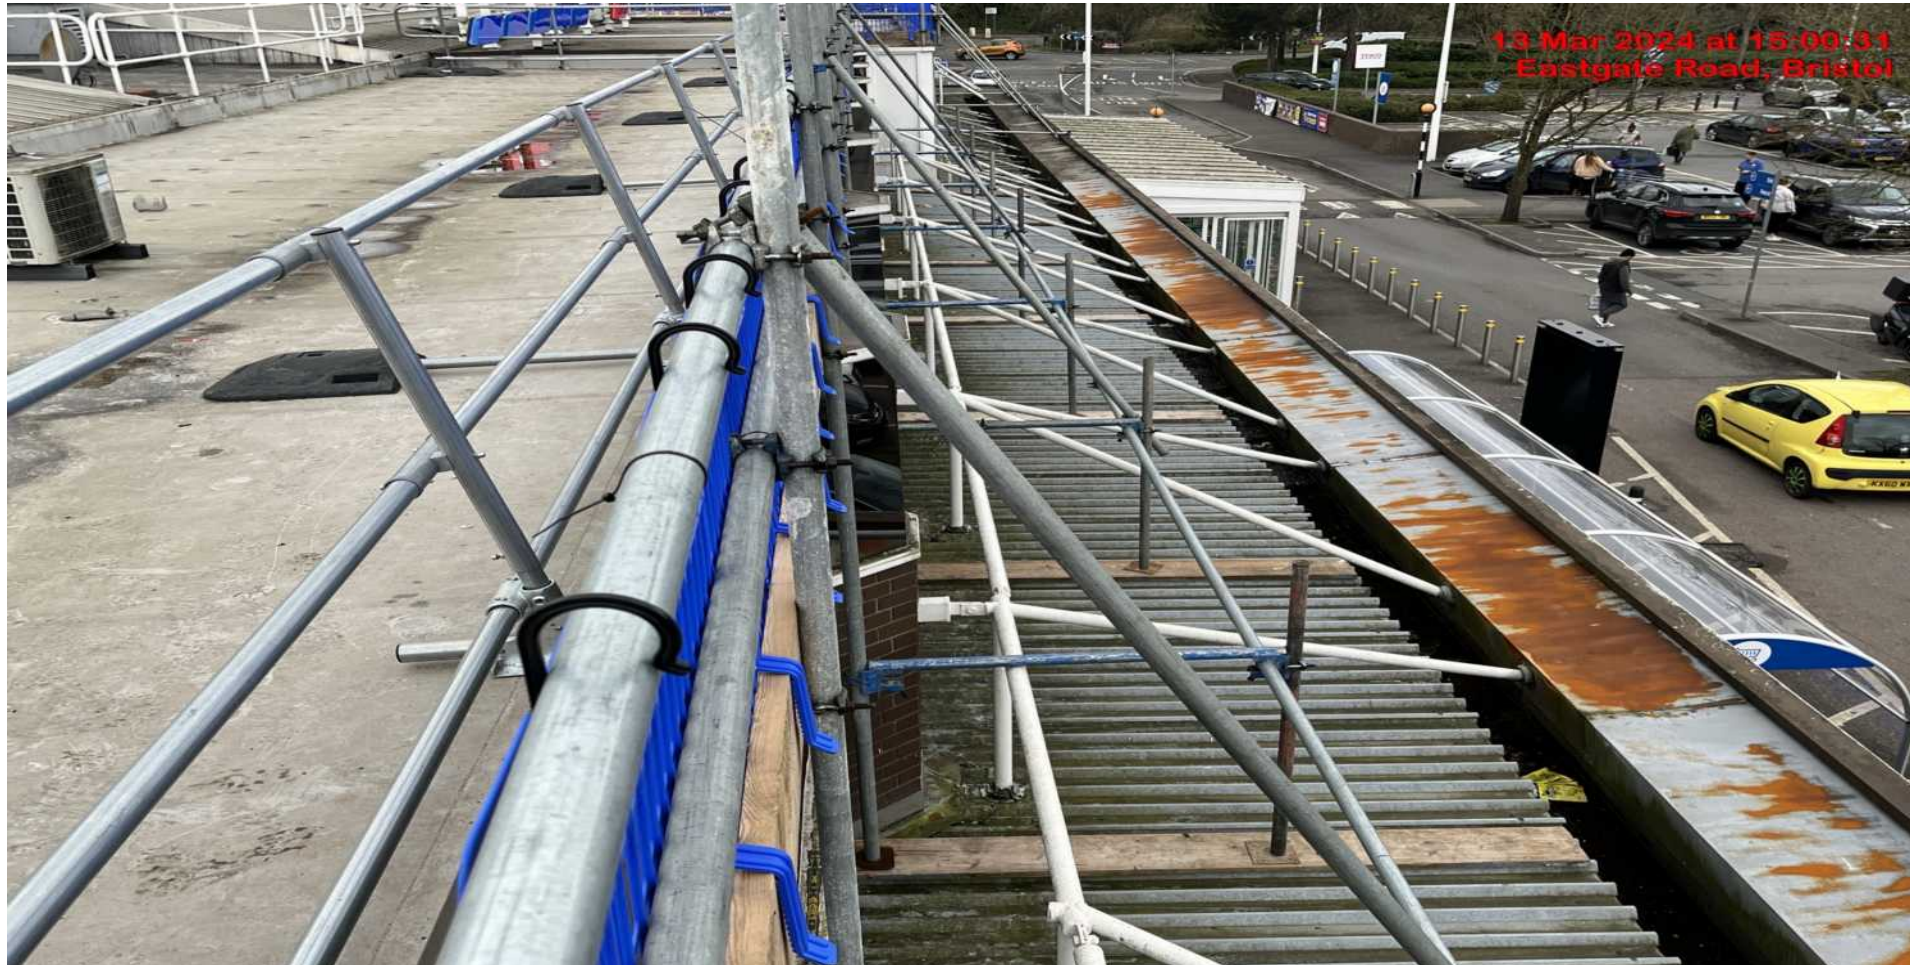
Notes: **No Handover Certificate in place for Edge Protection Handrails at time of the Scaffold Inspections.**

Edge Protection Handrails erected to meet requirements of TG20:21 and with sufficient Brickguards to prevent objects falling below.
